**Aerial Assessment of Charleston Side Channel Reservoir
(Embarras River) Champaign, Douglas and Coles Counties
July, 2005**

Prepared by Wayne Kinney for IL. Dept. of Agriculture

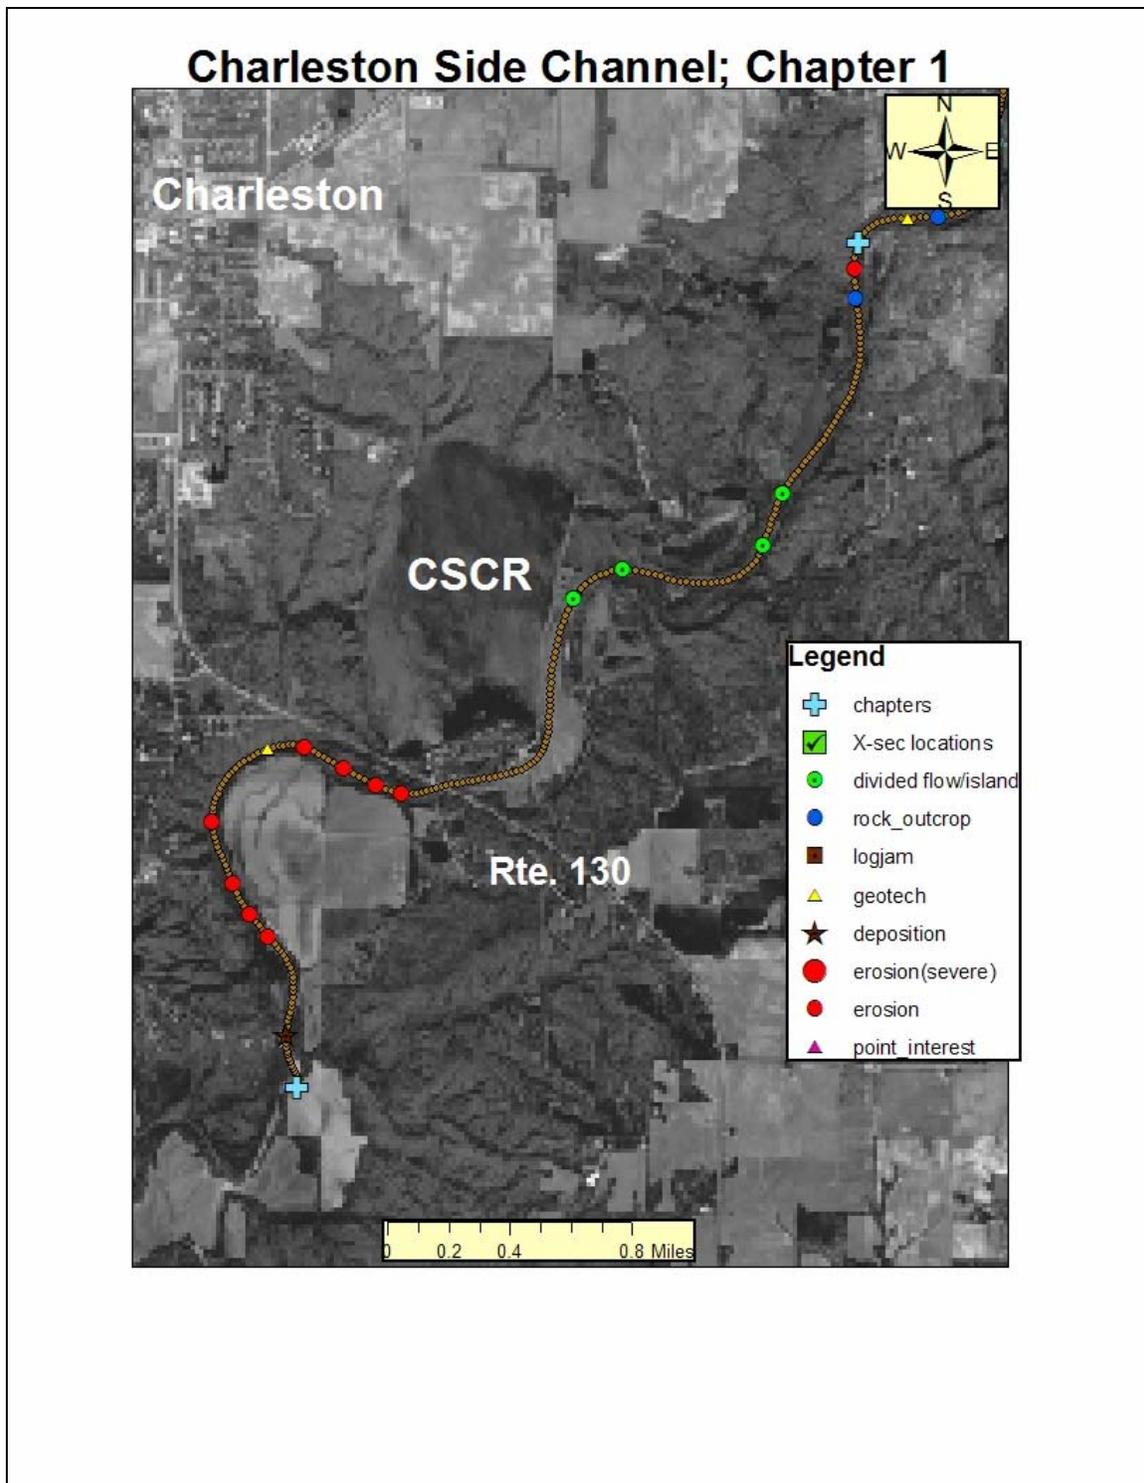
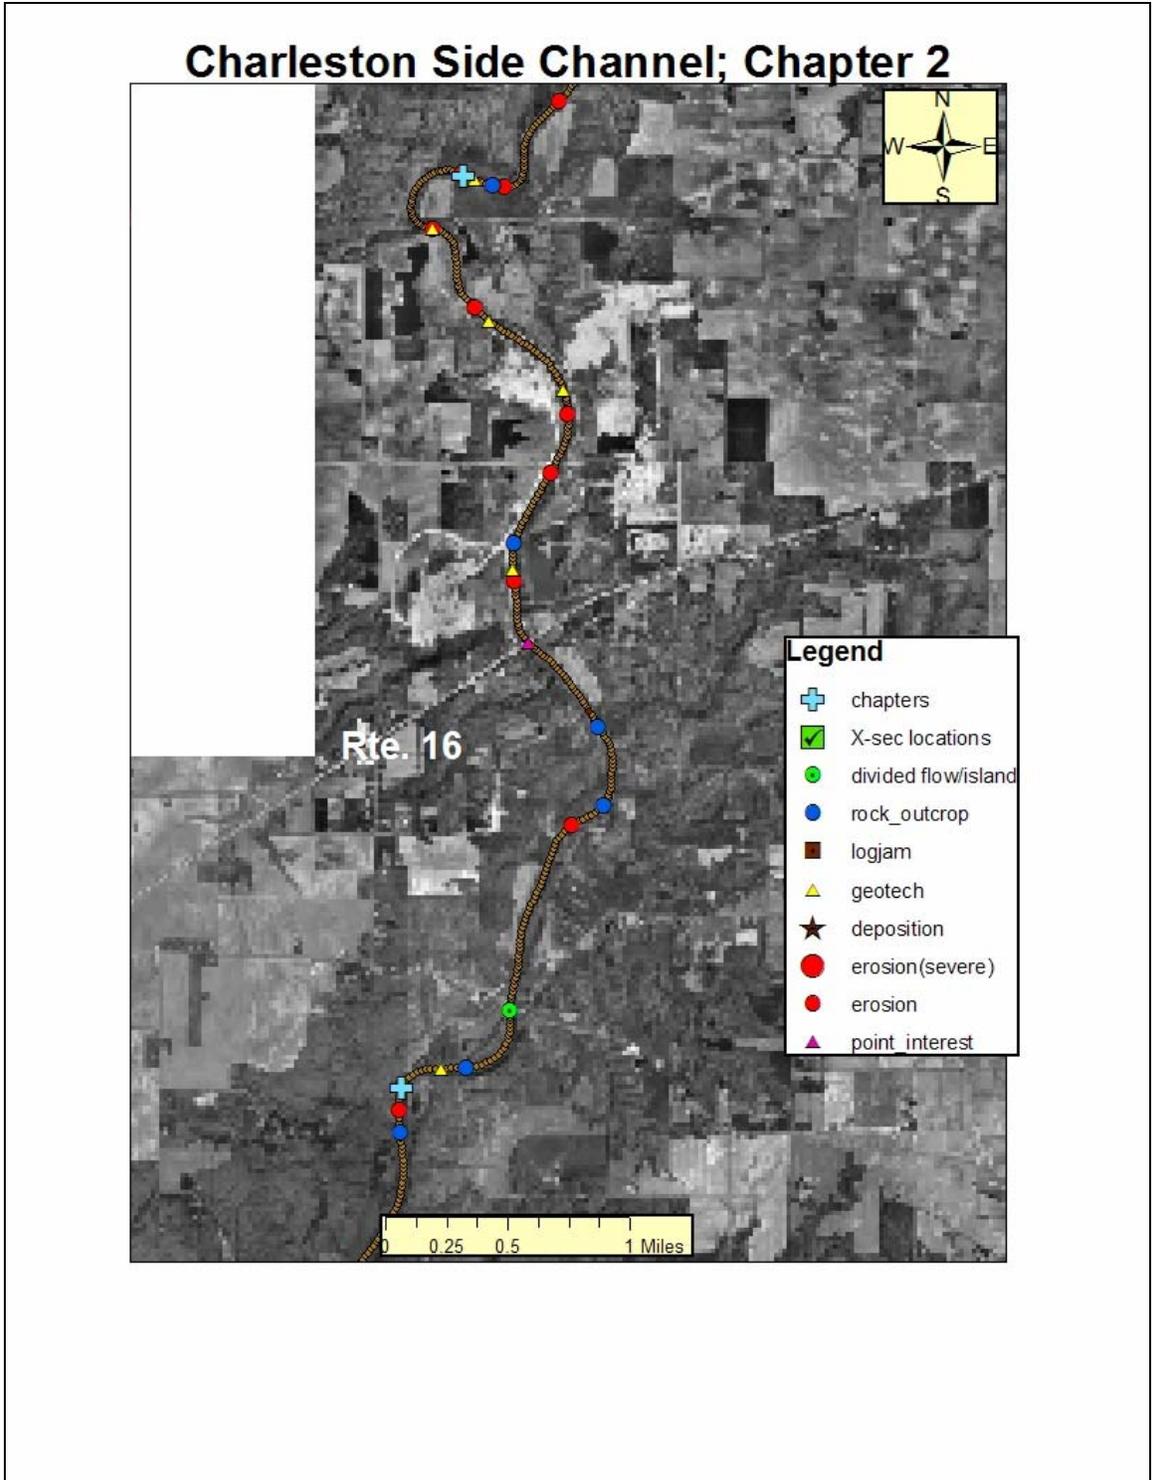
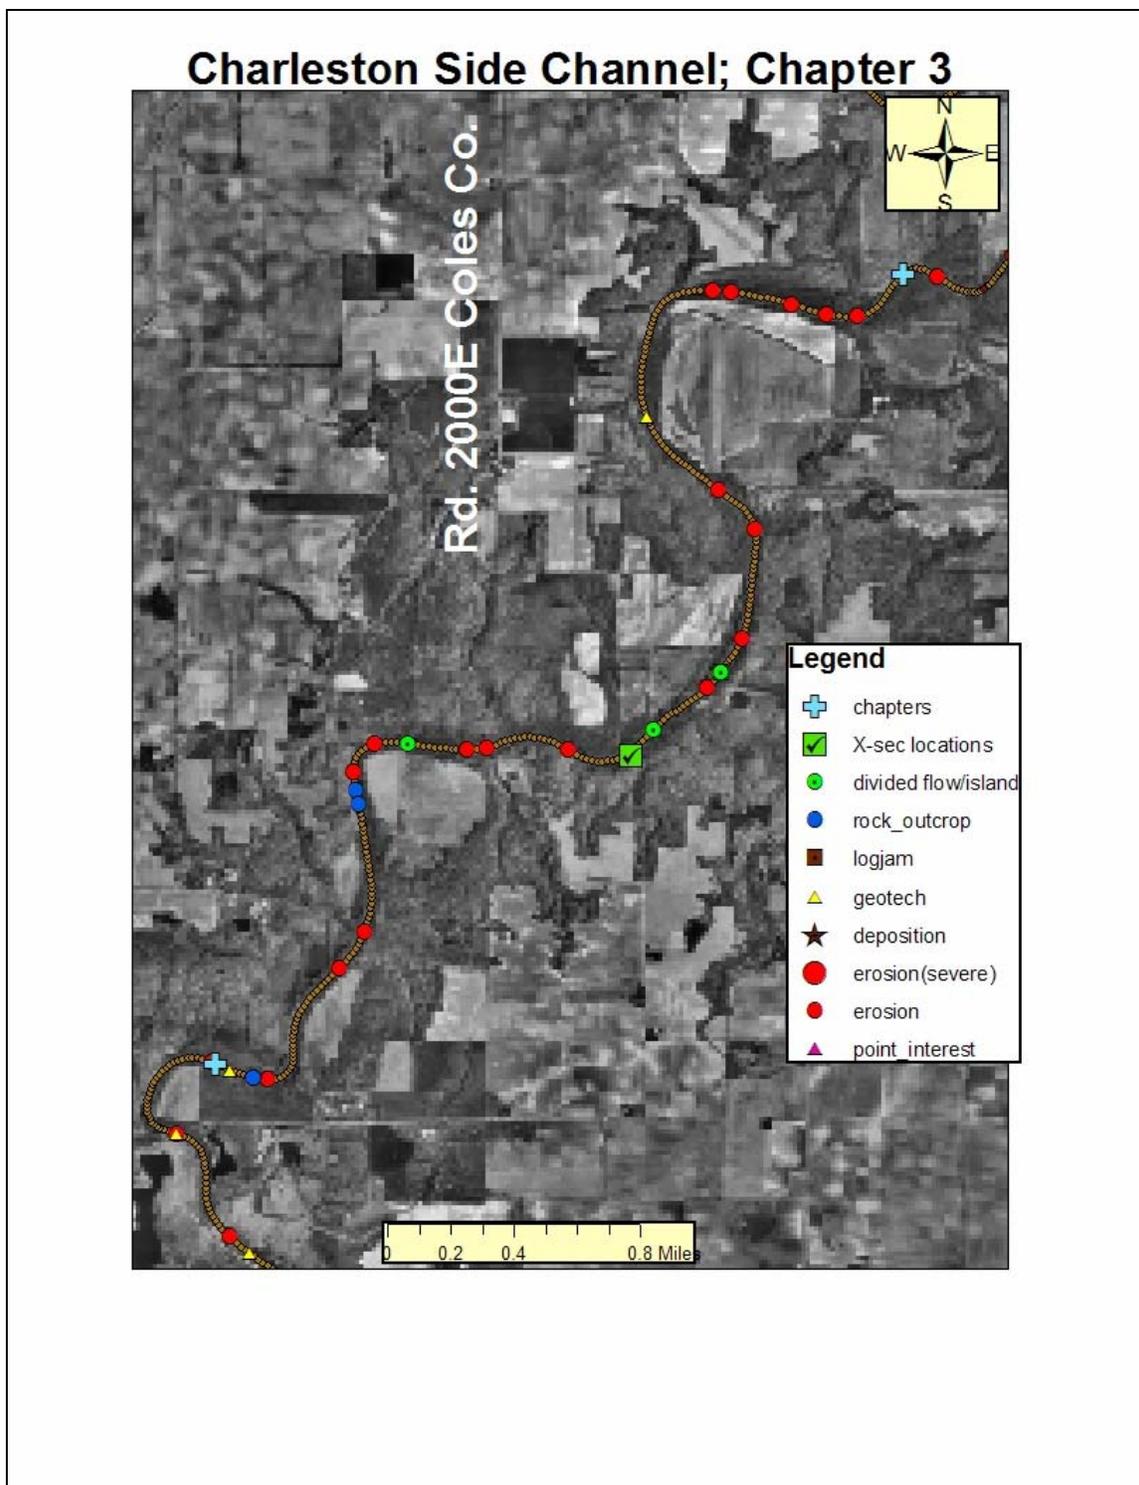
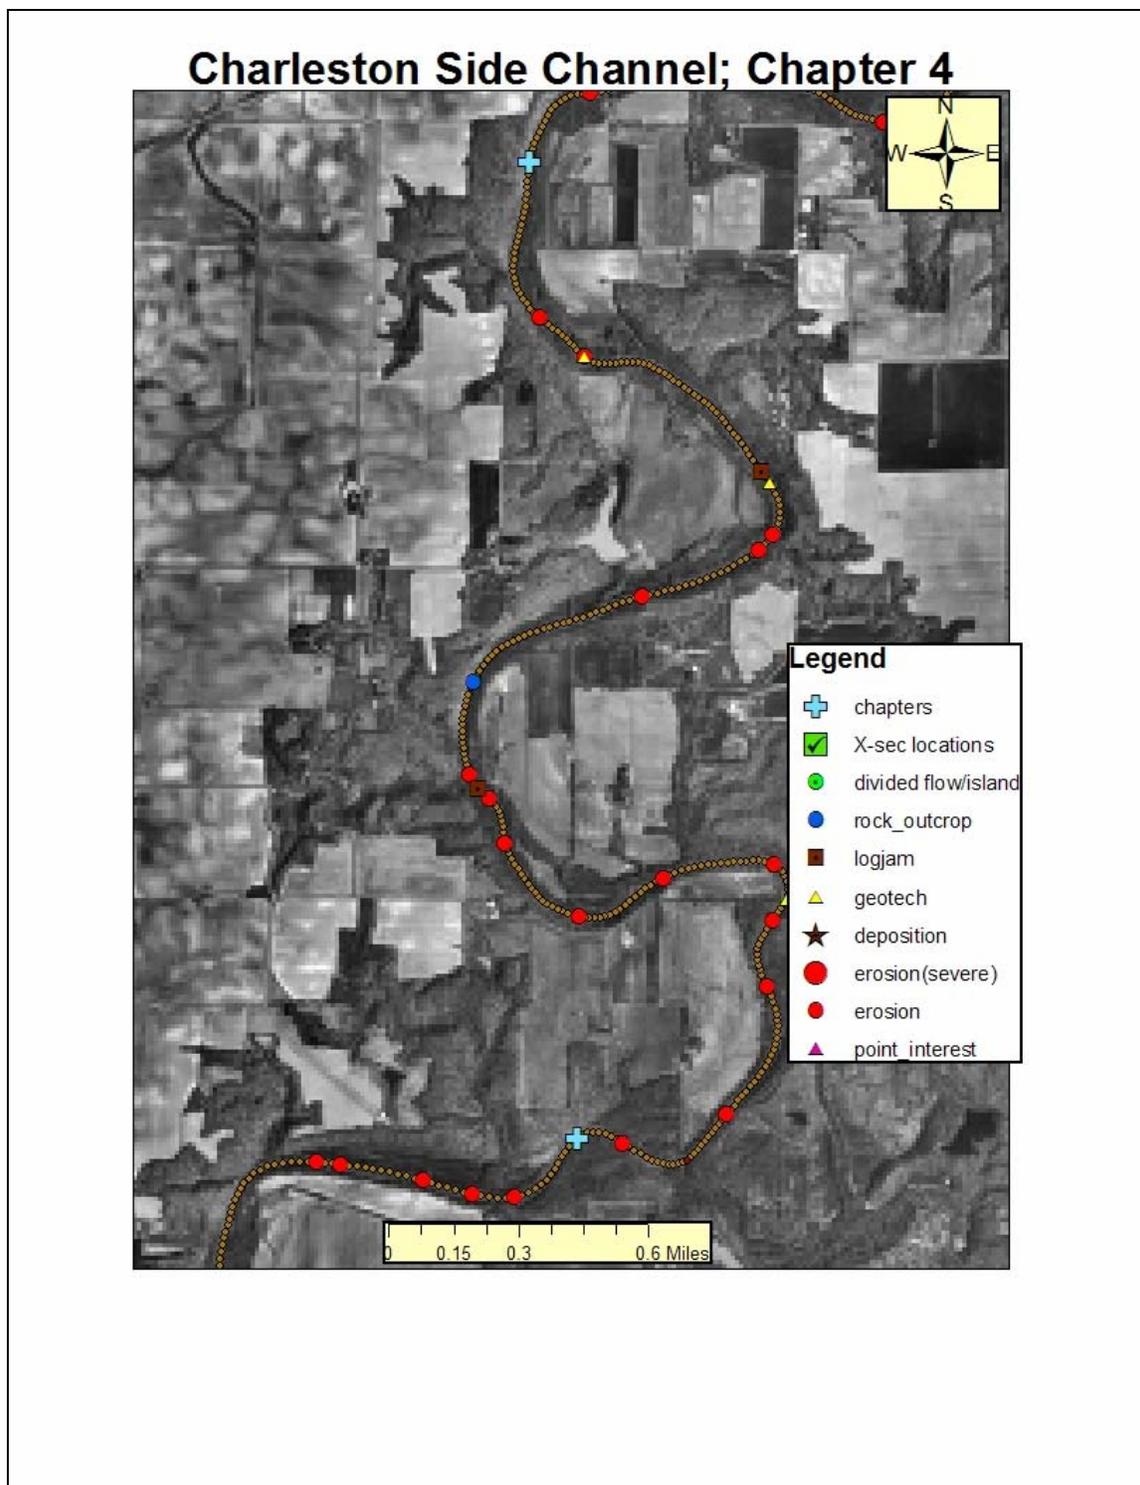
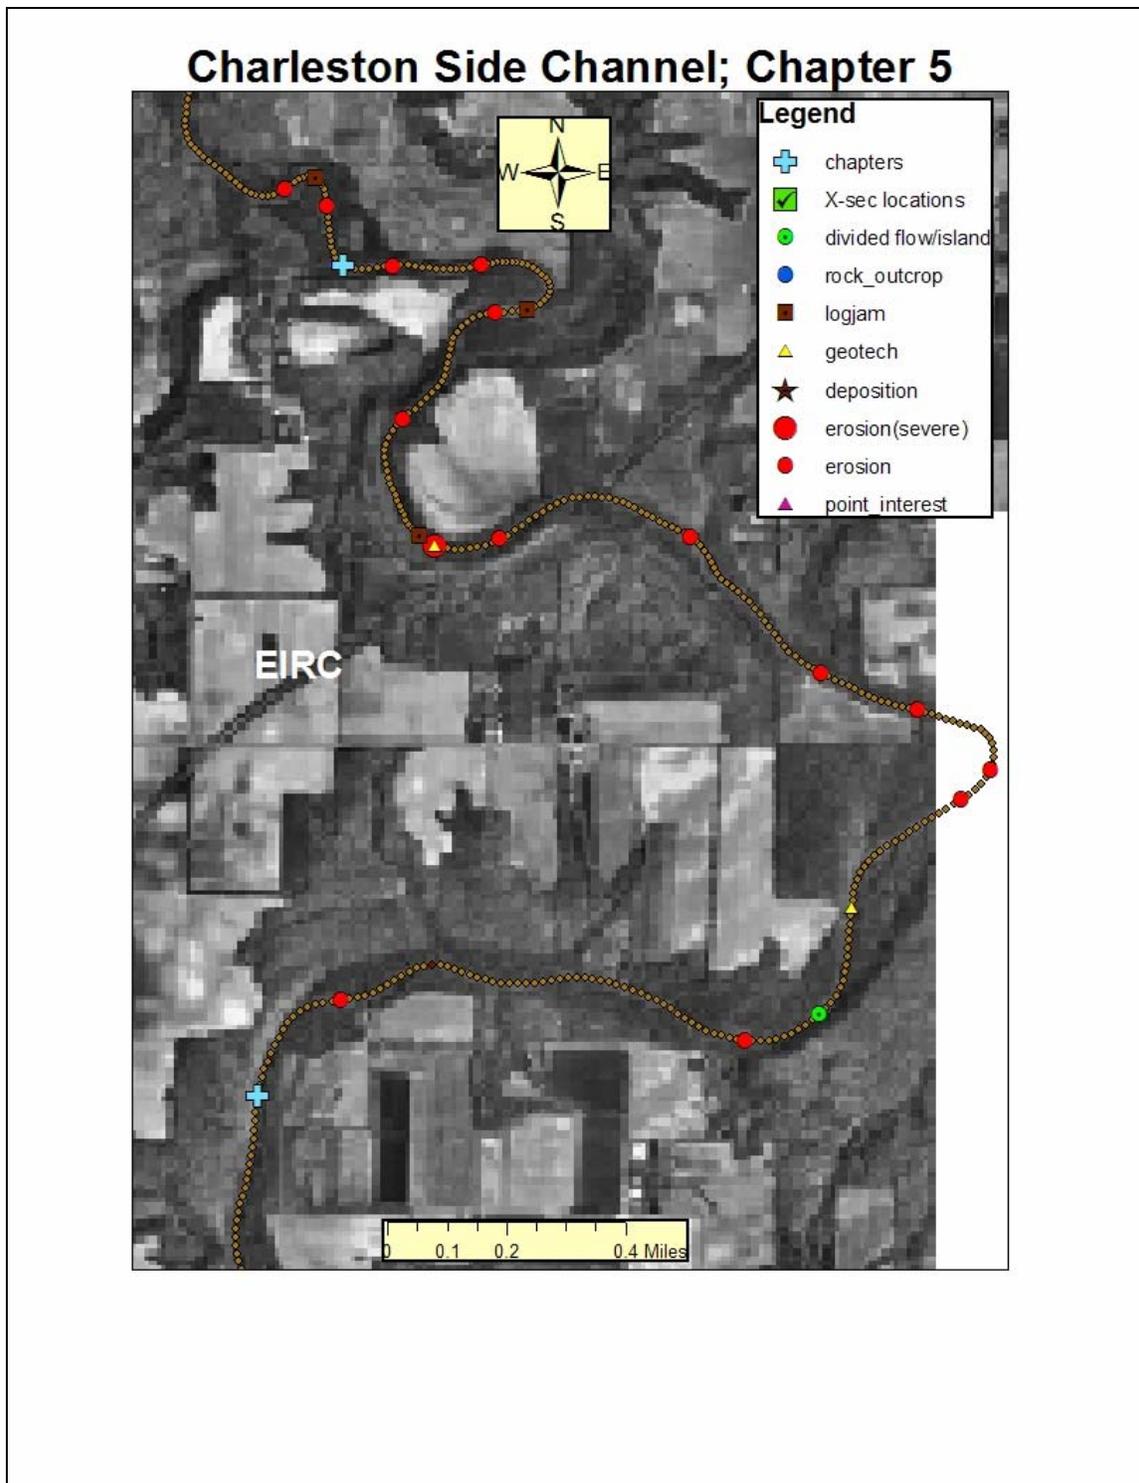
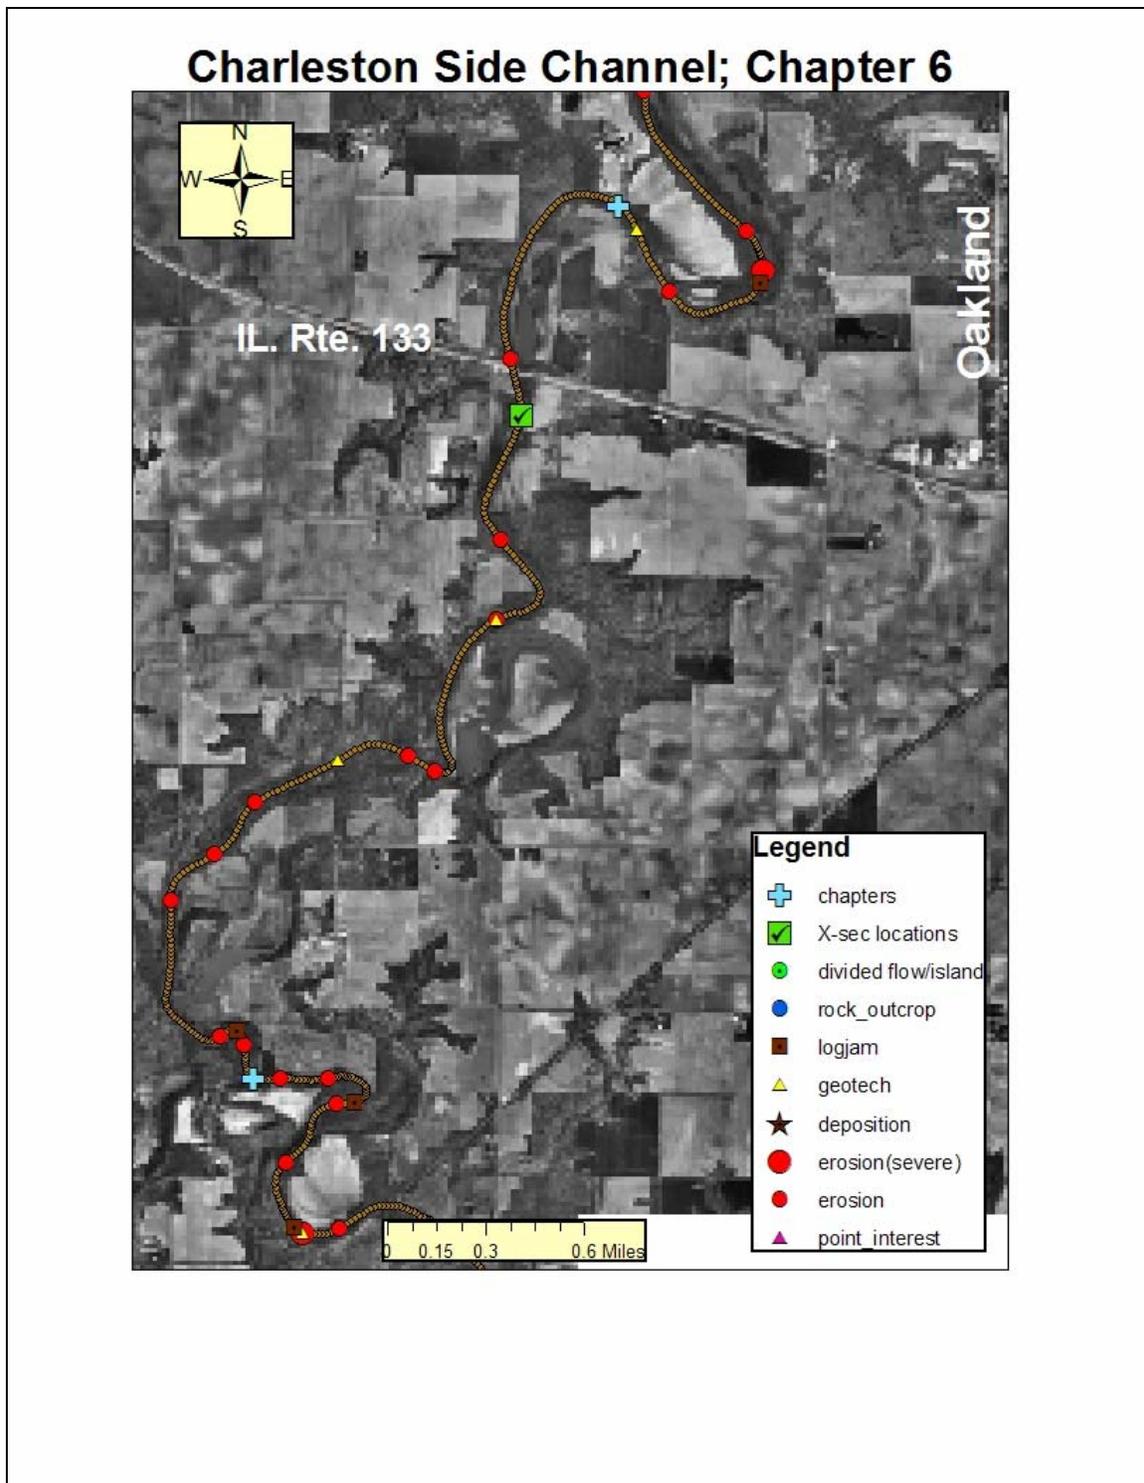
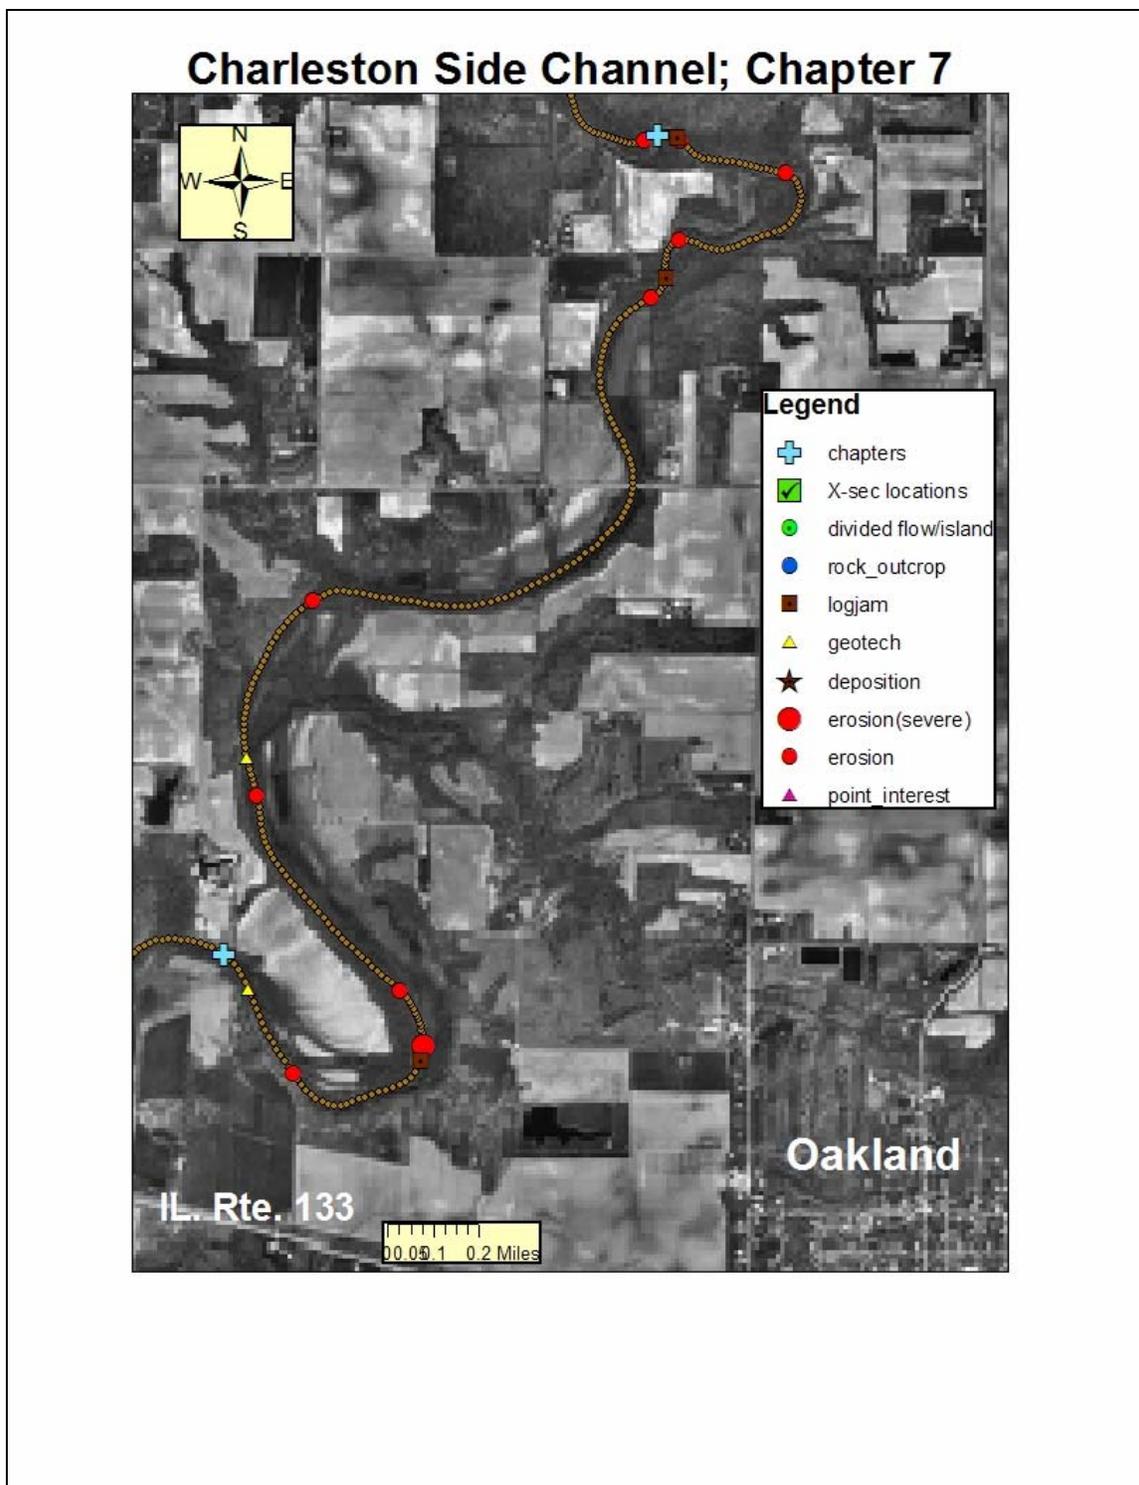
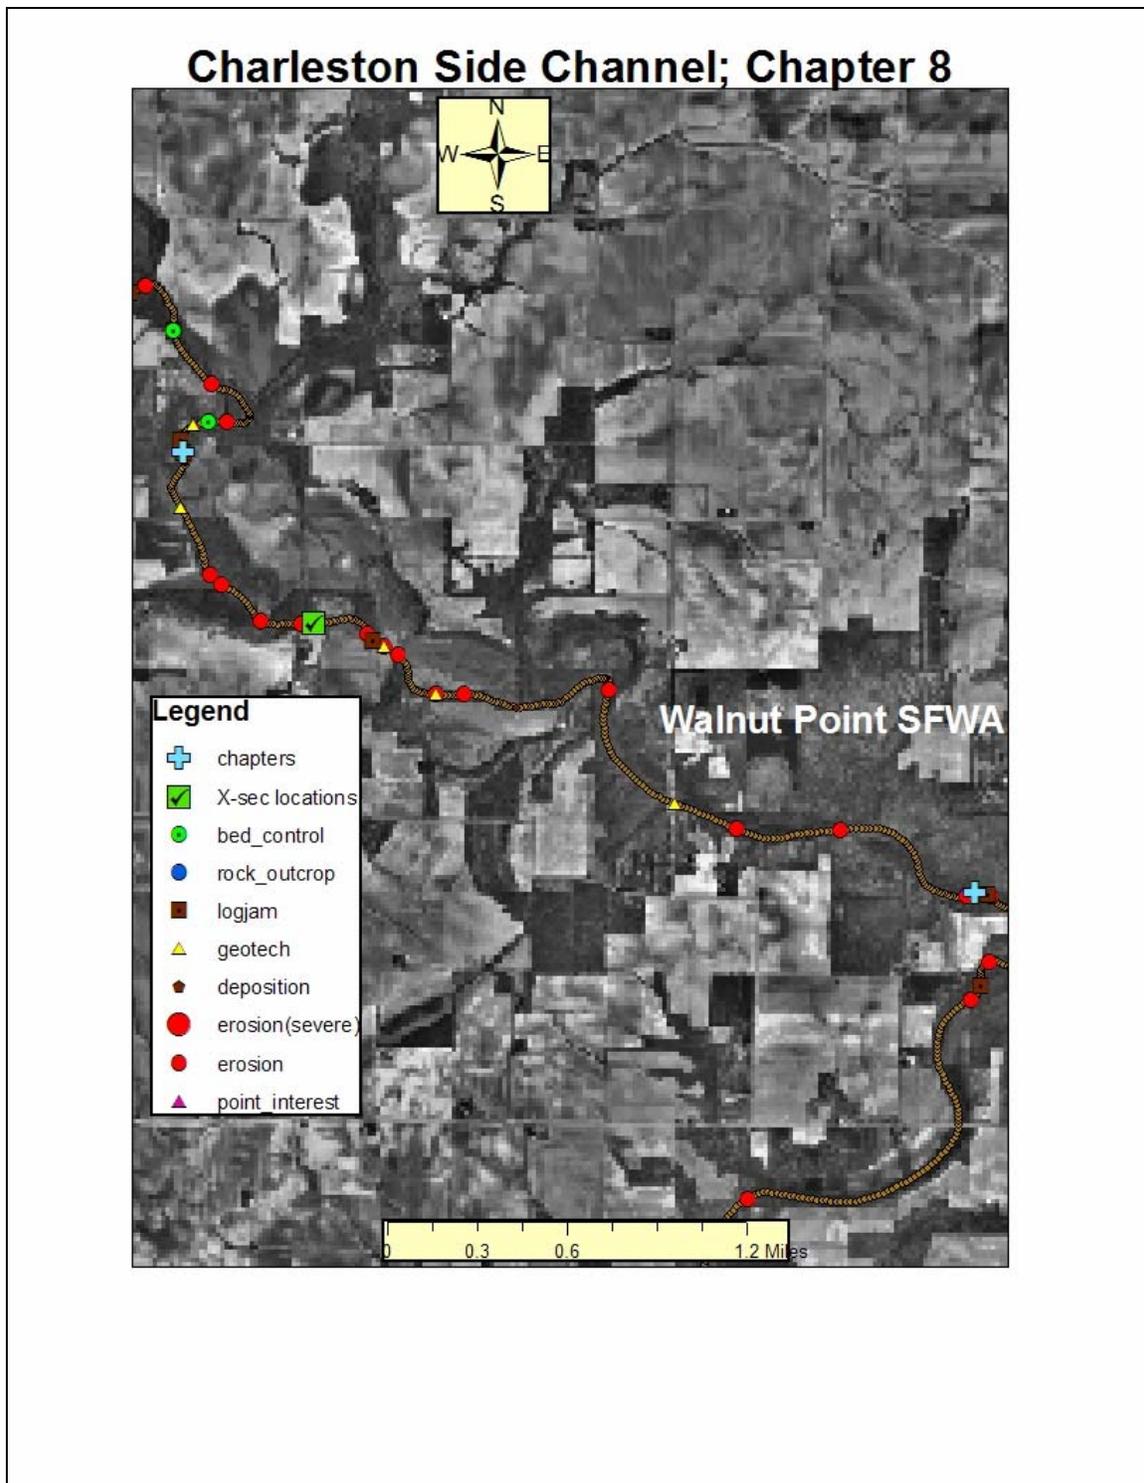
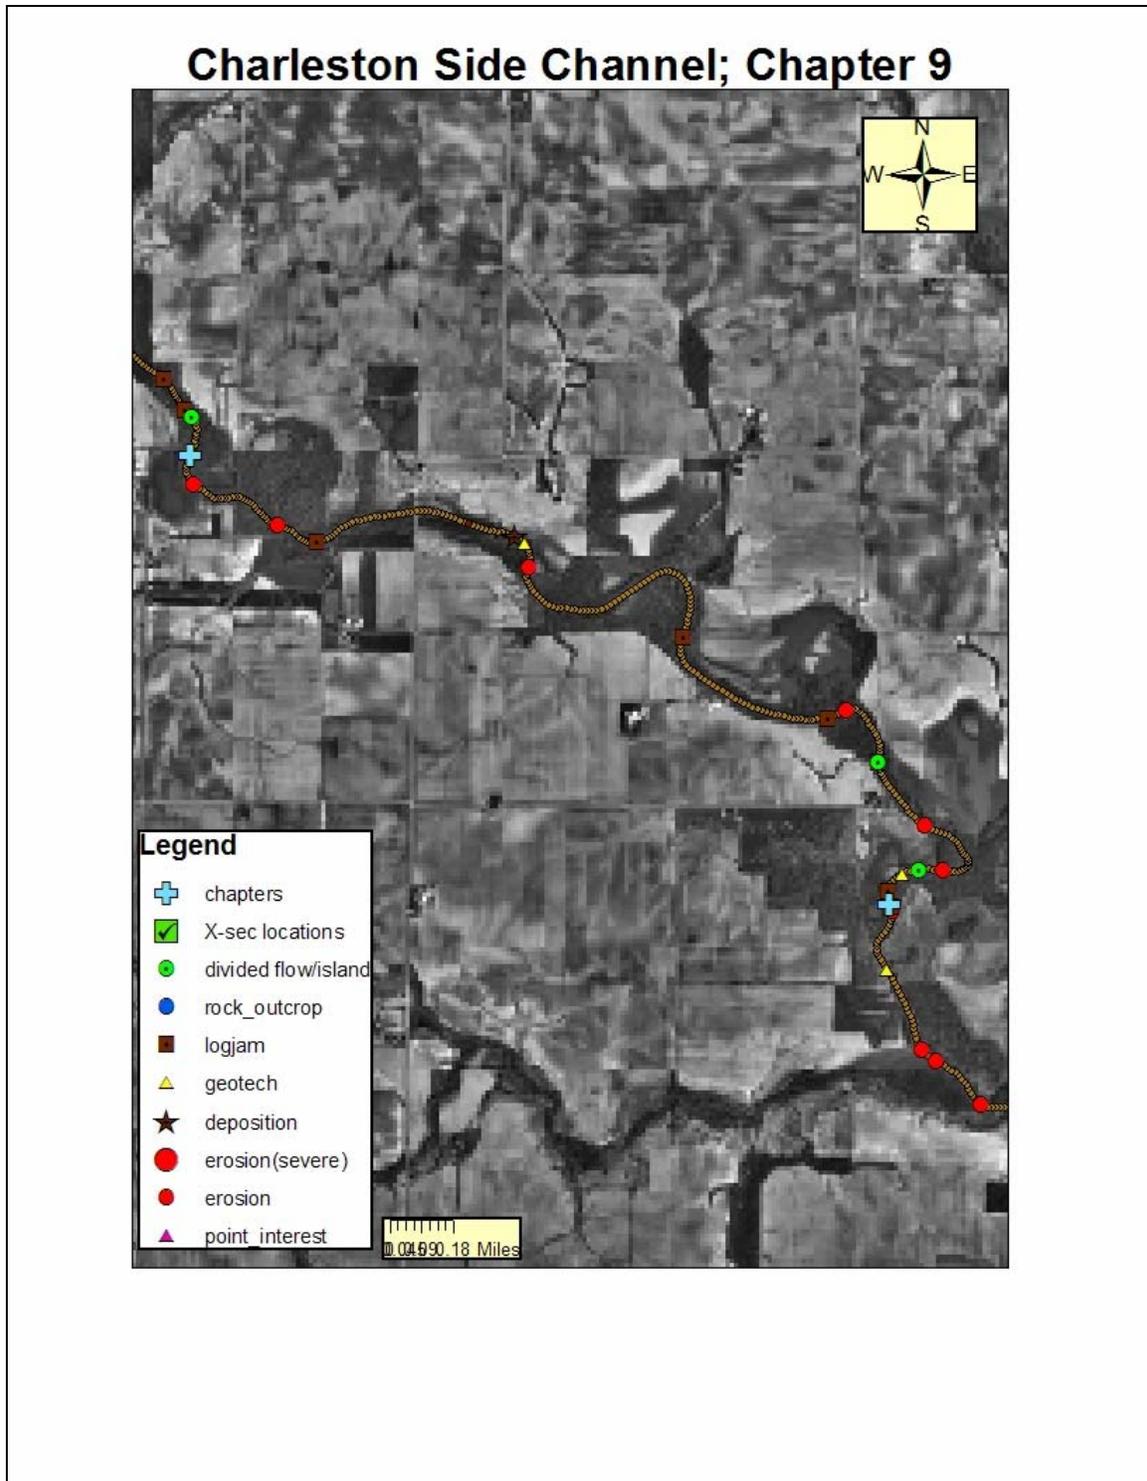
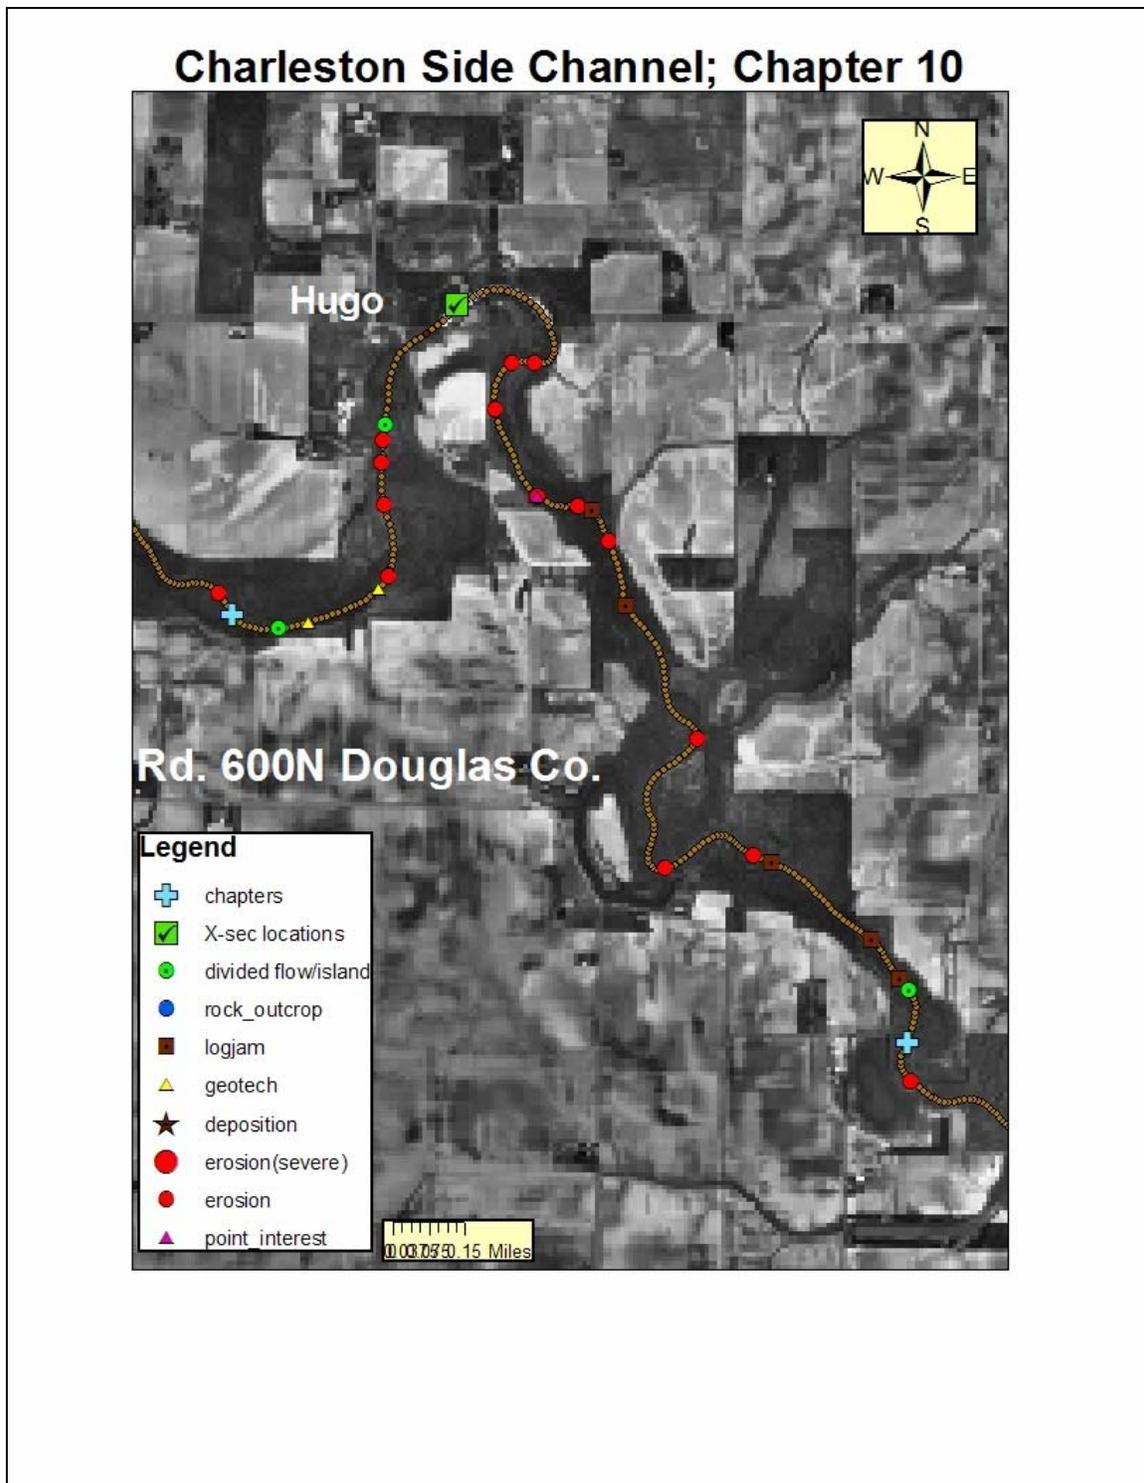
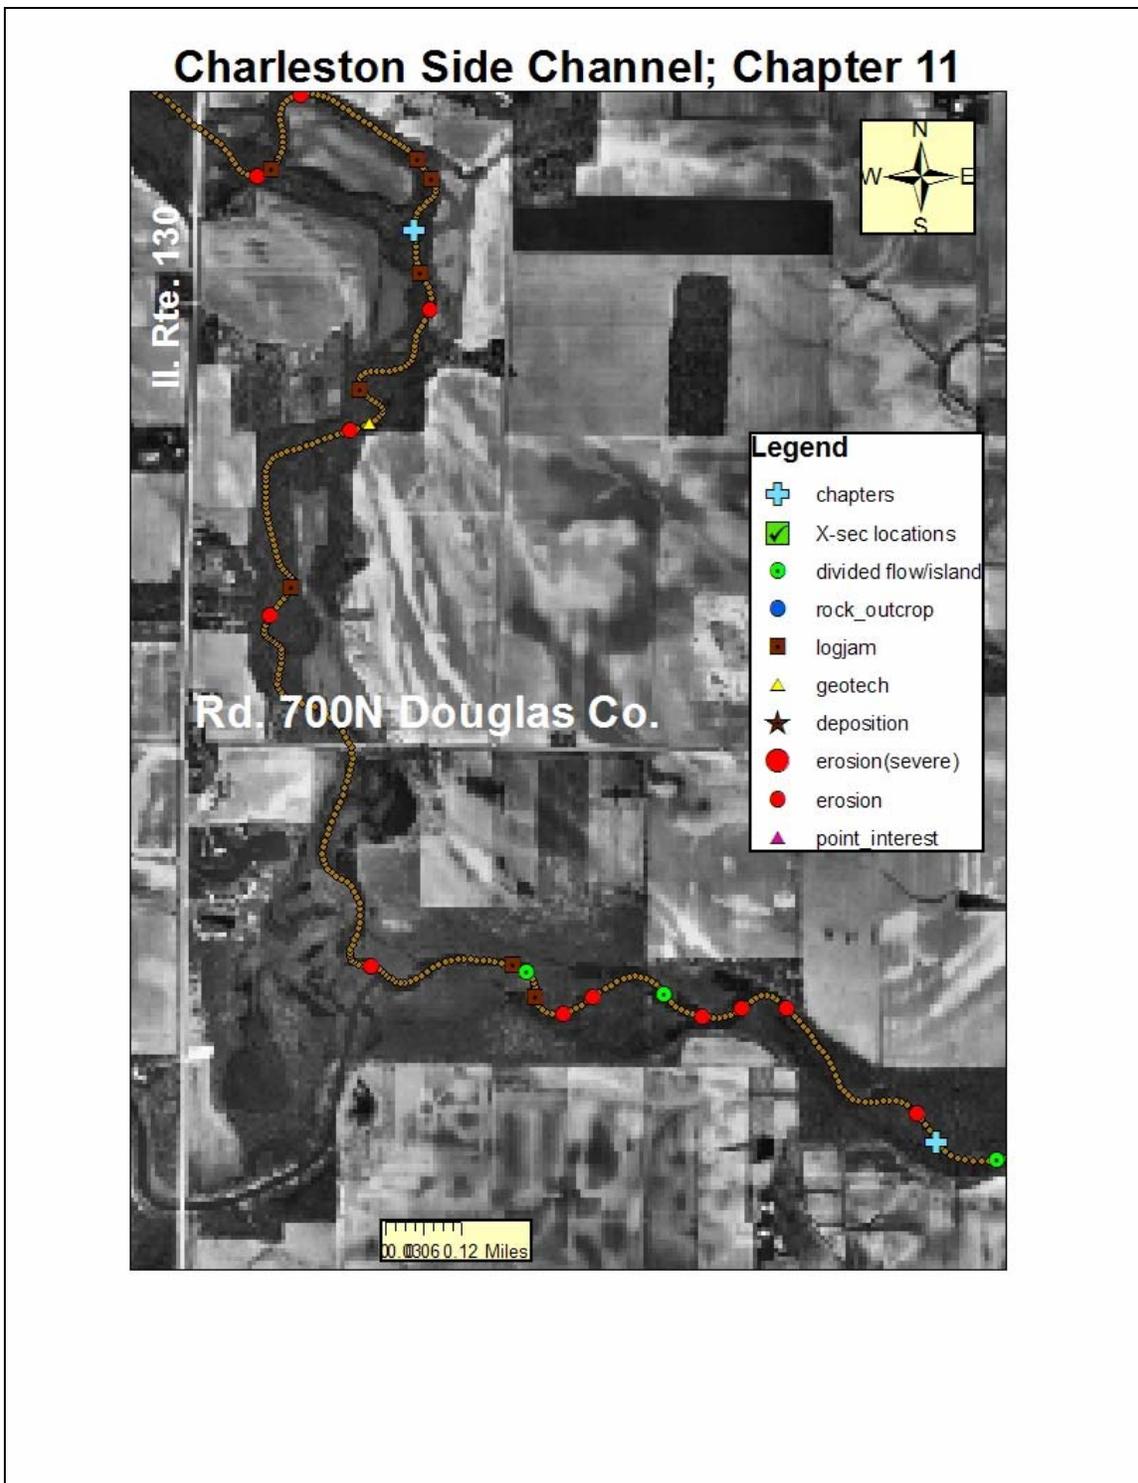
Figures 5 thru 20 show the location of eroding sites needing potential treatment, but no distinction is made for individual sites between those needing woody debris management only and those needing bank stabilization. No other treatment is recommended.

The recommendation is therefore to actively remove major logjams and large woody debris that is likely to form a logjam. The current erosion sites not associated with

woody debris could be successfully treated with stream barbs to stop the bank erosion and prevent additional trees from entering the channel through bank failure. It is estimated from the DVD that 40 to 50% of the erosion sites would be candidates for stabilization. The stone required for the average barb in the Embarras is estimated to be 150 tons at a cost of \$4500 each. Each outside bend treated will require 4 to 5 barbs at an estimated cost of \$18,000 to \$22,500 per site. The total cost of treatment with streambarbs would then be approx. 70 sites at \$20,000 each for a total of \$1,400,000.
