AERIAL ASSESSMENT OF DUTCHMAN CREEK JOHNSON COUNTY, IL December, 2004

Prepared by Wayne Kinney for Illinois Department of Agriculture

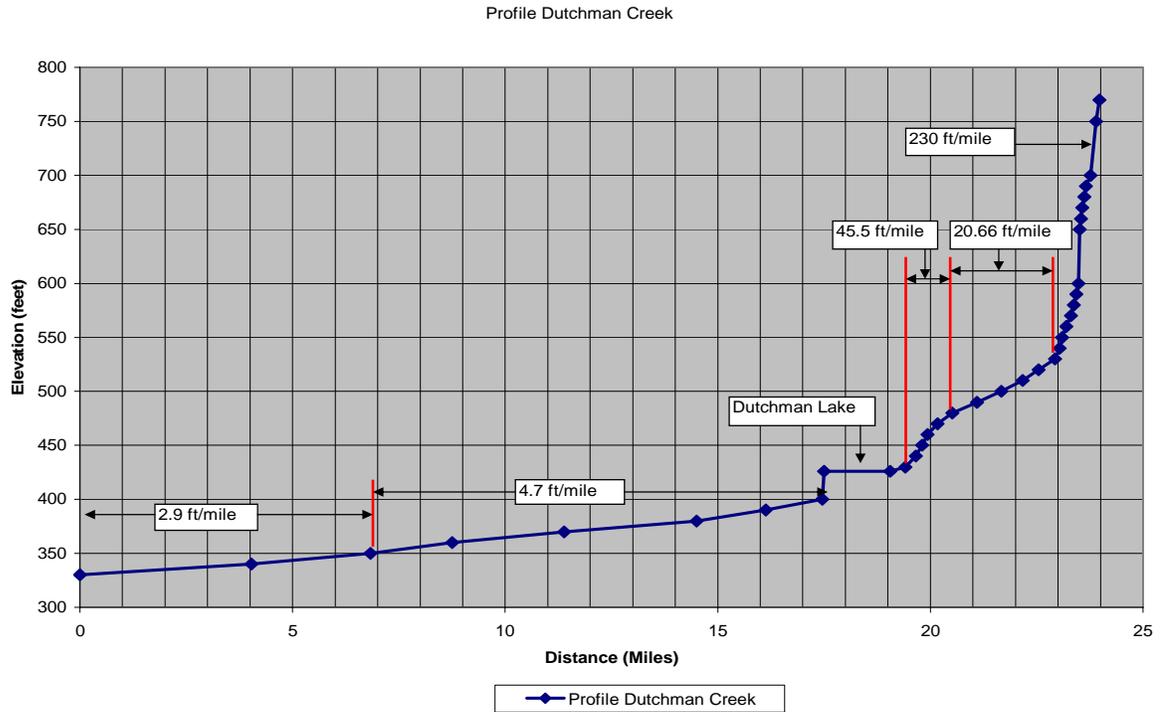
Figure 1. Valley Slope along Dutchman Creek from USGS Topographic Maps

There is a significant difference in the character of Dutchman Creek above Dutchman Lake as compared to Dutchman Creek below Dutchman Lake. First, the valley slope in Dutchman Creek reduces from 45 ft./mile immediately above Dutchman Lake to less than 5 ft./mile below the Lake. (Fig. 1)

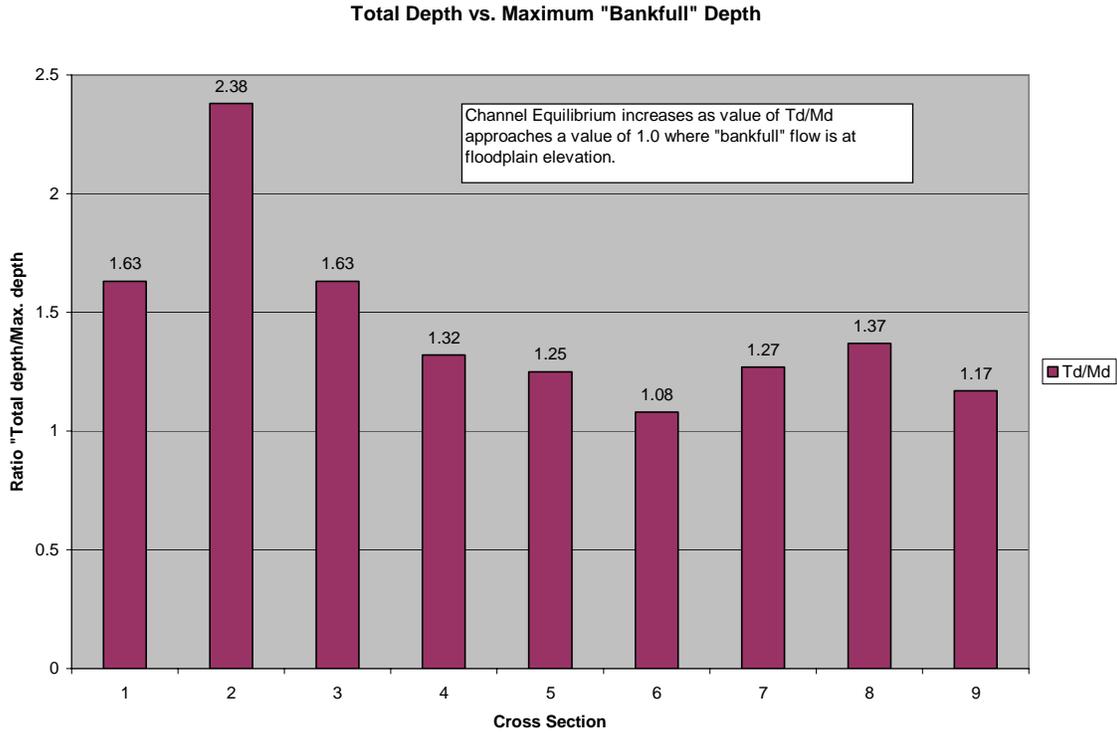
Figure 6. Total Depth at Top Bank compared to Maximum “Bankfull” Depth

Figure 6 shows the greatest incision, at 2.38 times bankfull depth occurs at Cross Section 2. It reduces at subsequent sections downstream to a value of 1.08 times bankfull until reaching Sections 7 and 8 where the incision increases somewhat to 1.27 and 1.37 respectively, before it reduces to 1.17 at Section 9.

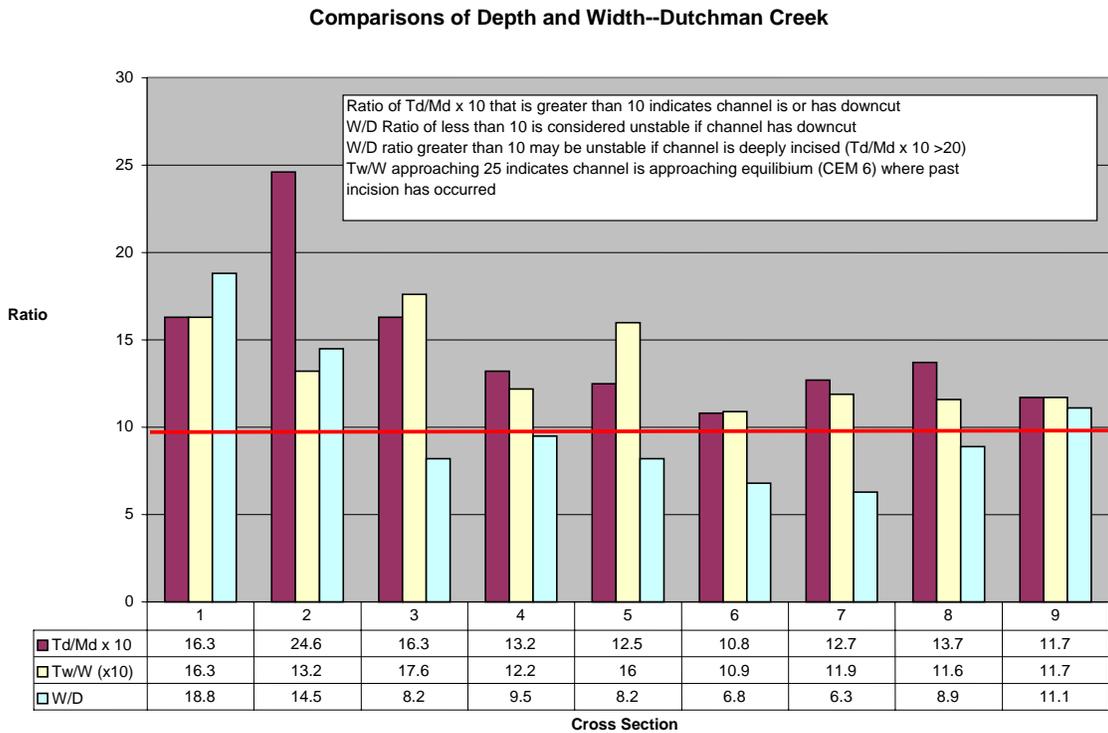
Figure 7. Comparisons of Depth and Width Computations on Dutchman Creek at Cross Section Locations

Although there is insufficient data analysis to assign a CEM stage to this combination of measurements, the following observations can be made. First, values of Td/Md greater than 10 indicate the channel has downcut, with higher values indicating more downcutting and increased separation from the floodplain.

Second, W/D ratios of less than 10 indicates the channel should be considered unstable and widening if the value of Td/Md indicates downcutting has occurred. W/D ratios of more than 10 may also be widening if Td/Md indicates that downcutting has been severe (W/D ratio greater than 20). Third, the Tw/W value indicates the amount of “floodplain” development that has occurred as the channel adjusts to past downcutting. A value of 25, meaning the active floodplain is 2.5 times the bankfull width has been suggested as approaching equilibrium (CEM stage 6).

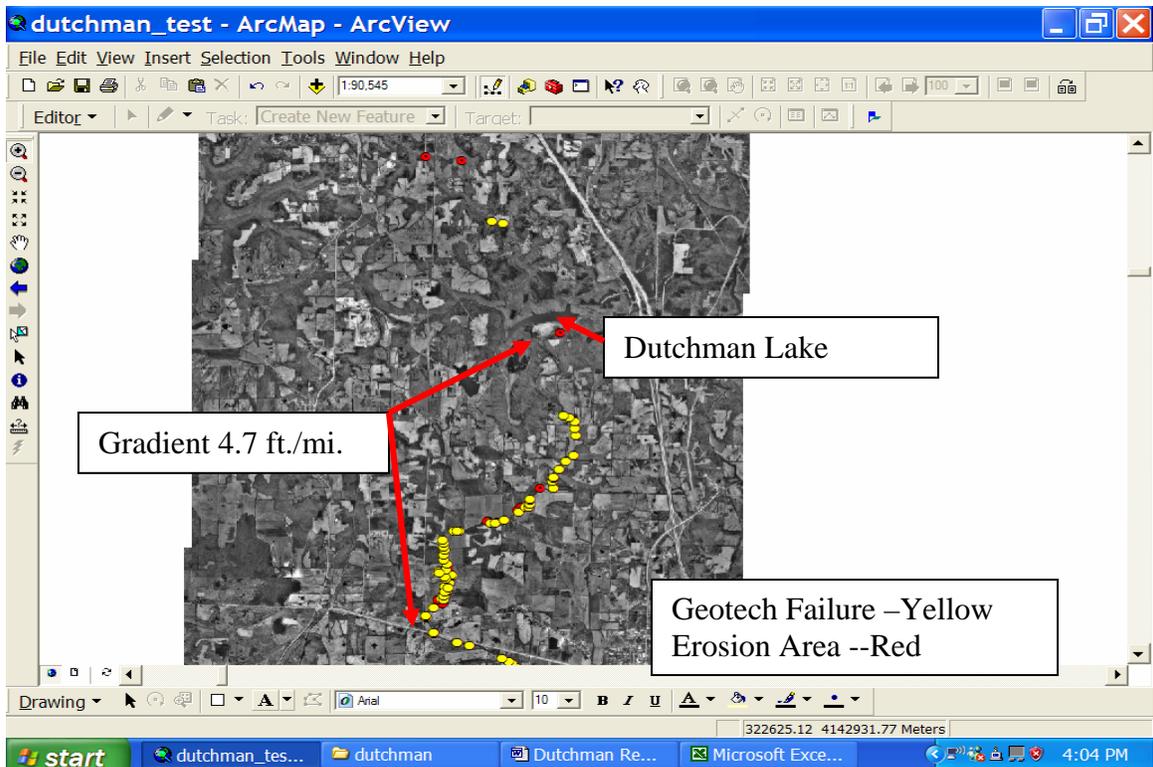
Fig. 8 Upper Dutchman Creek, above Illinois Route 146

Although Cross Section 9 was also determined to be stable by analysis, it does not agree with the USGS review of the DVD. This discrepancy is probably due to the fact that Section 9 was taken at the only “riffle” location in the lower portion of Dutchman and the field investigation found that this site has been channelized by excavating through a ridge that contained enough large stone and cobble to armor the bed. See Figures 8 and 9.

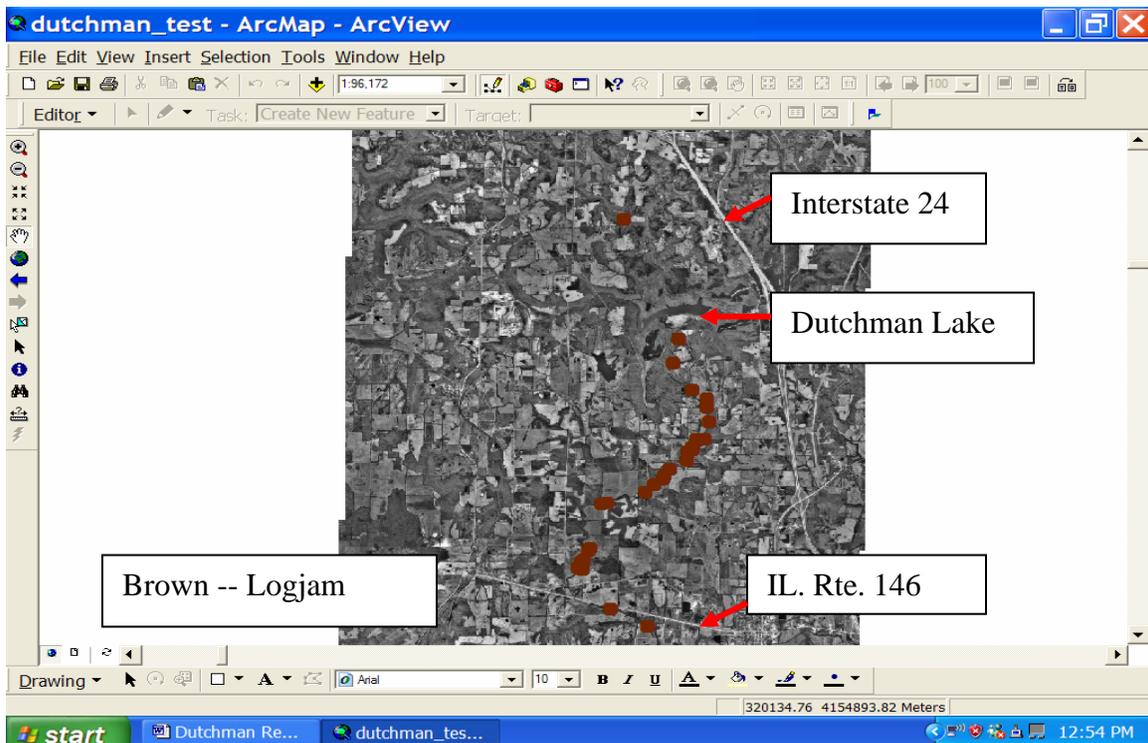
Fig. 10 Dutchman Creek Logjams, above Illinois Route 146

The large bank failures and numerous logjams below Dutchman Lake are presumed to be due to the geotech failures that caused large trees to fall into the channel. See Figures 10 and 11.

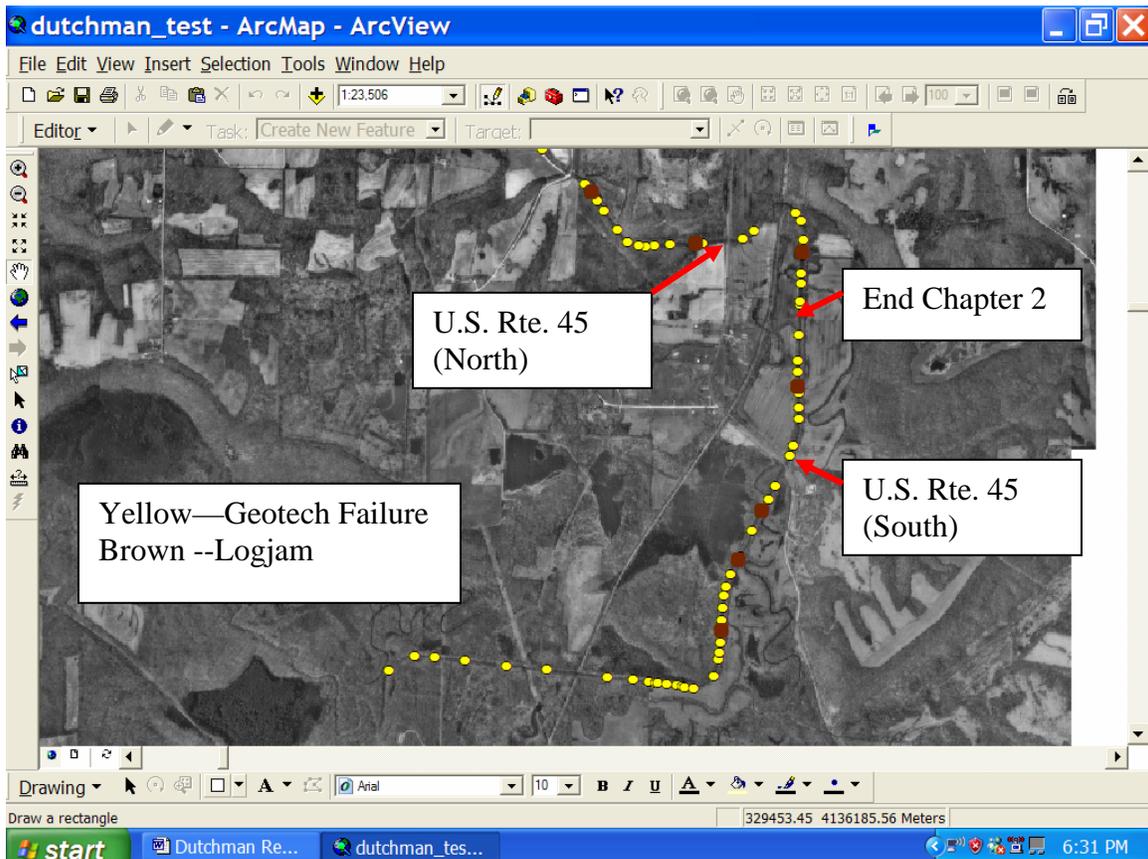
Figure 12. Chapter 2 Dutchman Creek

This section of Dutchman Creek begins at the confluence with the Cache River and continues upstream to a point above the U.S. Route 45 bridge and ends just below cross Section 9. The entire reach has been channelized and has a gradient of about 2.9 ft./mile. There are over 30 geotech failures identified in this reach. They are located all along the channel with no specific area of concentration. There are no grade breaks or riffles in this reach as it is one long slow moving pool about 2.4 miles long.

The bank failures appear to be the result of oversteepened banks, possible due to downcutting, although the pool depth in this reach prevented an accurate cross section from being collected. Downcutting has been identified in the Cache River immediately downstream and Newberry type Rock Riffle Grade Controls have been installed.

A series of Rock Riffle Grade Control Structures is recommended for treating this reach. The height and location of each structure will depend on a design survey and calculations that cannot be made at this time. However, there is only approximately 7 feet of fall in this entire reach, so for re-aeration purposes the structures cannot have a total drop of more than 7 feet plus any increase in water surface profile that can be achieved without causing flood damages.

For estimating purposes, assume 8 Newberry type structures three feet high with a net drop of 1 foot per structure. Each structure will require approximately 650 tons of stone at a cost of \$40 per ton installed. Therefore, each structure is estimated to cost \$26,000 for a total estimated cost of \$208,000. Fig. 13 is an example of a Newberry style rock riffle near Bloomington, Illinois.

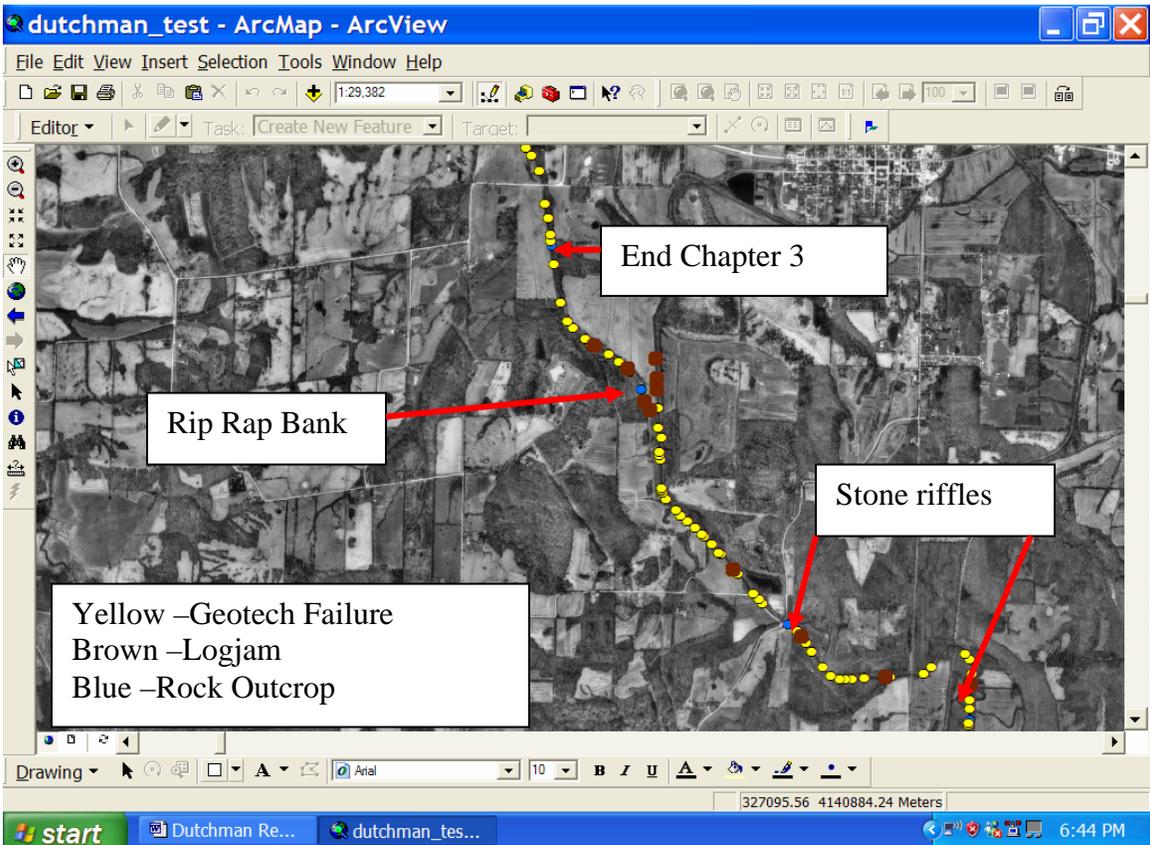
Fig. 15 Chapter 3, Dutchman Creek

This section begins approximately halfway between the two U.S. Route 45 bridges and continues upstream to approximately 0.5 mile below Old Cypress Road. This reach is very similar to Chapter 2 with the addition of two existing riffles where there is some re-aeration occurring. Both of these sites are stone cobble riffles that appear to be stable. Figure 15 shows the location of Chapter 3 and the identified features of geotech failure, logjams and rock outcrops.

This reach has over 40 identified geotechnical failures and at least 8 logjams. The recommended treatment for this 3.25 mile reach is also to construct either Newberry Rock riffles or Rock Cross Vanes. This structure will increase the aeration, create a riffle pool sequence that will help stabilize the banks and reduce the volume of woody debris which is contributing to the logjams.

Unlike Chapter 2, this reach has cross sectional data that suggest the channel has degraded and is still downcutting. In the very upper reach of Chapter 3, the gradient increases from 2.9 to 4.7 ft./mile and the channel bed has exposed residual material that strongly suggest active downcutting. Using available cross section data, it is estimated that the riffles can be 3.0 feet above the existing channel bed without increasing flood elevations.

There is approximately 10 feet of gradient in this reach, therefore the estimate calls for the installation of 8 additional grade control structures around the two existing natural riffles. The channel begins to reduce in width in this reach, especially above the confluence with the Little Cache River, therefore the estimated stone requirements for each riffle in this reach is reduced to 375 tons at a cost of \$15,000. The total estimated cost for riffles in this reach is \$120,000.

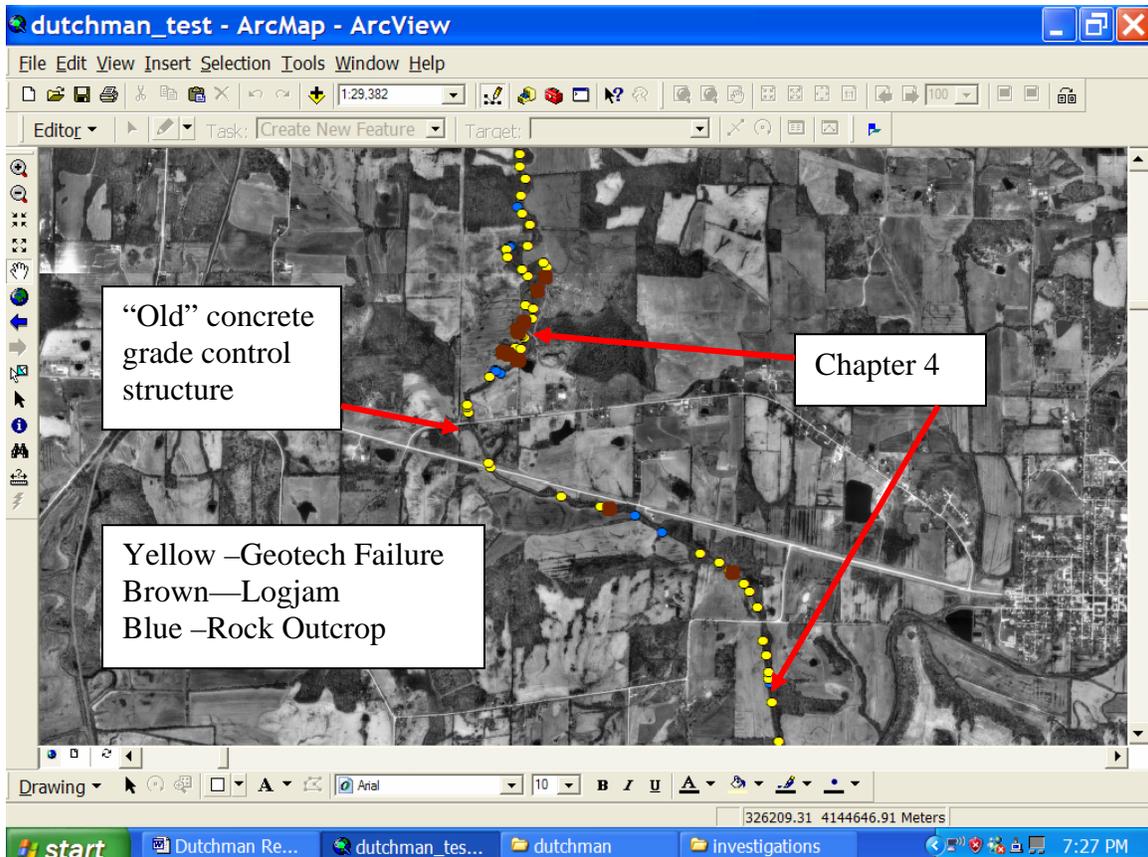
Fig. 16 Chapter 4 Dutchman Creek

This reach begins below Old Cypress Road and continues upstream about 0.75 miles above Old Route 146. The entire reach has a gradient of 4.7 ft./mile. There is a section of this reach below Illinois Route 146 that appears to be near equilibrium. The features of geotechnical failures, logjams and rock outcrops are shown in Fig. 16.

Chapter 4 has less than 20 geotechnical failures identified in 2.7 miles compared to 30 or 40 in chapters 2 and 3. The assessment suggests that the downcutting in Chapter 3 has not migrated as far upstream as Illinois Route 146, but is above Old Cypress Road. In addition there is an old concrete grade control structure just below the Old Route 146 bridge (DVD time 18:25). However, the structure is not in good shape and cannot be depended on to halt any downcutting. This structure demonstrates that with fine bedload, grade controls can be spaced farther apart without losing the ability to pass bedload.

The recommendation for Chapter 4 is to again install Newberry Rock Riffle Grade Control Structures or Cross Vanes to control bed instability and increase aeration. Even though the stream is near equilibrium below Route 146 the grade controls should be built along the entire reach to gain the maximum aeration possible.

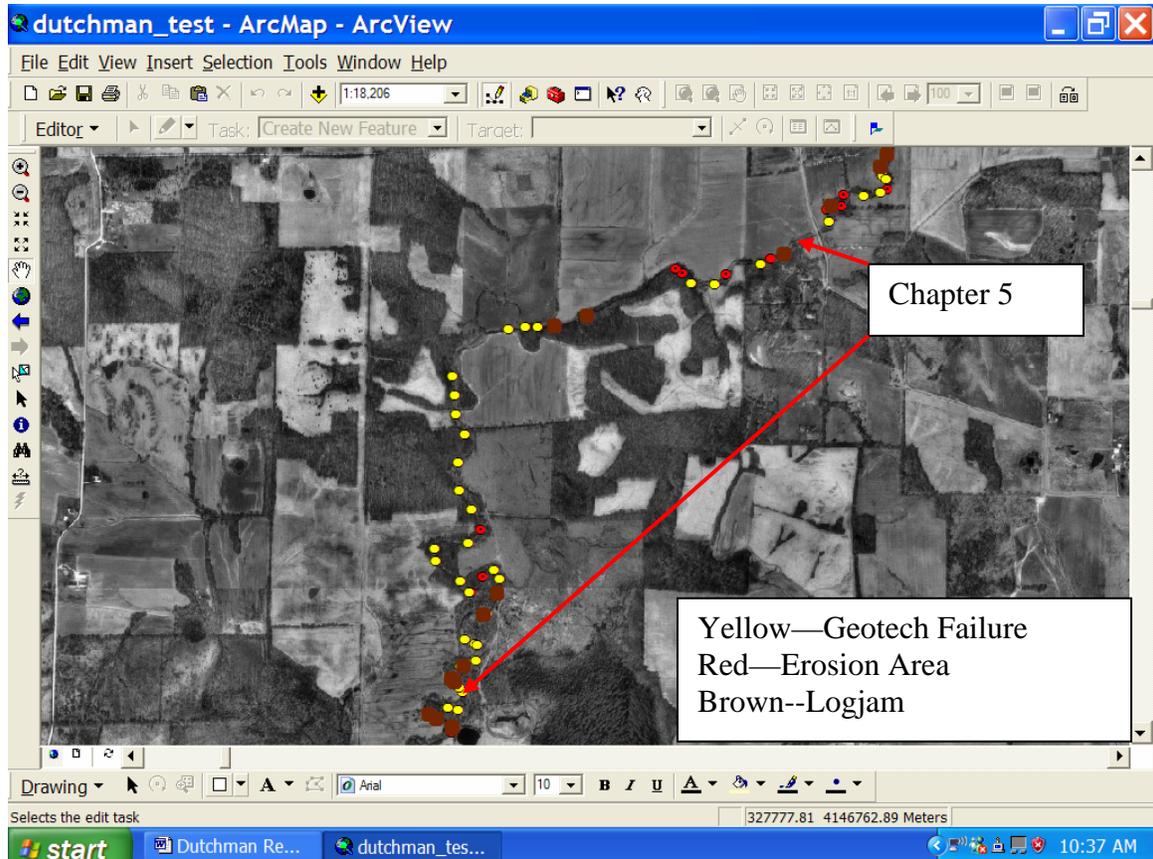
Fig. 17 Chapter 5 Dutchman Creek

This reach is approximately 2.25 miles long with 26 geotechnical failures and 6 erosion sites identified. Cross section 4 is located very near the upper end of Chapter 5 and there is a “knickzone” at this location. Therefore, the channel stability identified at Cross Section 5 below Illinois Route 146 is an isolated segment with downcutting occurring above and below.

Chapter 5 also has the first sites identified as erosion sites rather than geotechnical failures. The erosion sites are on outside bends and represent bank failure due to scouring action rather than soil conditions, although there is likely a component of both present at some sites. These erosion sites then become candidates for lateral bank stabilization and also present another opportunity to create turbulence and therefore re-aerate the flow. The recommendation for Chapter 5 will include grade control and bank protection.

The entire reach of Chapter 5 is recommended for grade control, and with a total of approximately 11 feet of gradient in this section there is opportunity to build 11 structures with each having a 1.0 foot of net overfall. Each riffle will require approximately 250 tons of stone at a cost per riffle of \$10,000. The estimated total cost for riffles will be \$110,000.

Potential Stream Barbs locations are found at DVD times of 20:19, 21:28, 23:19, 23:39, 23:48, 24:37 and 25:00. Each site is estimated to require an average of five Stream Barbs at 50 tons each for a total of 250 tons or \$7500 per site. The total estimated cost for Stream Barbs in Chapter 5 is \$52,500.

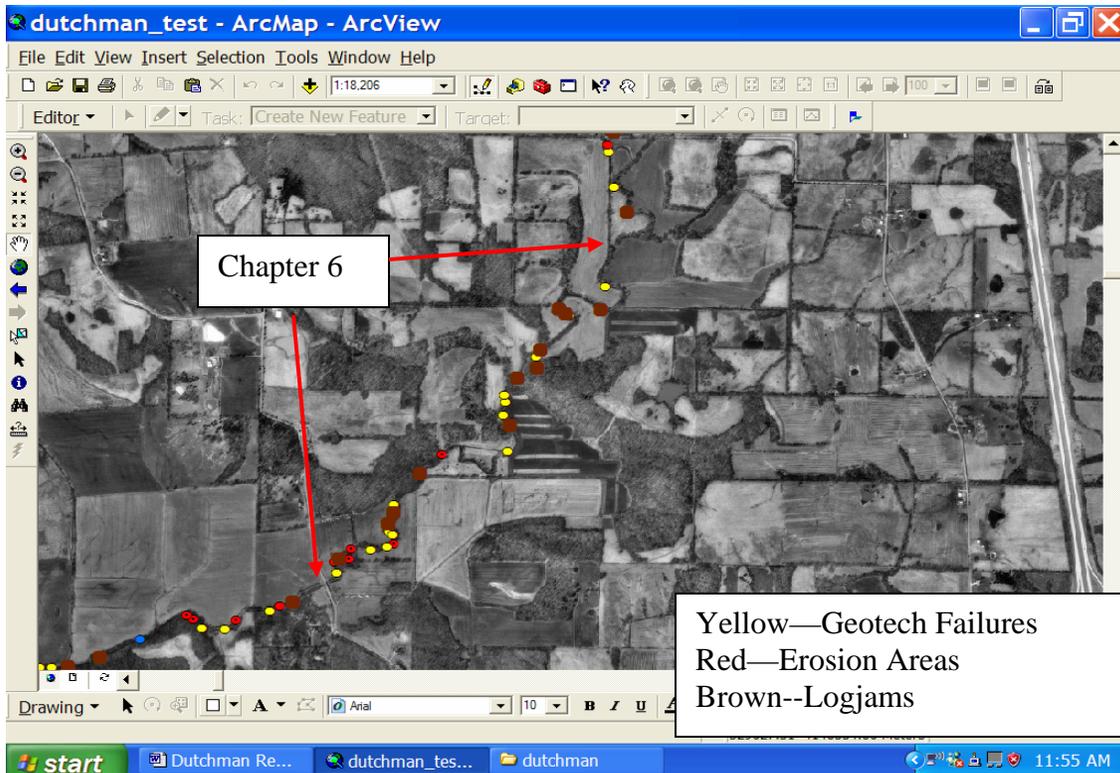
Figure 18 Chapter 6 Dutchman Creek

This chapter is approximately 2.2 miles long with 13 identified geotechnical failures and 5 erosion sites. (Fig. 18) There are no identified grade controls other than two field road crossings, therefore the downcutting from Chapter 5 can and has moved through Chapter 6. In addition, there are some reaches of channel that have been straightened, which are contributing to the downcutting problems.

There is approximately 10 feet of gradient in this reach allowing for approximately 10 grade control structures with 1 foot of net overfall. The stone required for each structure in this reach will be approximately 225 tons for a cost of \$9,000 per structure. The total estimated cost for grade control in Chapter 6 is \$90,000.

The 5 erosion sites needing lateral bank stabilization are at DVD times of 25:52, 26:10, 28:22, 29:36, and 29:55. Stream Barbs are recommended at each site for the same reasons as stated for Chapter 5 and the cost per site will be the same. The estimated cost to install Stream Barbs at 5 sites in Chapter 6 is \$7500 per site or \$37,500 for all 5 sites.

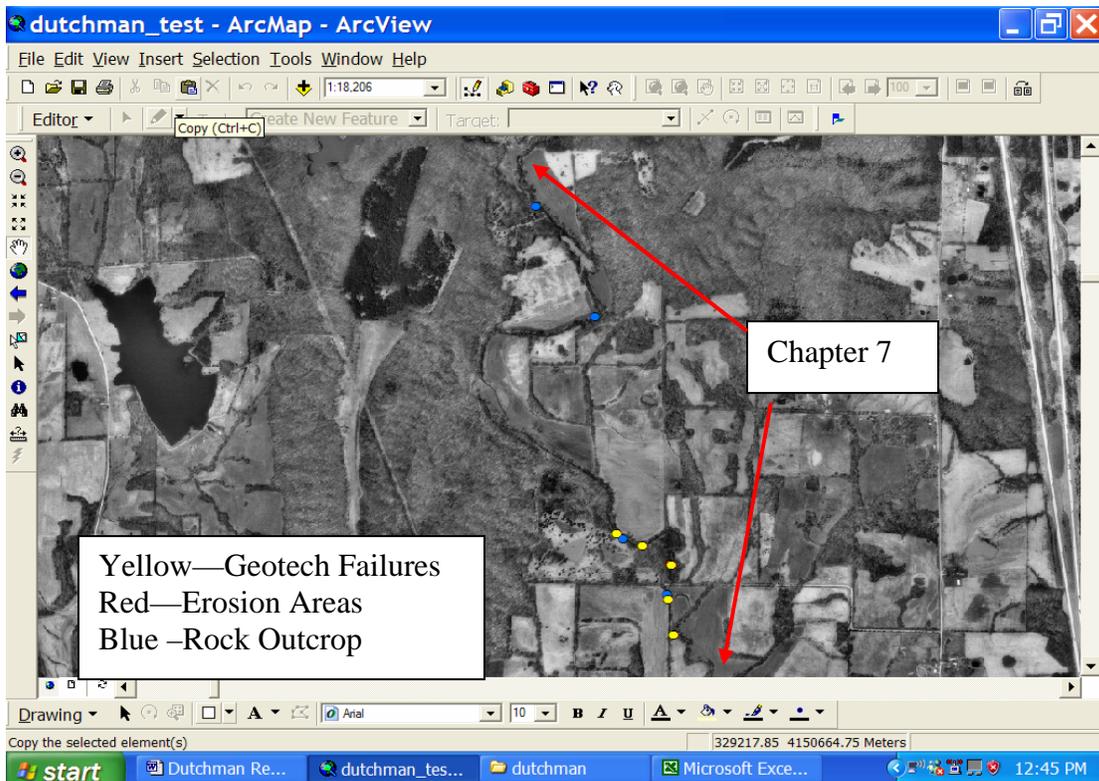
Fig. 19 Chapter 7 Dutchman Creek

This reach begins below Brown Road and extends upstream for approximately 2.2 miles. This reach has only 5 geotechnical failures identified and 2 erosion sites (See Fig. 19).

The recommended treatment for Chapter 7 is to install grade control with 1 foot of net drop allowing for about 10 structures in this reach. As in chapter 6, the cost per structure will be \$9,000 for a total cost of \$90,000.

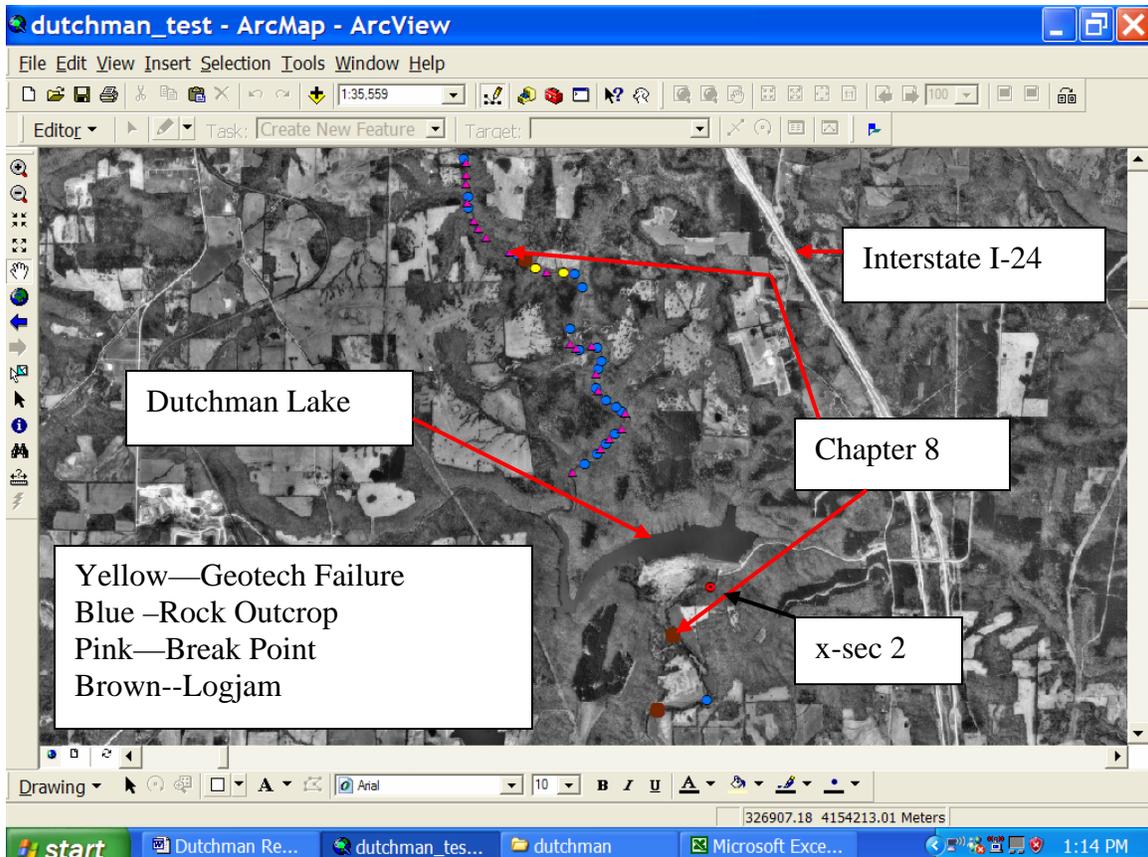
Fig. 20 Chapter 8 Dutchman Creek

Chapter 8 begins below Dutchman Lake and continues upstream past the lake. (Fig. 20) Since there is a significant difference in the channel above the lake, the recommendations for this reach will be divided into two segments.

Below Dutchman Lake: This reach is only 0.6 mile in length and has no identified problem features. Cross section 2 is located in this reach and shows the channel to be severely incised and bank failure can be anticipated. The stability currently present is probably due to the rock outcrops in this reach. The gradient is 4.7 ft./mile and there is only about 3 feet of gradient in this reach, therefore only 2 grade controls can be built. The estimated cost for each structure is \$9,000 each, therefore the total cost is \$18,000 for this reach.

One additional element that may be incorporated is to examine the possibility of adding a boulder field or other energy dissipation device at the outlet end of the principle spillway on Dutchman Lake. The turbulence generated as the overflow operates could do quite a lot of aeration considering the velocity of flow in the spillway pipe. There is no cost estimate for this recommendation as more investigation and consultation with NRCS will be required before any modification to the outlet structure can be recommended.

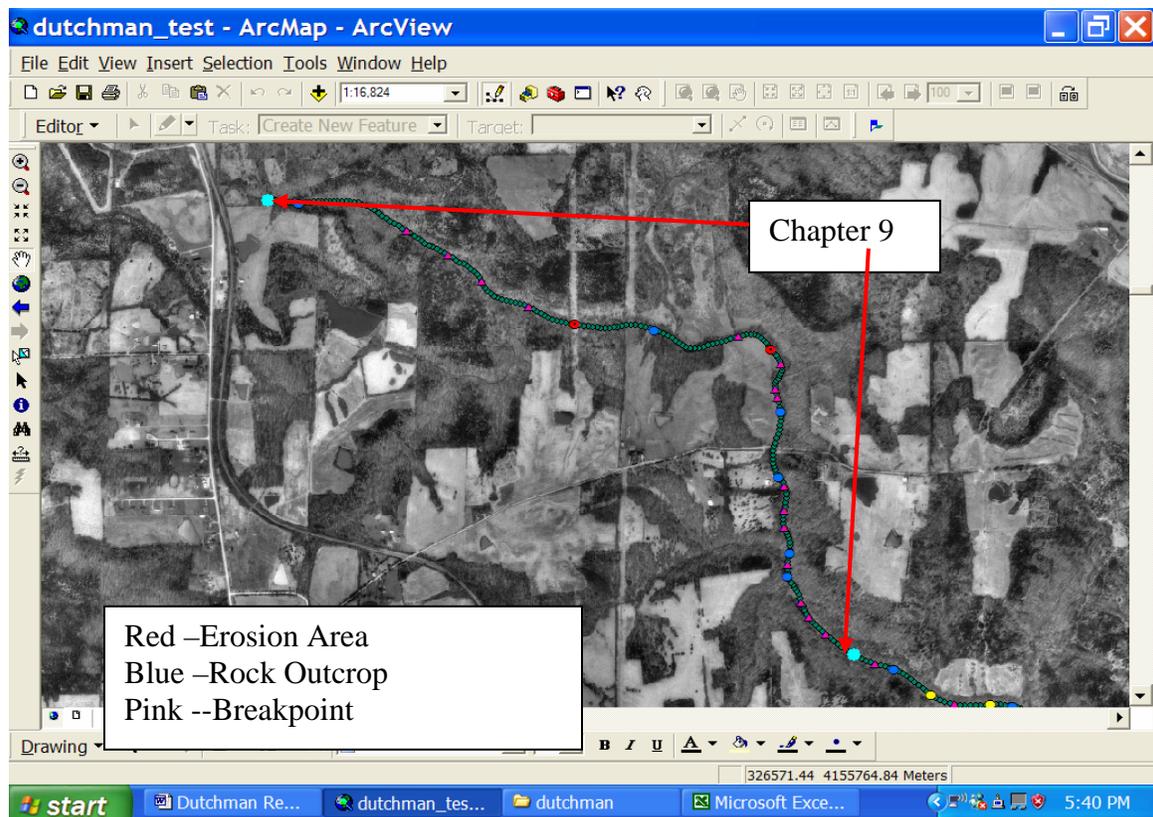
Fig. 21 Chapter 9 Dutchman Creek

This reach of approximately 2.3 miles begins with about 1.3 miles on a 20.6 ft./mile gradient and then increases to approximately 230 ft./mile for the remaining 1.0 mile (Fig. 21). There are 15 breakpoints, 6 rock outcrops and only 2 erosion areas identified in this reach. Similar to Chapter 8 above the lake, there is little need to add instream structures for aeration in this reach.

The two erosion areas are in pastureland at DVD time 42:09 and 42:56 and can be easily treated with Stone Toe Protection. Each is about 200 feet long and can be treated with 0.75 ton/ft. of stone at a cost of approximately \$5,000 each. Therefore, the estimated total cost of treatment for Chapter 9 is \$10,000.
