Tivoli Mfg. Ltd.

Safety Bulletin

Bulletin No: RMSA007

Purpose: Inspection and Reinforcement of Seat Side Rails

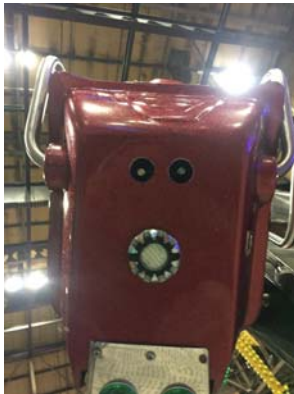
Figure 1

Tivoli's representative, following further examination became aware that the securing bolt/fastener used to hold the side restraint bar in position, located on the side of the vehicle had fractured allowing the side restraint to detach from the vehicle.

During further investigation, it was noted by that several other similar bars were found to be slightly loose and showing signs of corrosion around the fastening point. It was also noted that these side restraint bars had noticeably more movement at the point where it entered the lower seat point.

- Cut two 1 ¼" (30mm) access holes with hole saw on bottom of fiberglass seat as indicated on attached picture (see figure 1). These holes are 1 ¾" (45mm) off each side of the centerline on the seat bottom, in line with the center of the side bars.
- Drill and tap two holes (See figure 2 & 3) for an 8mm 1.25 x 25mm (grade 8.8) socket head bolt with washer.
- Install bolts with Loc tite (blue) and tighten snugly
