RE: Oak Trace (Project 16-056) Response to Request for Additional Information

Fairview 2009 Facility Assessment Report Update

Physical Plant Assessment - Update

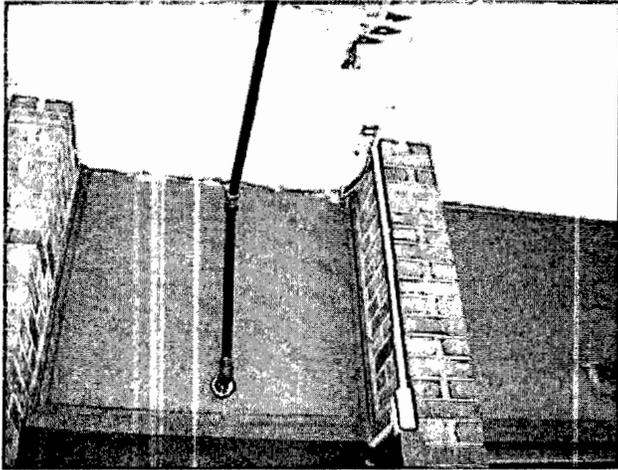
Exterior wall –
Water issues at the green
house. Insulated glass seal
has be broken.

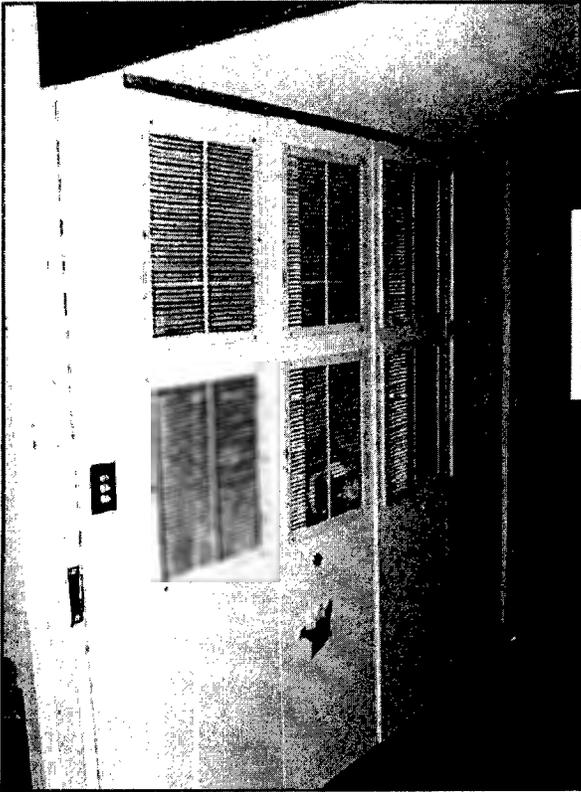
No sprinklers at the closet

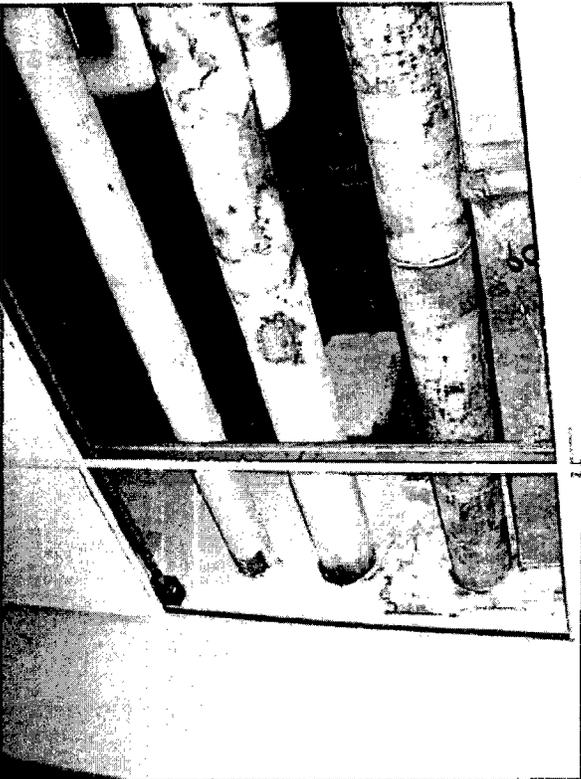
Water damaged insulation
and corroded piping

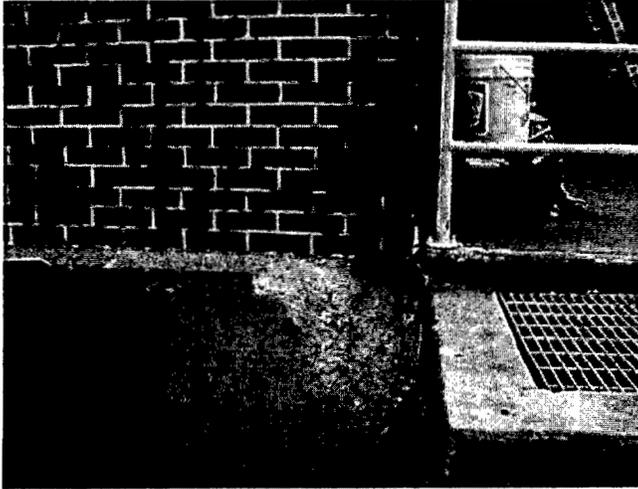
Exterior wall –
Water entering Basement

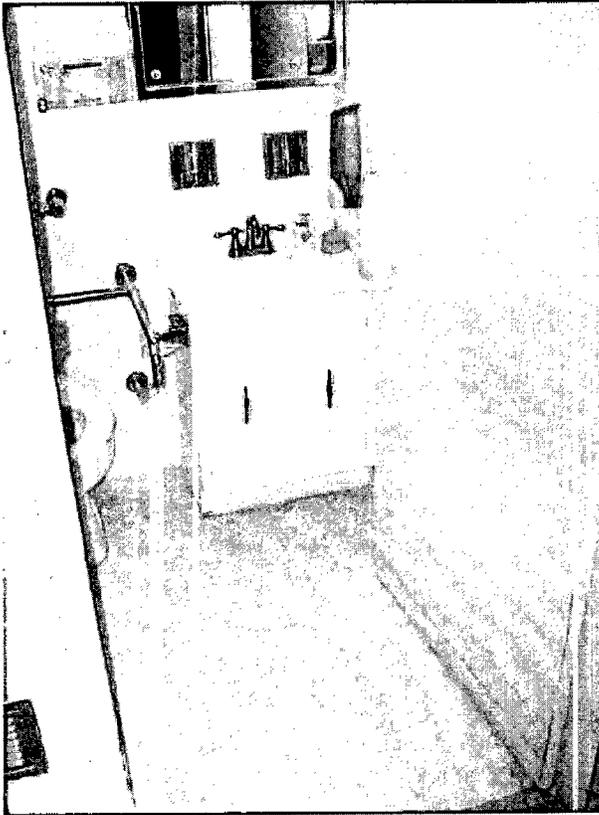
Typical resident toilet room
requiring updating.

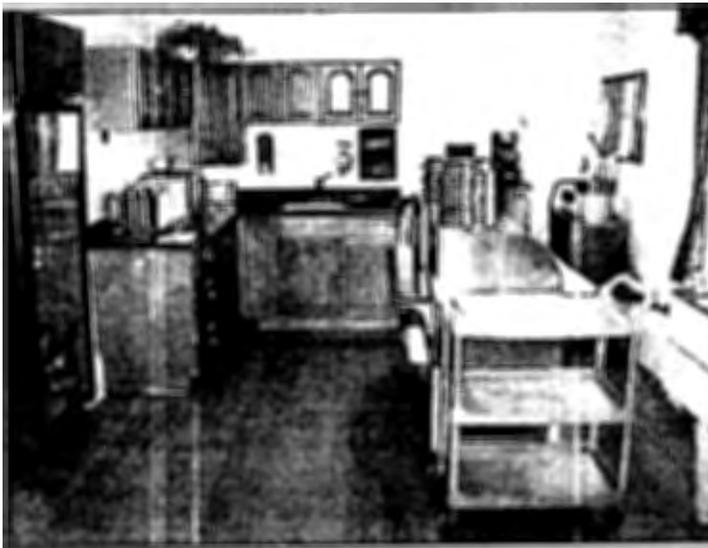
No ventilation in this area

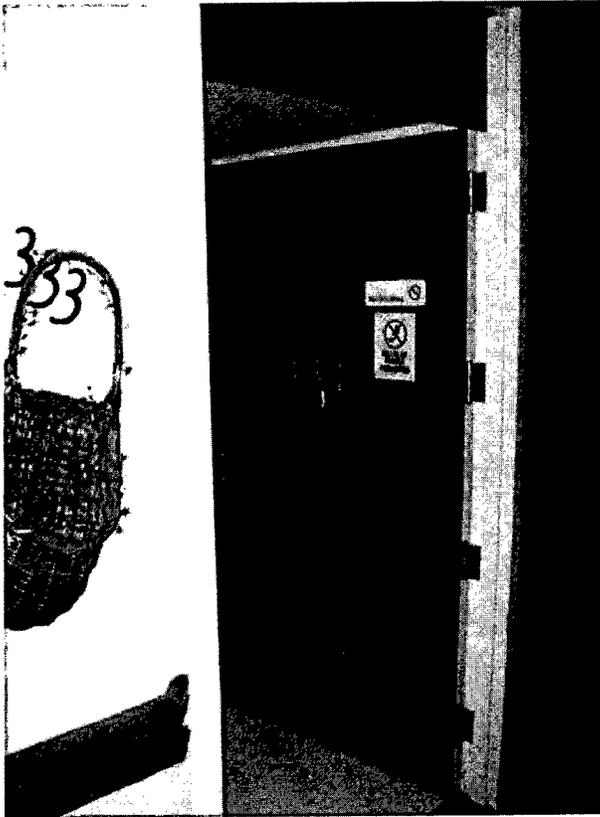
Typical resident room
without closer and door is
showing its age.

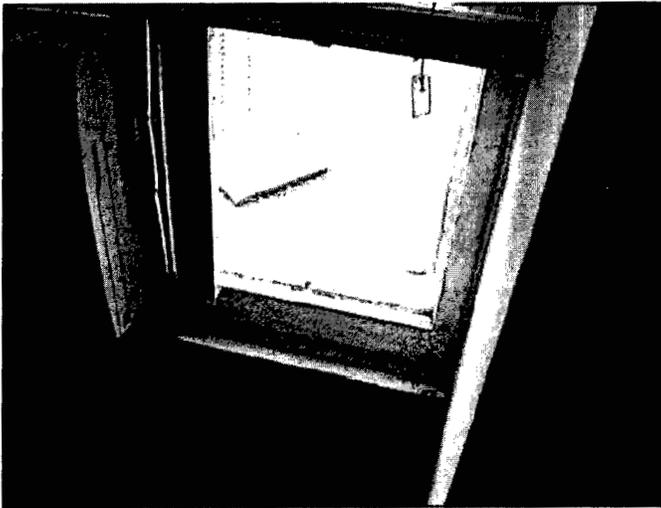
Supplemental Cooling

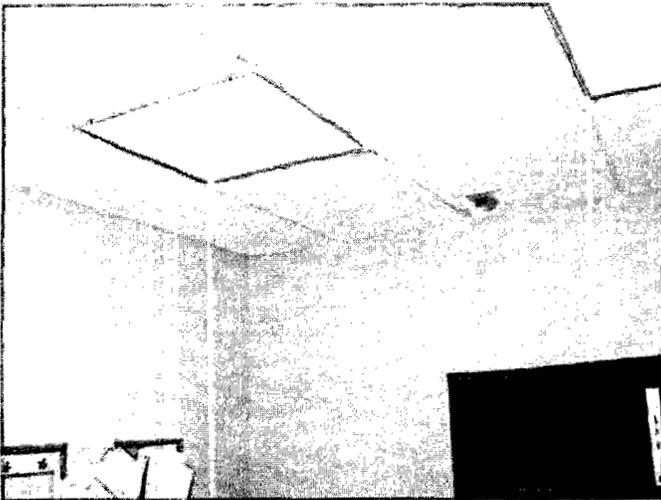
Water damage

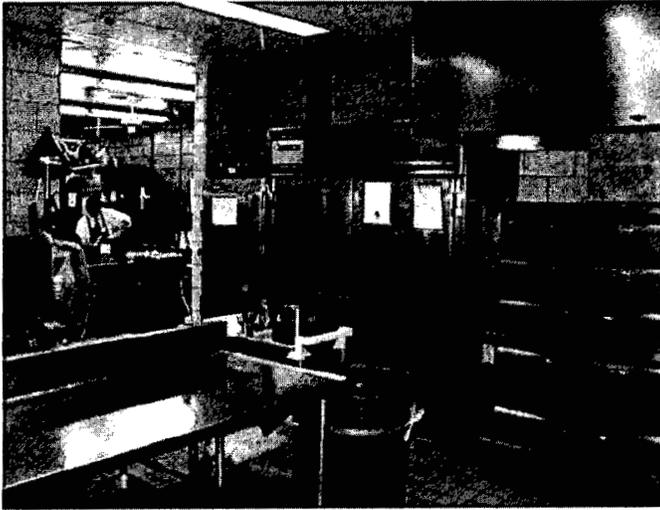
Aging food service
equipment

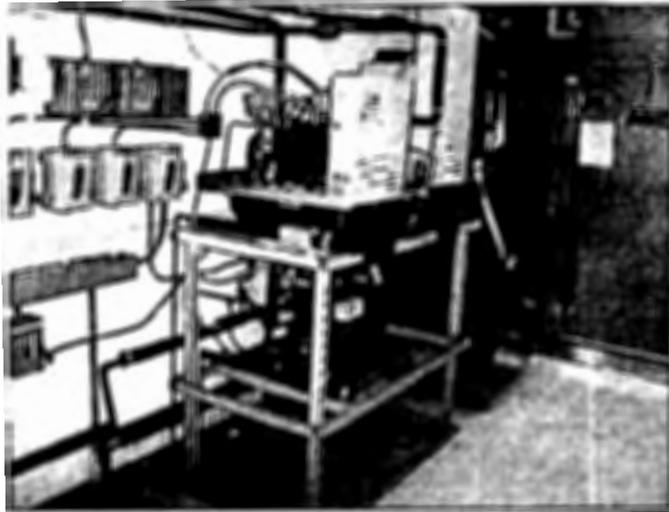
Water cooled Condensing
units.

- Investigate natural gas drop in pressure issue.
- Replace various mechanical equipment, such as aged pumps. Etc...
- Provide ventilation at indoor condensing units. Convert water cooled condensers.

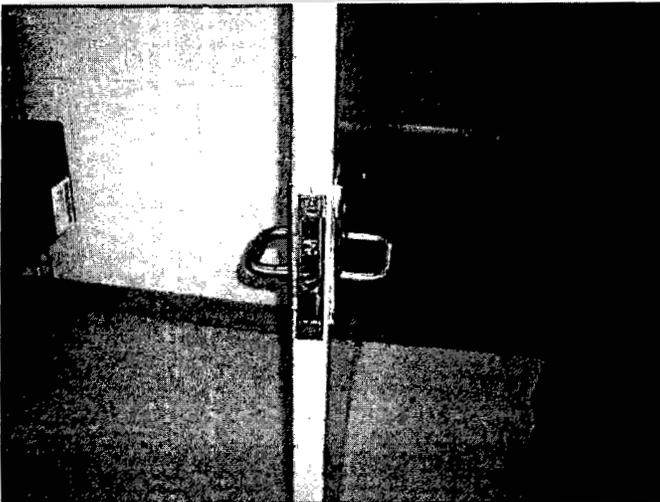
Damaged Hardware

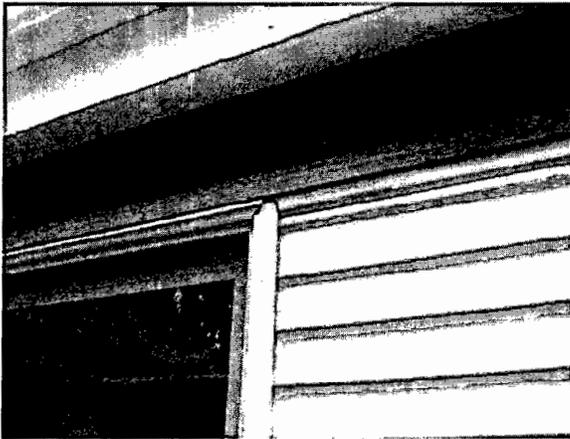
Wood Trim

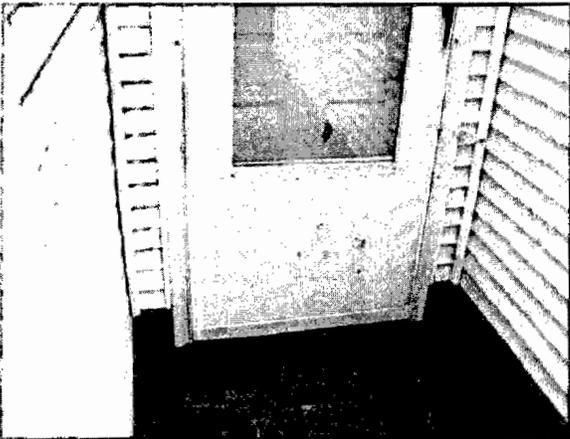
Screen Doors
