AERIAL ASSESSMENT REPORT FOR Hodges and Otter Creek

Macoupin County

December 2005

Prepared by Wayne Kinney for IL. Dept. of Agriculture

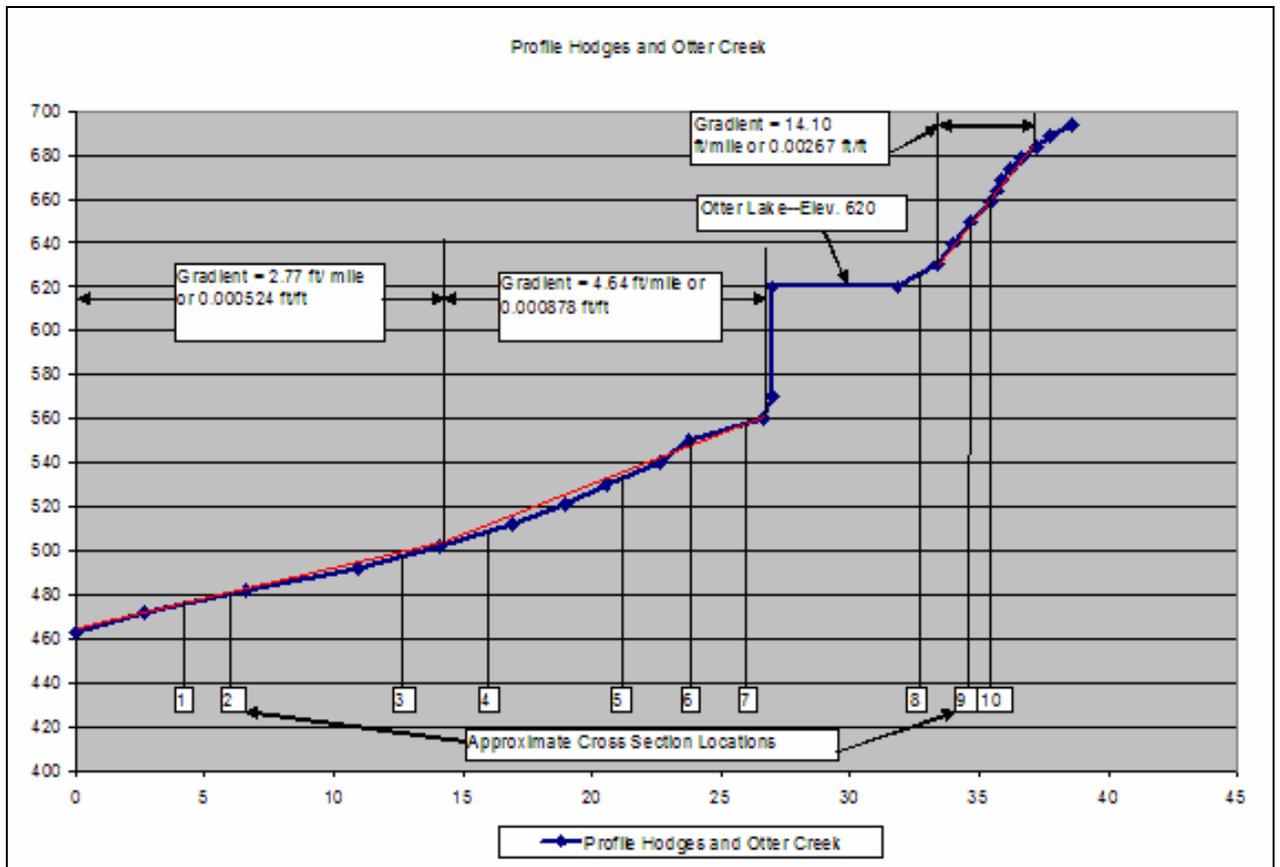
Fig. 2 Channel Profile Hodges and Otter Creek

Detailed elevation data is not available; therefore the channel slope is calculated from USGS topo maps by measuring the channel length between contour lines. The report refers to this as “valley profile” although a true valley profile would use a straight line distance down the floodplain rather than channel length. However, this method is used because it incorporates sinuosity into the calculation and allows the channel slope to be assume equal to “valley slope” in order to estimate channel capacity, velocity, etc., although there are short segments where the channel slope may differ significantly near roads, logjams, knickpoints, etc.

4. Gradient below Otter Lake drops to 4.6 ft/mile from 14 ft/mile above Otter Lake. The steeper gradient above Otter Lake is degrading also although Otter Lake obviously acts as a grade control to prevent any degradation below Otter Lake from impacting the area above the dam.

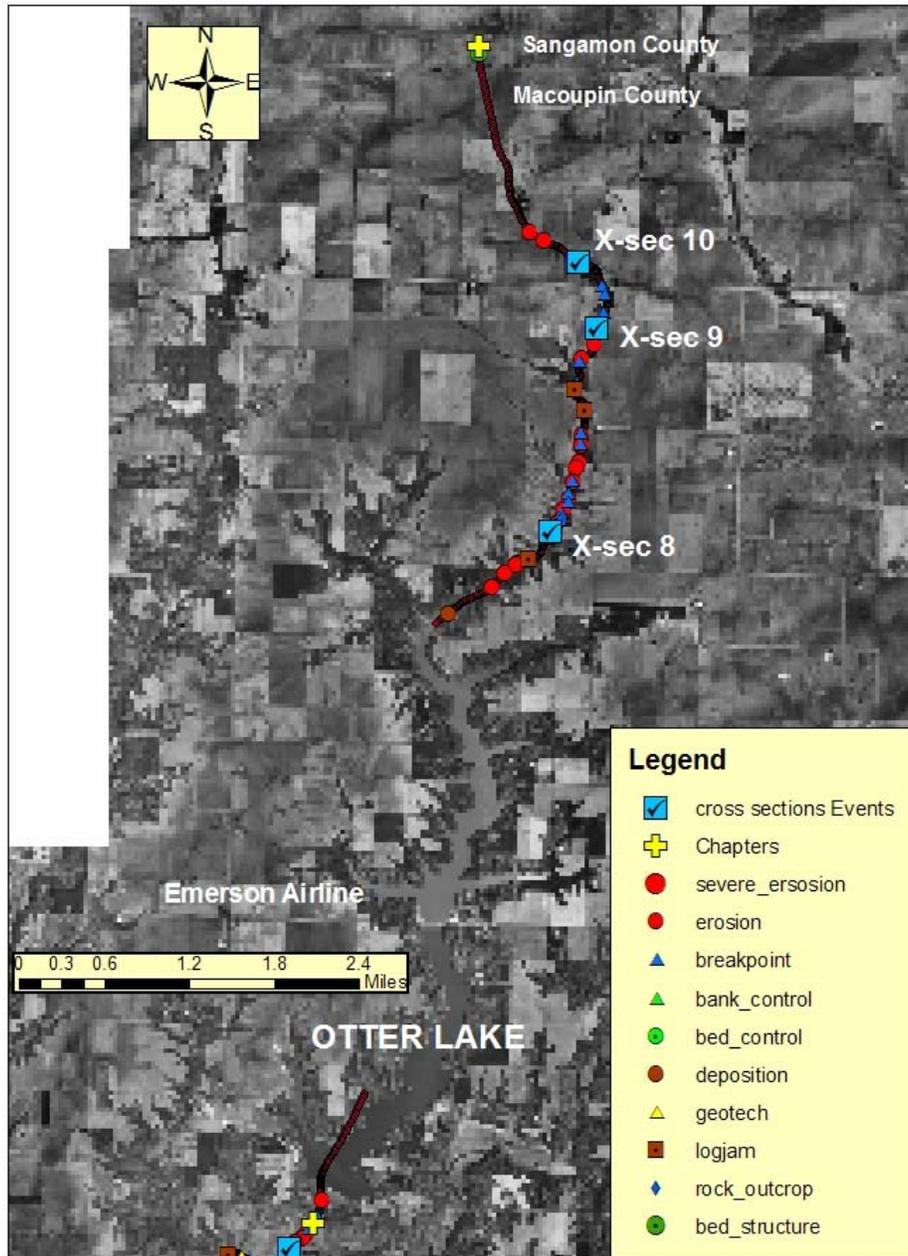
Figure 11. Chapter 1 Features

Chapter 1 is the very upper end of the aerial assessment and represents the only portion inventoried above Otter Lake. Cross section 8, 9 and 10 are in this segment. Cross sections 9 and 10 show incision to a depth of over 3 times the bankfull depth. Section 8 is nearer to Otter Lake and influenced by its backwater effects limiting incision to slightly less than twice the bankfull depth. Cross section 8 is depositional in CEM stage 5 while 9 and 10 are degrading although they are partially armored by the heavy cobble eroded from the glacial till exposed in this reach. There are 16 breakpoints and 23 erosion sites identified in chapter 1.

The recommendation is to install Rock Riffle Grade Control structures above cross section 8 to a point about one half mile above cross section 10. While preliminary analysis shows that riffle more than 0.6 ft. in height will increase the water surface profile significantly this segment is incised approximately 2.5 to 3.0 ft. and therefore riffles 2.0 ft. high can be safely installed without increasing out of bank flow. Lateral bank treatment is recommended using Stone Toe Protection at the 23 identified sites. Table 3 shows the estimated treatment costs and quantities required for this segment.

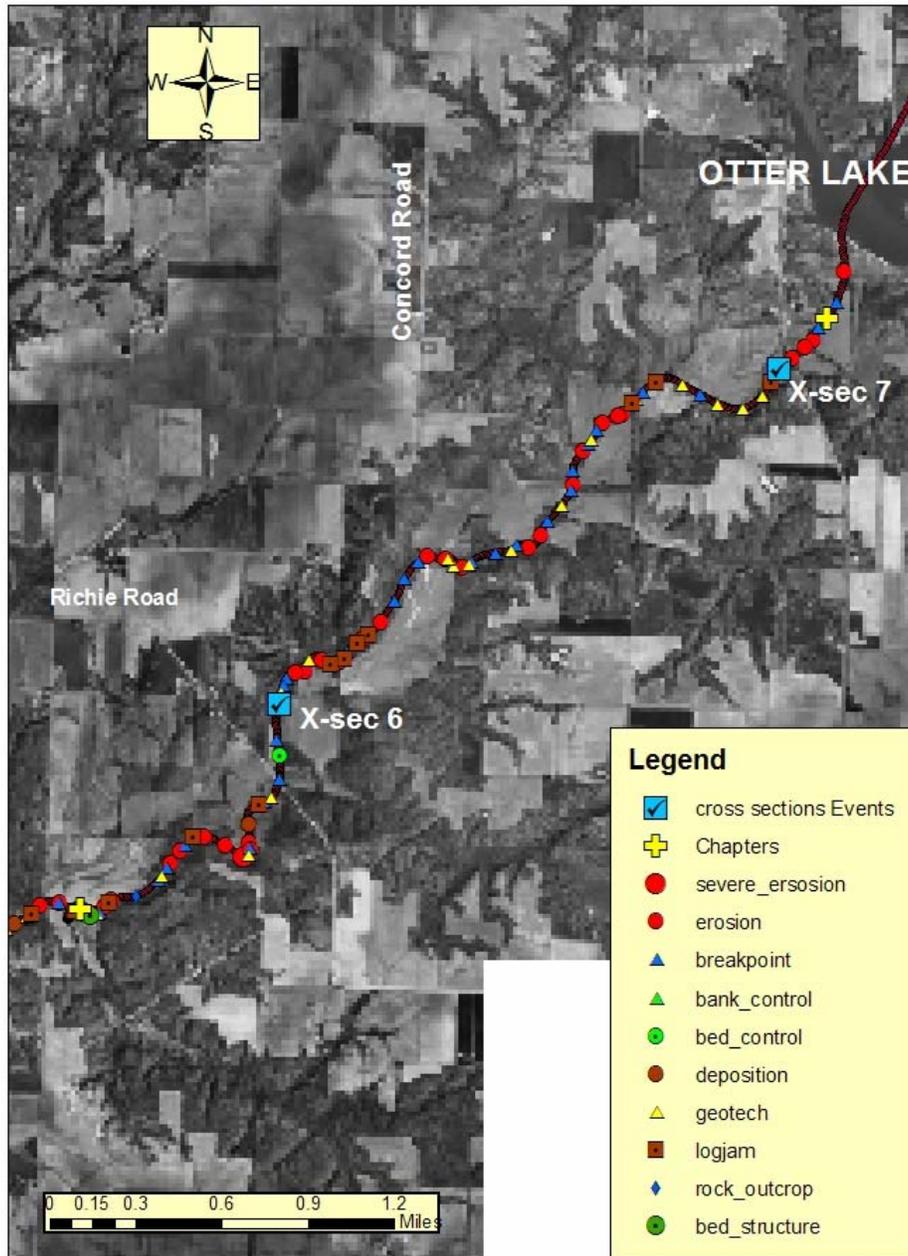
Figure 12. Chapter 2 Features

This segment begins below Otter Lake and extends downstream approximately 4 miles. Cross sections 6 and 7 are located in chapter 2. There are 30 erosion sites, 20 geotechnical failures and 11 logjams identified in this reach as well as 29 breakpoints. The identification of such a large number of problems indicate a very unstable channel in this segment, although the cross sections do not indicate significant degradation. Cross sections 6 and 7 have bankfull elevations within one foot of the floodplain elevations and the diameter of the bedload is less than 1 inch however no exposed residual material was found in the “breakpoints” identified.

This segment is in CEM stage 4 where the channel is both degrading and widening resulting in the multiple problems of bank failure through lateral erosion and geotechnical failures.

The recommended treatment is to install Rock Riffle Grade control structures approximately 2.5 ft. above the riffle (breakpoint) elevations. The increased pool depths created will dissipate energy, halt downcutting and improve aquatic habitat. Lateral bank erosion is severe and will require additional treatment with Stone Toe protection. The estimated treatment needs and cost are presented in Table 4 below.

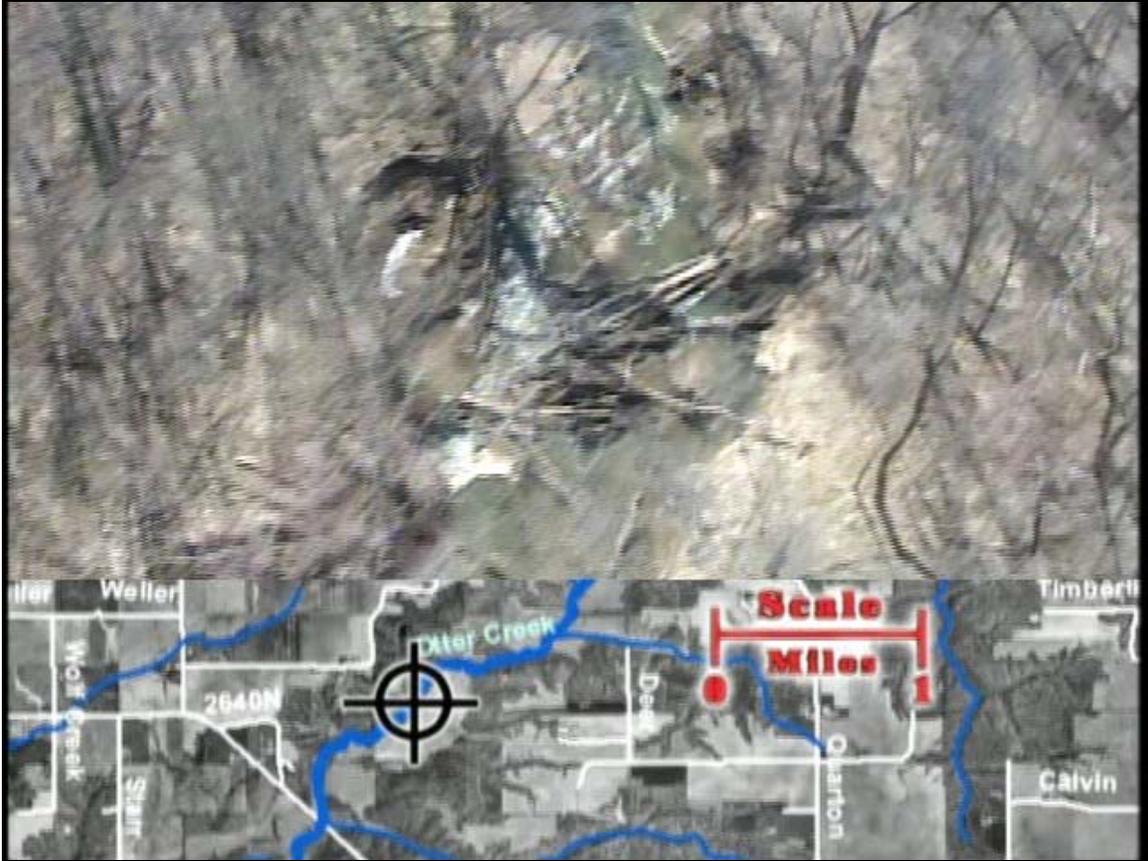
Logjam in Chapter 2 caused by failing banks

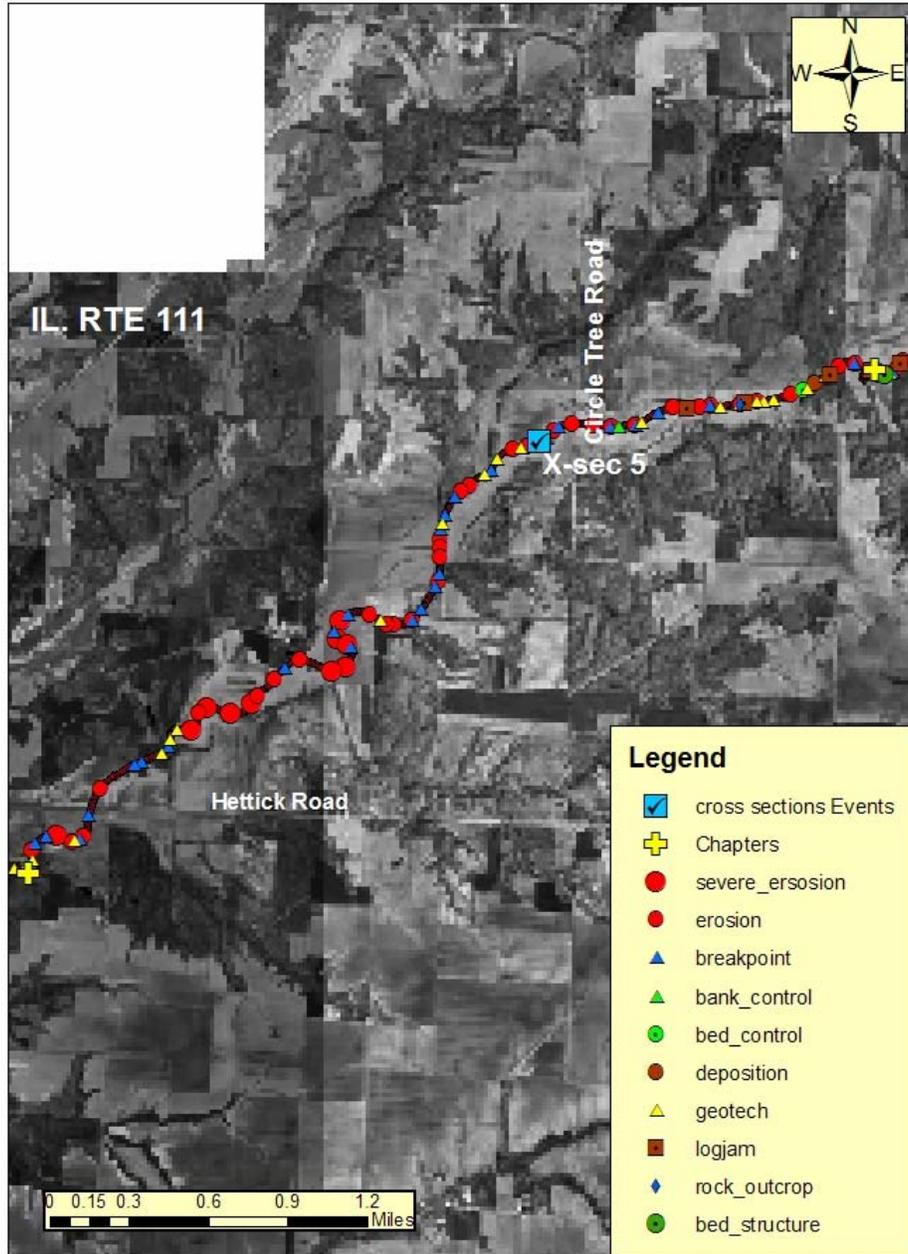
Figure 13. Chapter 3 Features

This reach is about 4.5 miles long and extends downstream approximately one half mile below Hettick Road. Chapter 3 contains cross section 5 which is located below Circle Tree Road and is located in a definite “knickzone” where degradation is severe. The channel is incised approximately 2 feet at this location and has a very narrow width/depth ratio of 5.9 indicating a very unstable channel. Chapter 3 has 35 erosion sites, plus 10 additional sites identified with severe erosion, 19 geotechnical failures and 26 breakpoints identified by the aerial assessment.

This reach is extremely unstable and will require use of Rock Riffle Grade control structures and lateral bank treatment to achieve any stability in the near future. The preliminary analysis indicates that riffles may be built to a height of 3.0 feet with no impact on out of bank flow or backwater. Given the incision that has already occurred even greater riffle heights would be feasible and perhaps desirable. For this report a riffle height of 3.0 ft. will be used to determine estimated cost.

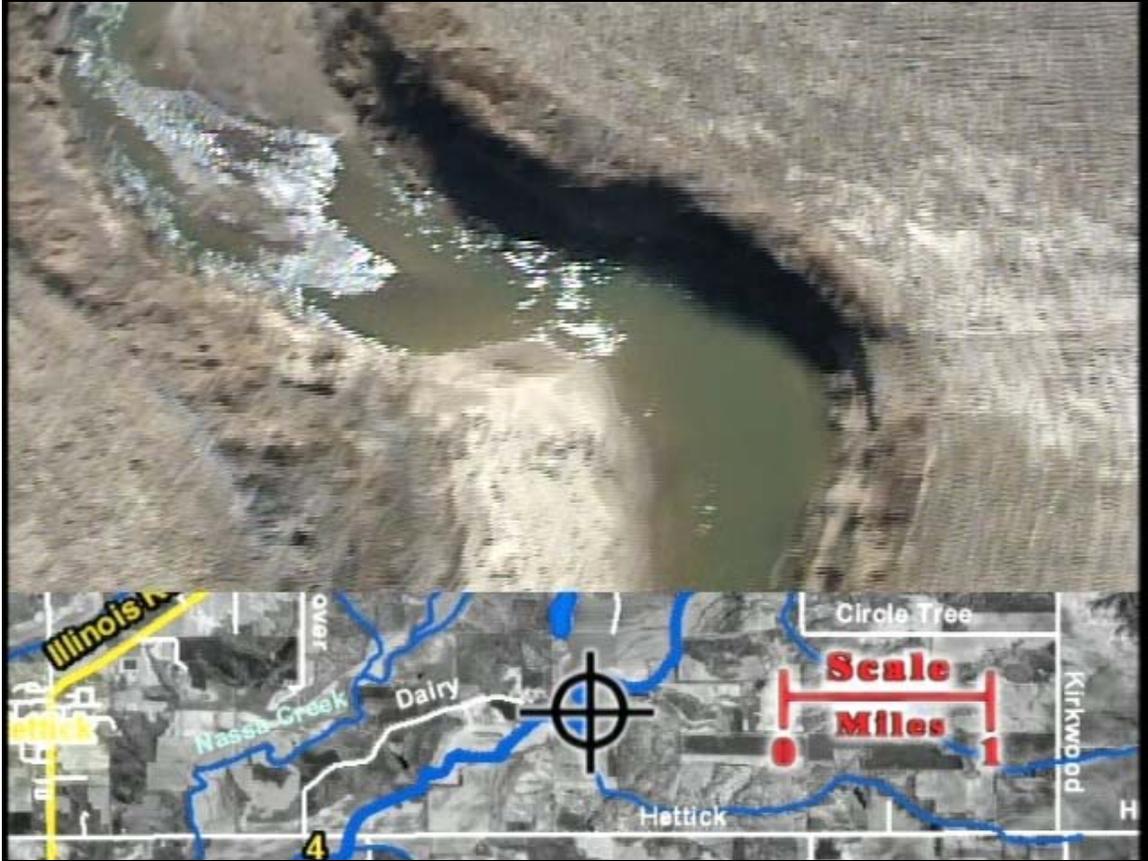
Severe Erosion in Chapter 3

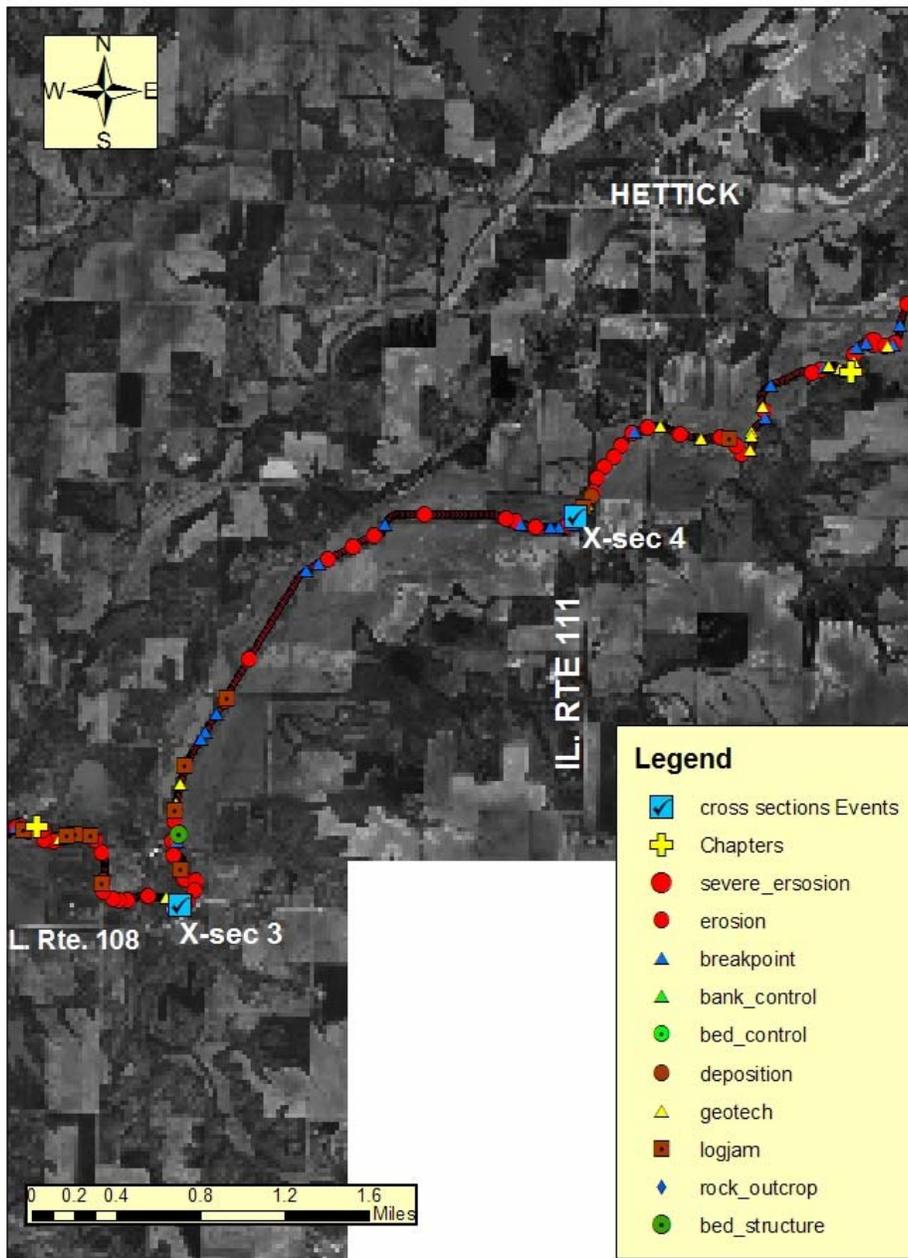
Figure 14. Chapter 4 Features

This chapter is approximately 6 miles in length ending about a mile above the IL. Rte. 108 bridge. Cross sections 3 and 4 are located in this chapter. This segment has been extensively channelized and no doubt contributes significantly to the problems identified in chapters 2 and 3. However, the same problems of degradation and widening are occurring below this site as well, but at a reduced intensity and are thought to be impacted by the extensive channelization and downcutting found downstream in Macoupin Creek. Cross section 3 near the end of chapter 4 appears to be well connected to the floodplain, however there is a knickpoint at this location on residual soil material indicating active downcutting is beginning to occur and will migrate upstream if left untreated.

This chapter has 44 erosion sites, 16 geotechnical failures and 16 breakpoints identified by the aerial assessment. Treatment recommendations for this segment remain the same with a need for Rock Riffle Grade control structures approximately 3.0 ft. high and lateral bank protection with Stone Toe Protection. Table 6 provides the estimated treatment needs.

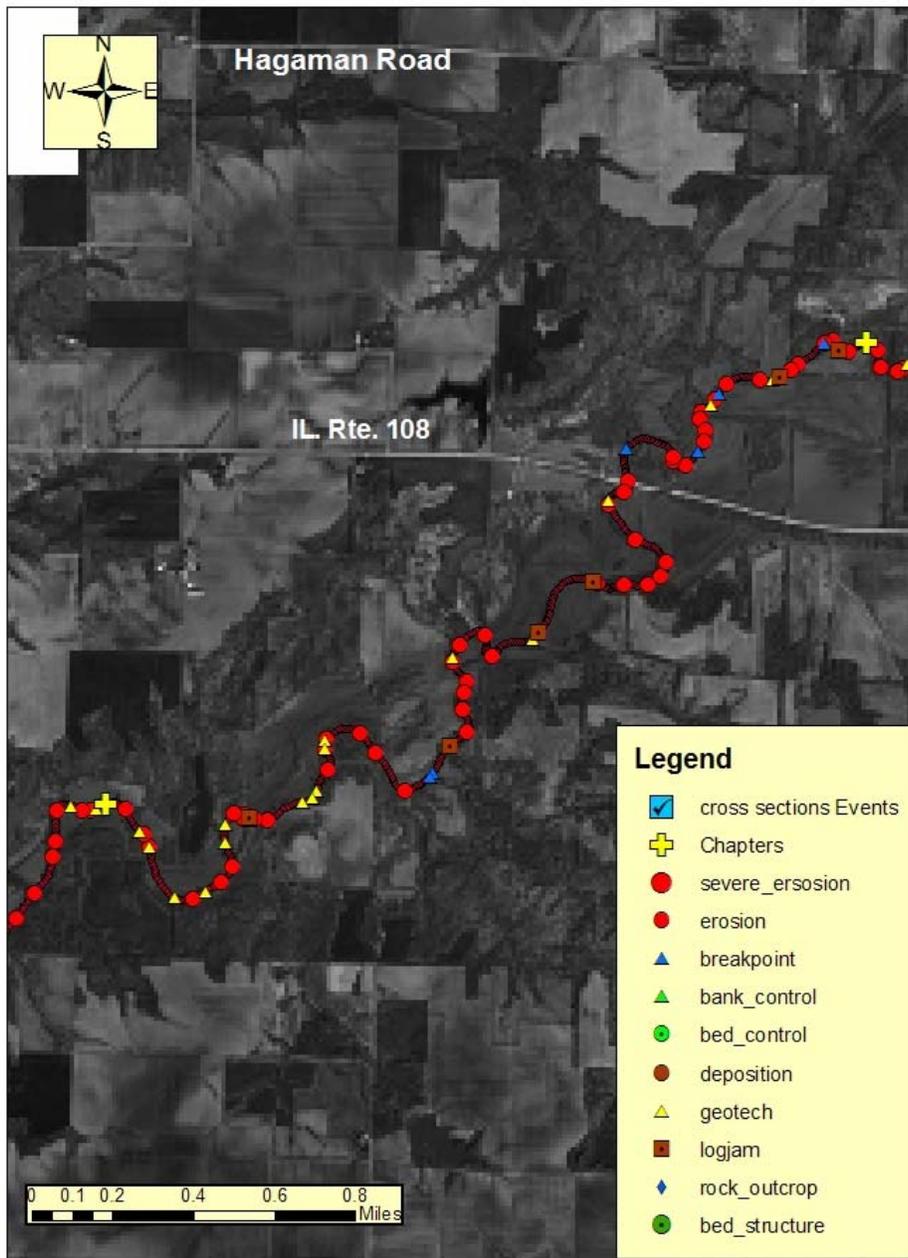
Figure 15. Chapter 5 Features

These chapters represent the remaining length of Otter and Hodges Creeks ending at the confluence with Macoupin Creek. The total length of these segments is approximately 10 miles. In this segment there is a marked decrease in breakpoints although the number of erosion sites and geotechnical failures remains fairly consistent with the upper chapters.

Therefore, evening the absence of obvious “breakpoints” the recommendation is to continue with the installation of Rock Riffle Grade control structures to halt any current downcutting masked by low flow conditions re-depositing bedload and to prevent additional degradation on Macoupin Creek from migrating up Hodges Creek.

Rock Riffle Grade control structures can be at least 4.0 ft. high in this segment with no impact on out of bank flow (flooding) or backwater.

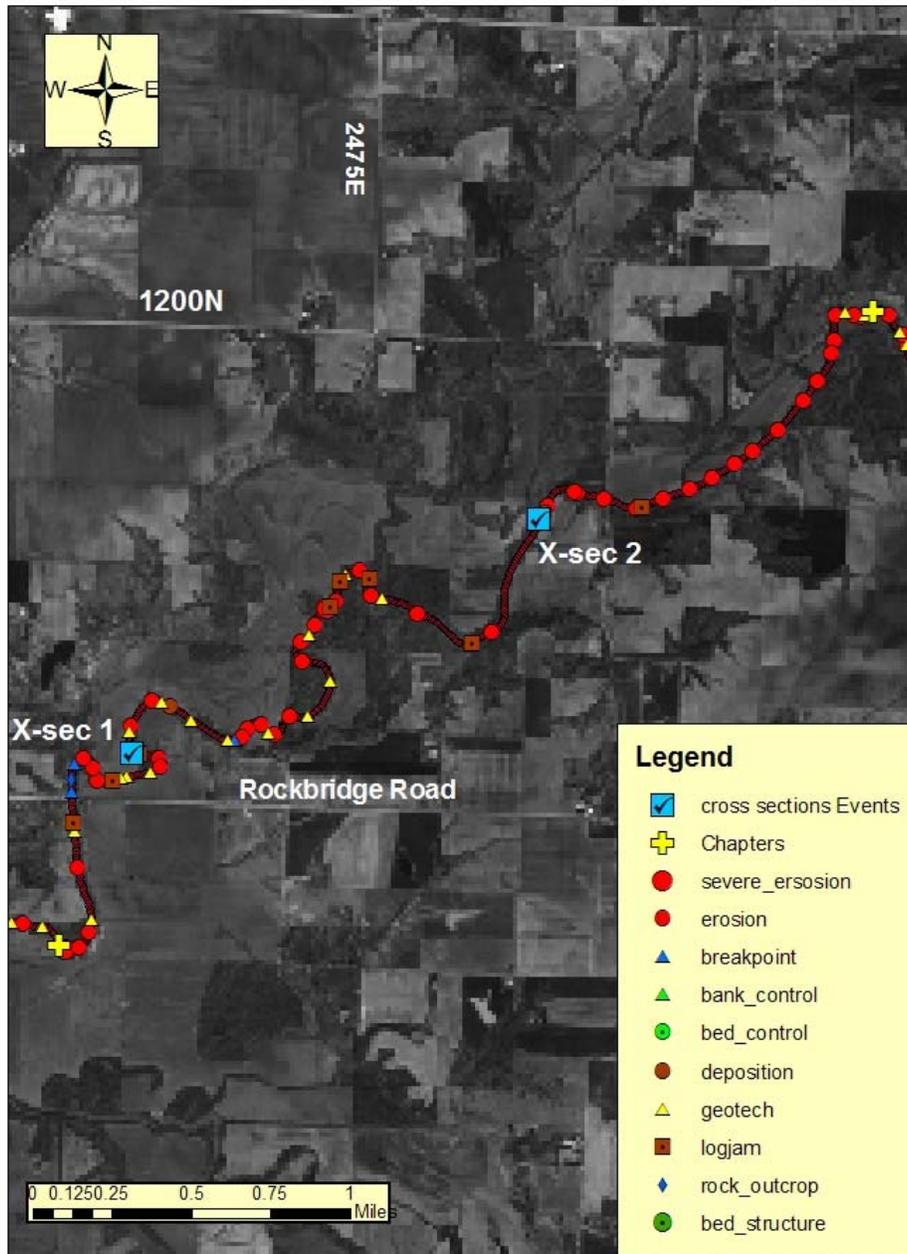
Figure 16. Chapter 6 Features

Given present knowledge about the downcutting occurring in Macoupin Creek and the continued stream instability it seems highly likely that even this lower reach of Hodges Creek is degrading. Cross sections 1 and 2 located in Chapter 6 would tend to support that conclusion as the floodplain is at least 1 foot above the bankfull elevation.

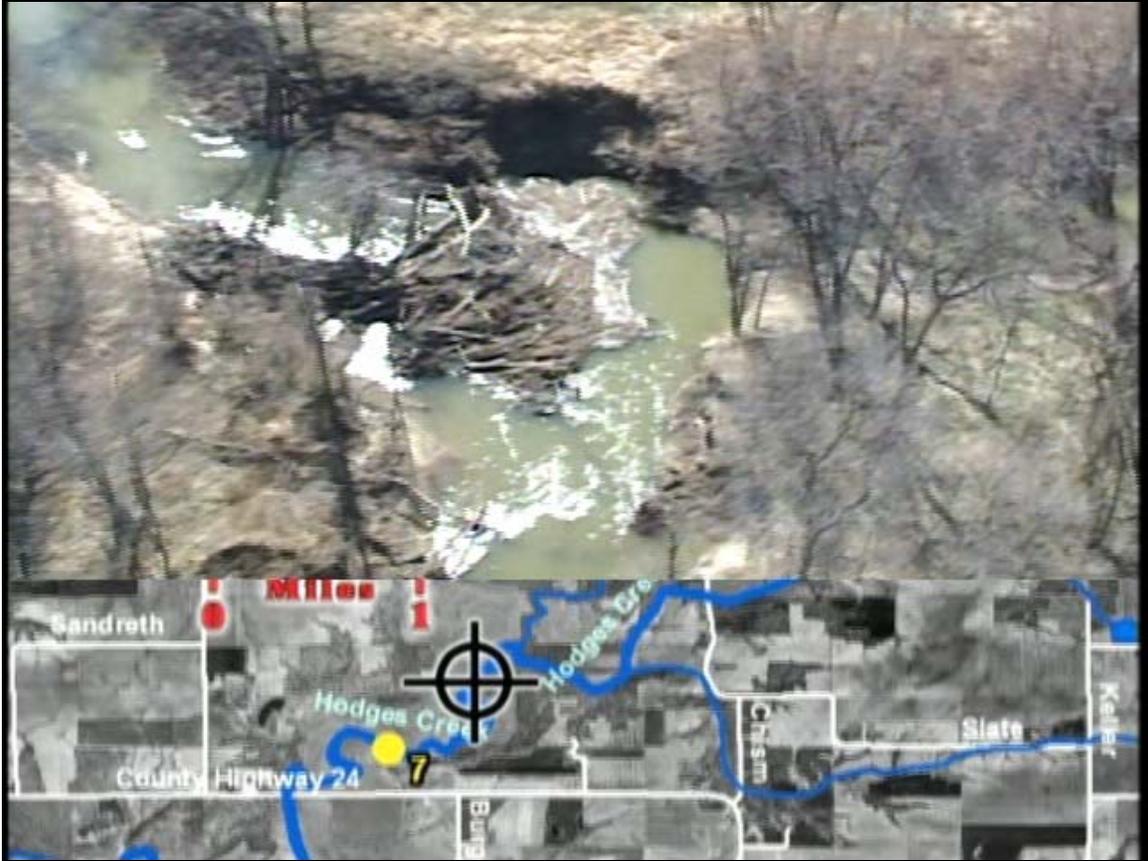
Logjam in Chapter 6

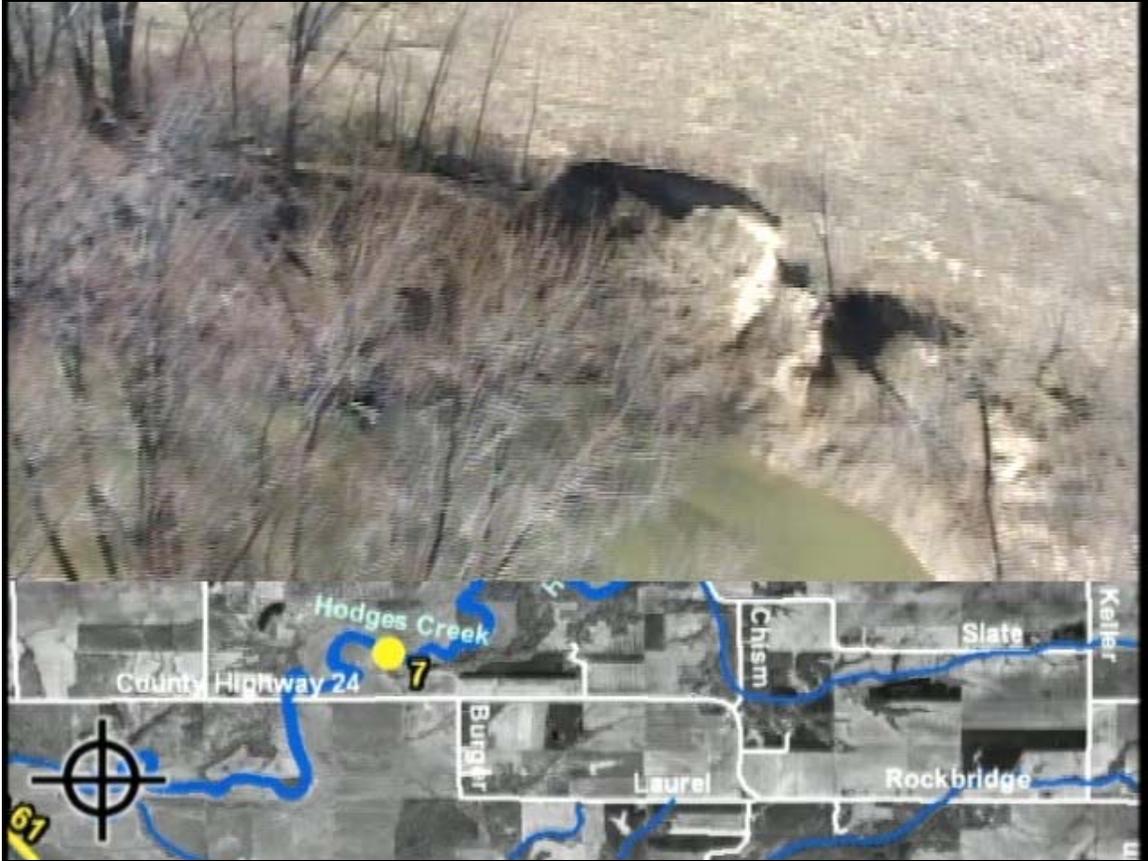
Geotechnical failure just above the confluence of Hodges and Macoupin Creek

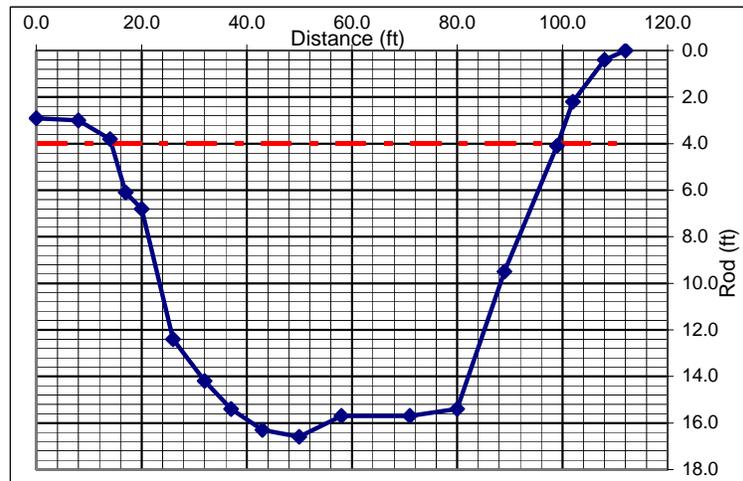
Project: X sec 2
 Assisted by: Wayne Kinney
 Date: 12/20/2005
 Channel Slope (S): 0.000524 ft/ft
 Manning's n: 0.040
 Flow Depth: 12.6 ft

Rod (ft)	Distance (ft)
2.9	0.0
3.0	8.0
3.8	14.0
6.1	17.0
6.8	20.0
12.4	26.0
14.2	32.0
15.4	37.0
16.3	43.0
16.60	50
15.70	58
15.70	71
15.40	80
9.50	89
4.10	99
2.2	102
0.4	108
0.0	112

Trial Depth 2	Trial Depth 3
Selected Flow Depth:	12.6 ft	13.7
Channel Flow (Q):	2,702.6 cfs	2,956.6
Channel Velocity:	3.5 ft/sec	3.4
Cross-Sectional Area (A):	769.2 sq.ft.	867.2
Hydraulic Radius (R):	8.4 ft	8.0

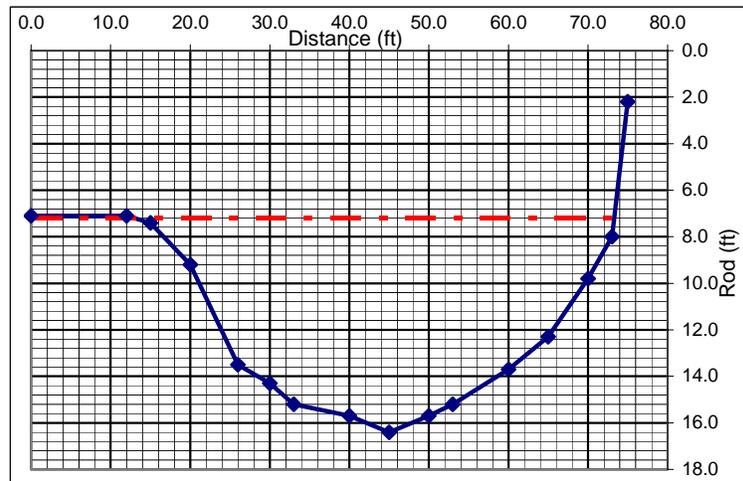
Project: X sec 3
 Assisted by: Wayne Kinney
 Date: 12/20/2005
 Channel Slope (S): 0.000524 ft/ft
 Manning's n: 0.040
 Flow Depth: 9.2 ft

Rod (ft)	Distance (ft)
7.1	0.0
7.1	12.0
7.4	15.0
9.2	20.0
13.5	26.0
14.3	30.0
15.2	33.0
15.7	40.0
16.4	45.0
15.70	50
15.20	53
13.70	60
12.30	65
9.80	70
8.00	73
2.2	75

Trial Depth 2	Trial Depth 3
Selected Flow Depth:	9.2 ft	9.3
Channel Flow (Q):	943.6 cfs	857.8
Channel Velocity:	2.7 ft/sec	2.4
Cross-Sectional Area (A):	355.3 sq.ft.	361.3
Hydraulic Radius (R):	5.5 ft	4.7

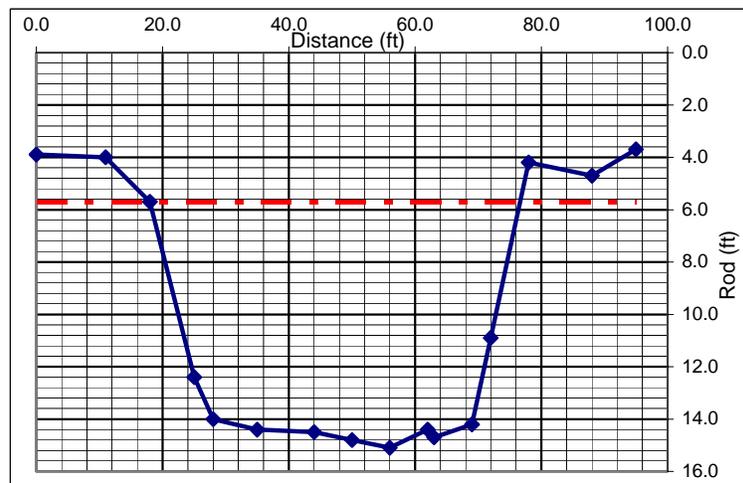
Rod (ft)	Distance (ft)
3.9	0.0
4.0	11.0
5.7	18.0
12.4	25.0
14.0	28.0
14.4	35.0
14.5	44.0
14.8	50.0
15.1	56.0
14.40	62
14.70	63
14.20	69
10.90	72
4.20	78
4.70	88
3.7	95

Trial Depth 2	Trial Depth 3
Selected Flow Depth:	9.4 ft	11.2
Channel Flow (Q):	1,732.7 cfs	1,945.0
Channel Velocity:	3.9 ft/sec	3.5
Cross-Sectional Area (A):	441.7 sq.ft.	563.6
Hydraulic Radius (R):	6.7 ft	5.6
