Charleston Side-Channel Reservoir
Sedimentation Basin
Project Final Report

For
Illinois Environmental Protection Agency
Financial Assistance Agreement
Number 3190321

July 10, 2007

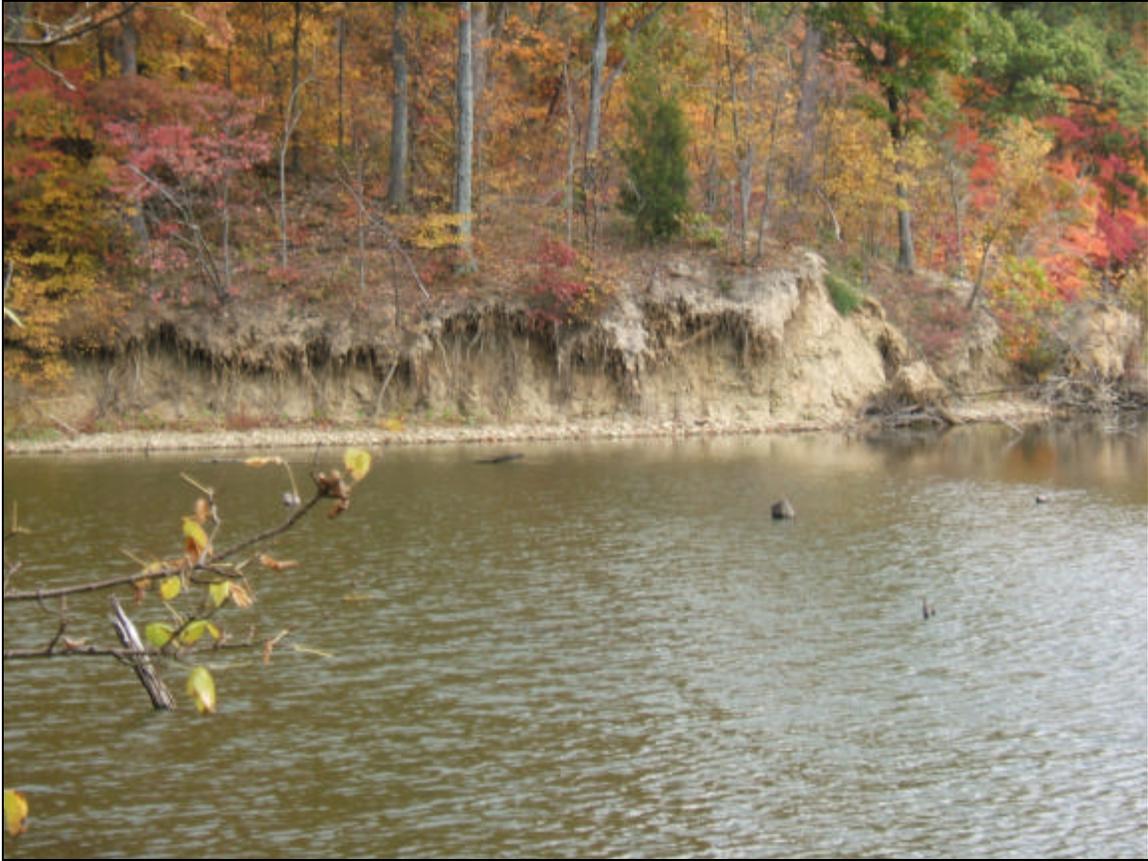
Figure 3. Pre-construction photo east shore of cove

The 2003 proposal called for the construction of a sedimentation basin at the CSCR. The basin would serve to trap nonpoint source pollution before it enters the CSCR. The original design called for the construction of a road to gain access to the proposed dam location. The construction method was modified to employ barge transport thus eliminating the need for a roadway. Because the shoreline and adjacent hillside were severely eroded on either side of the proposed dam, riprap areas were included in the project.

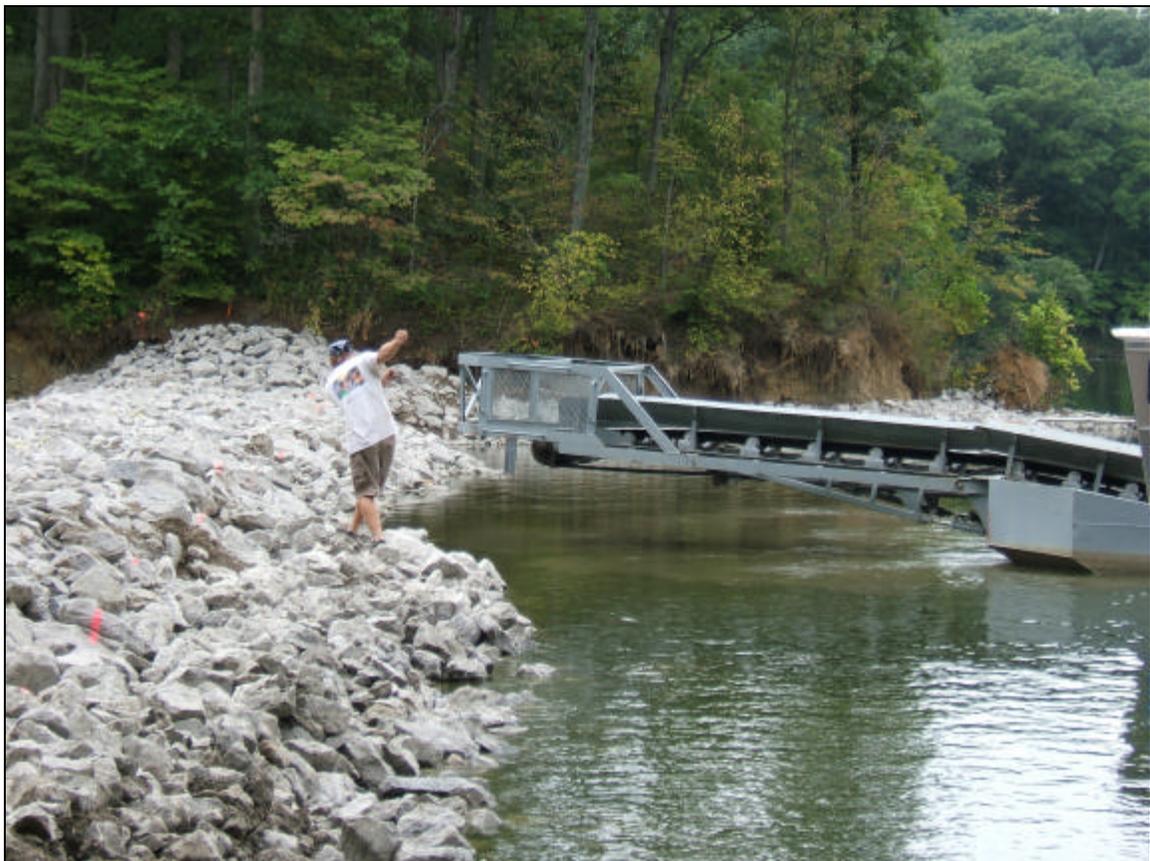
Figure 7. Barge building dam, shoreline work in background

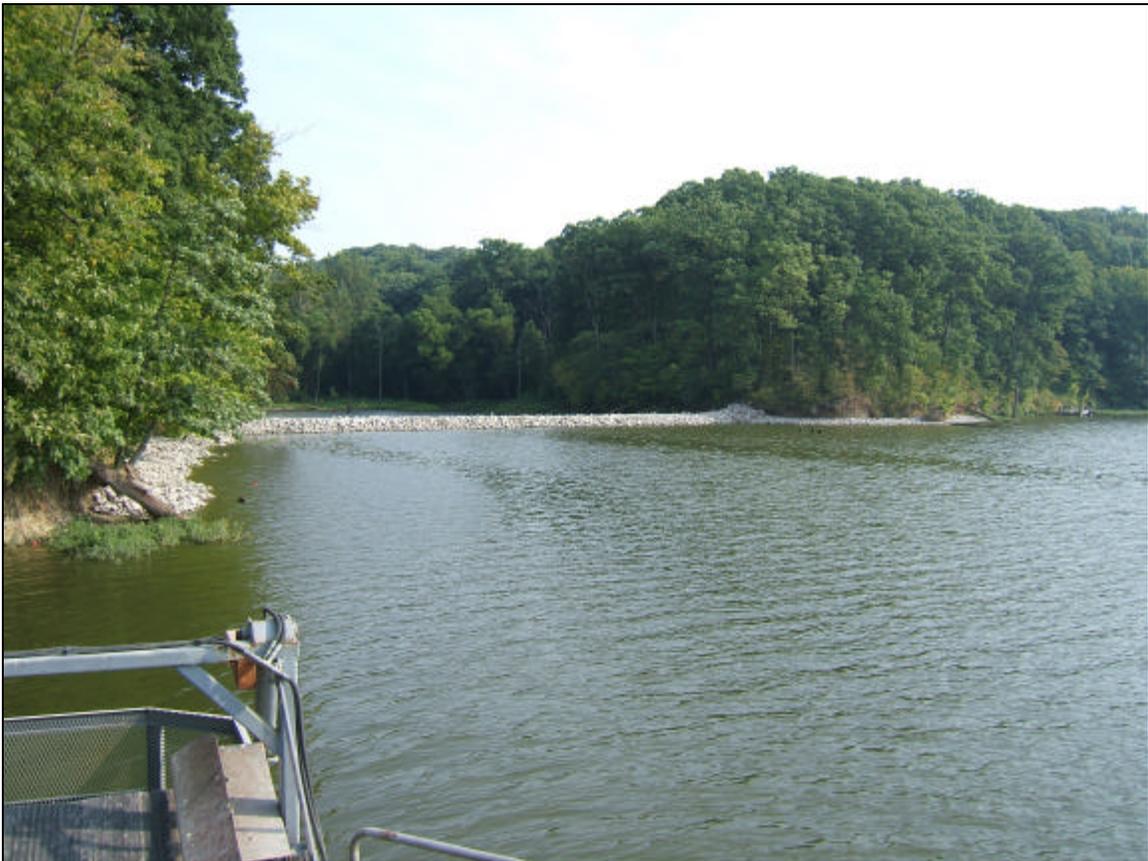
Figure 8. The Dam and Shoreline RipRap.

Photo shows the completed dam and some riprap. Note riprap was not yet finished on left side of photo.

The Inspection and Maintenance operations for the sedimentation basin are performed by the Charleston Water Treatment Plant staff in coordination with the City's engineering staff. Funding is provided through the Water Treatment Plant budget. The dam face and sides are inspected once a year and after rainfall events of 2 inches of rain or greater in 24 hours.

- 1) Check dam face and ends for possible damage from overtopping or wave action.
- 2) Keep trees and brush from growing on the dam or in the abutment.
- 3) Check for burrowing animal holes near abutment and fill as they occur
- 4) Check for settling of dam.
- 5) Inspect for hillside erosion above rock structure.
- 6) Record elevation of the sediment within the basin.
- 7) Take corrective actions when it is warranted.

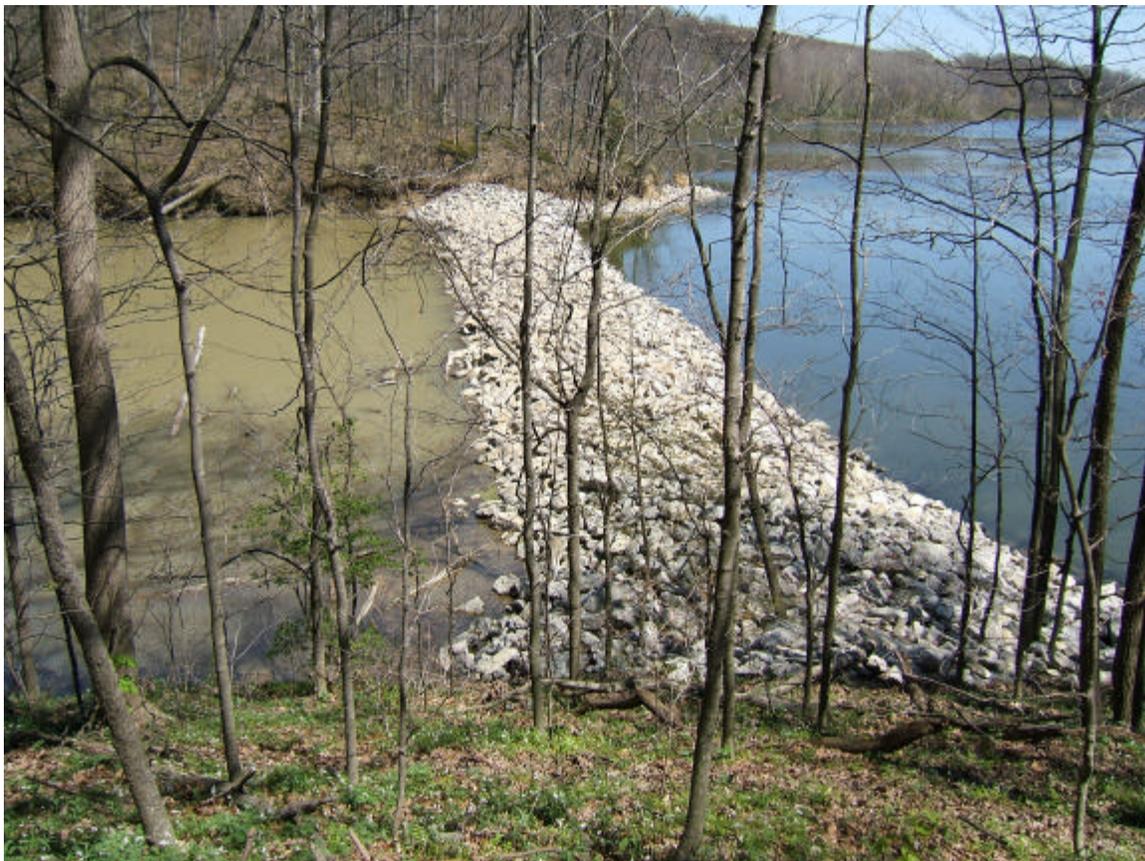
Figure 9. Basin and CSCR after April 2007 storm event

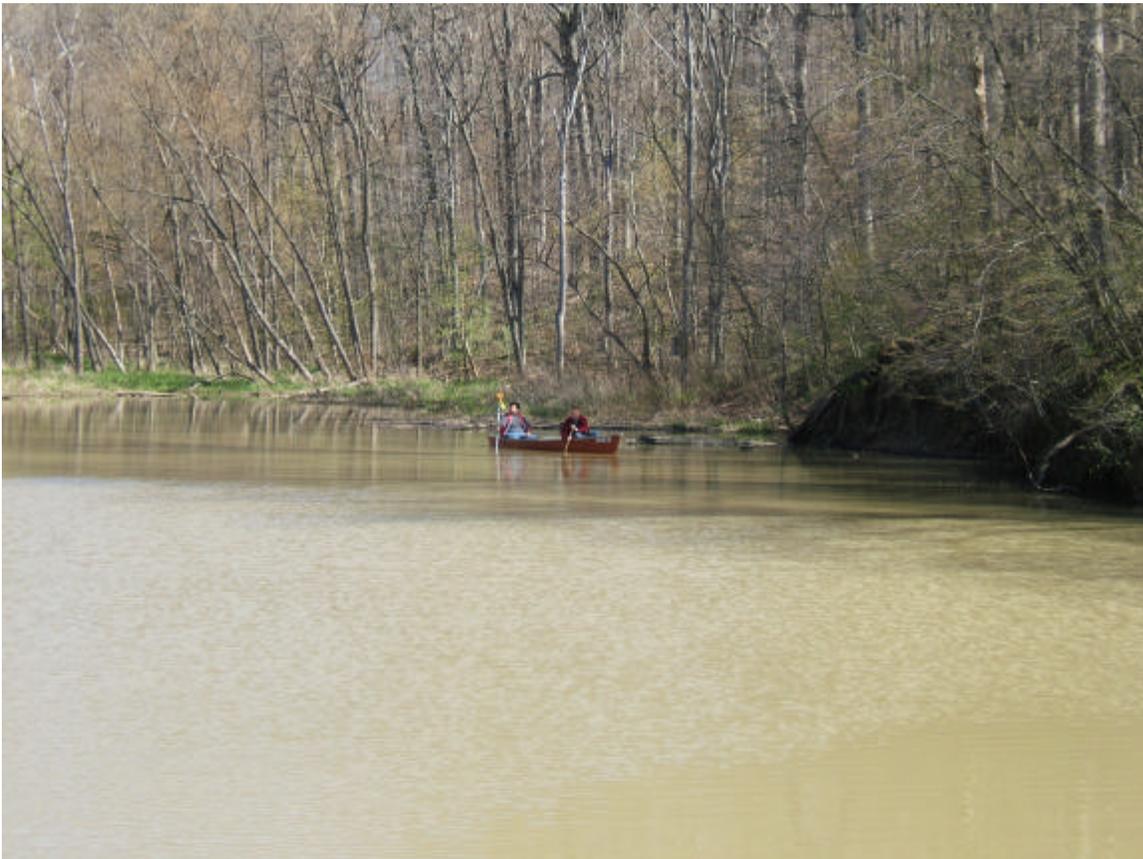
Figure 10. Survey crew working in the basin

Surveying and mapping was performed by the Gamma Theta Upsilon, GHO chapter from the Department of Geology/Geography at Eastern Illinois University. The work was under the direction of Dr. Vincent Gutowski and Steven Di Naso. Students contributing to this process included Rob Queer III and Neal Pleskunas. The objective of this task is to document the post construction condition of the project. With subsequent measurements the City will be able to track the rate of deposition in the basin. This could potentially provide evidence as to the impact of land use changes.

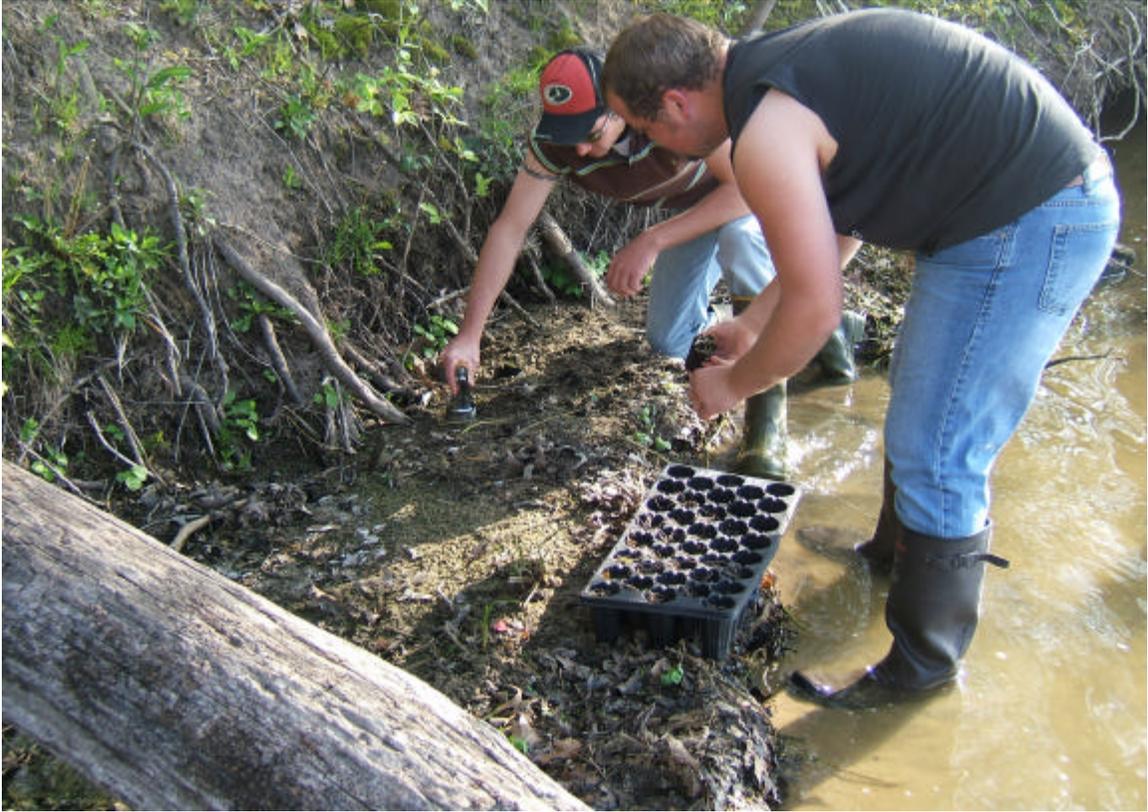
Figure 12. Planting aquatic vegetation behind breakwater

Plant material was purchased from JFNew of Walkerton, Indiana. Contact was first made with this company in 2005. The plant installation needs to be done during a time favorable to growing and after basin and riprap construction. The spring of 2007 became our target for planting. The order for the plants was made on February 21, 2007. The plant plugs and bulbs were received on April 9, 2007. A grow area was setup to maintain the viability of the material until we could plant it. This aquatic vegetation was planted on April 23 and 24. It was originally intended that \$1000.00 of aquatic vegetation would be planted. This was scaled back due to the limited amount of suitable planting space. Some areas would have had a very low probability of sustaining plant growth. Table 2, provides a list of plant material and cost. The labor for the planting involved 3 people over 2 eight-hour days. The operation involved the use of one pontoon boat, one canoe and one truck.

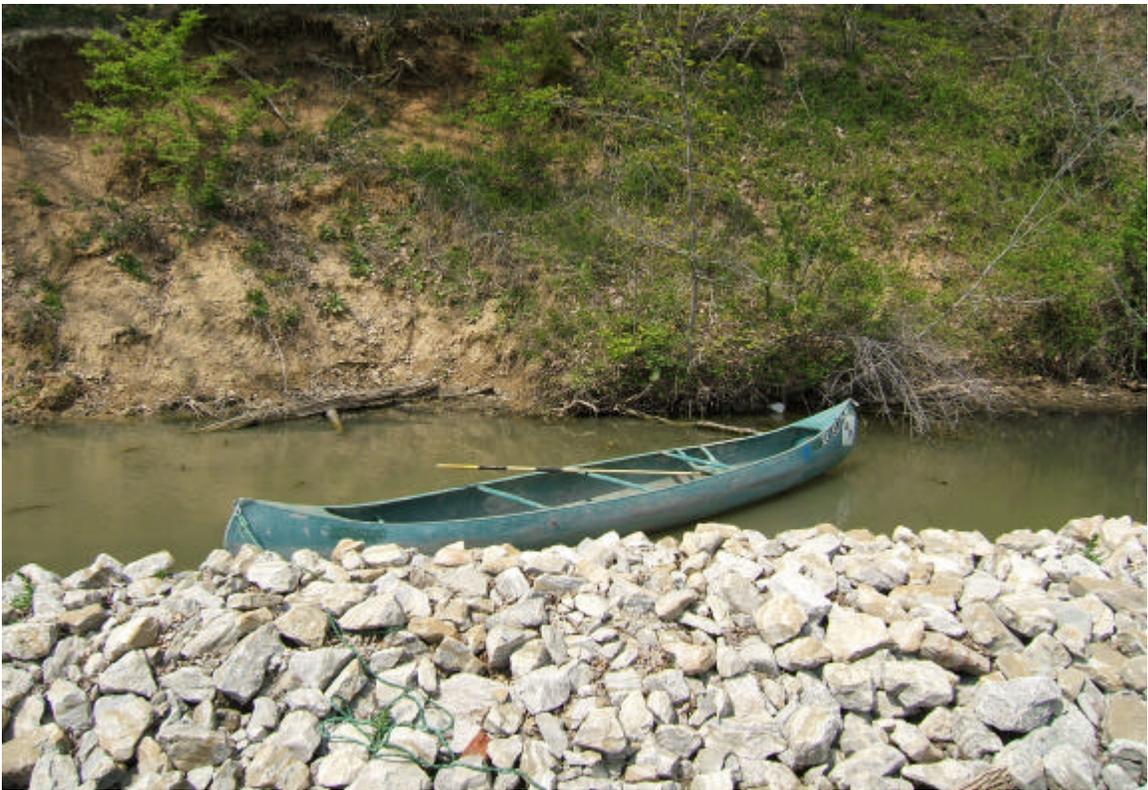
Figure 13. A portion of planting area behind breakwater
