Final Report

Countryside Lake Water Quality Monitoring Program

Project No. 60089645

November, 2009

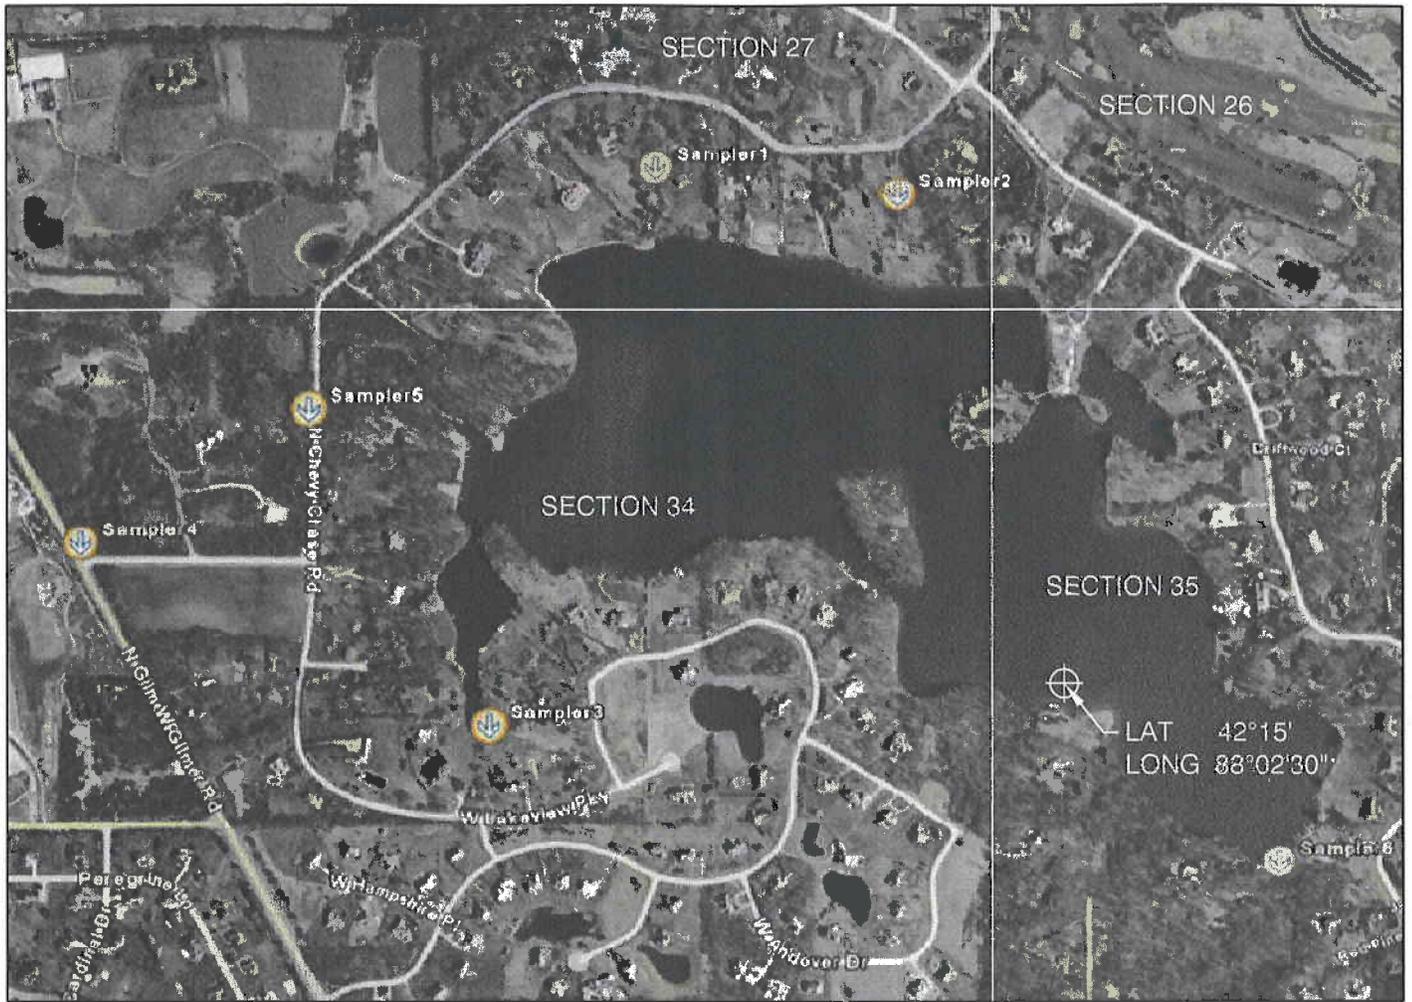
Drawn :	KLC	10/22/2009
Checked:	DJH	10/22/2009
Approved:	DJH	10/22/2009
PROJECT NUMBER	60089645	
FIGURE NUMBER	1

PART OF SECTION 26, 27, 34 AND 35,
TOWNSHIP 44 N, RANGE 10 E

Countryside Lake is located in unincorporated Fremont Township adjacent to the Village of Mundelein (T44N, R11E, Section 27, 34, 35). The project location is shown in Figure 1 in Appendix A.

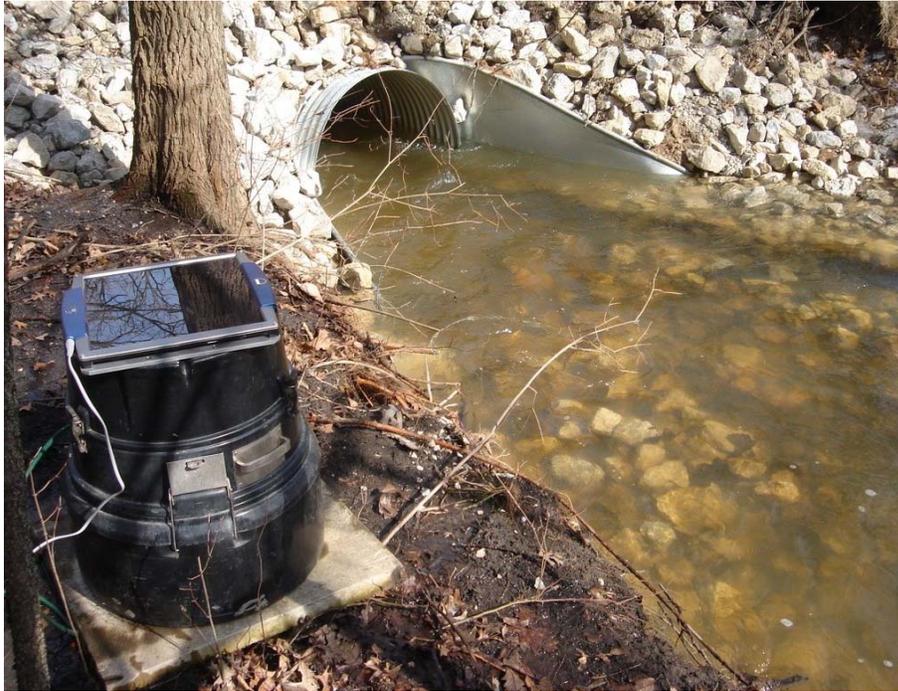
Typical ISCO Model 6712 automatic sampler (#5) installation at Chevy Chase Rd. Note solar panel above sampler.

The Chevy Chase Model 2700 (# 5) was replaced with a 1680 unit which was battery powered with a solar panel in 2005 and relocated so the intake hose was in the direct flow of the culvert current somewhat further downstream. The 1680 was replaced with a new 6712 at the beginning of the 2008 season.

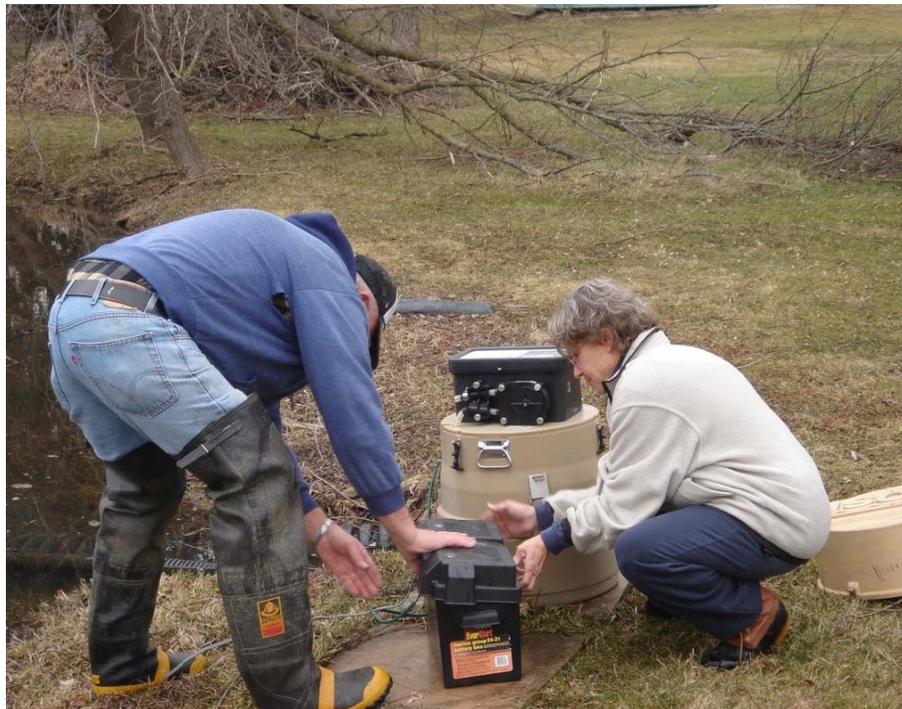
Isco Model 2700 sampler (# 1) located at the Larsen drain. Note battery pack.

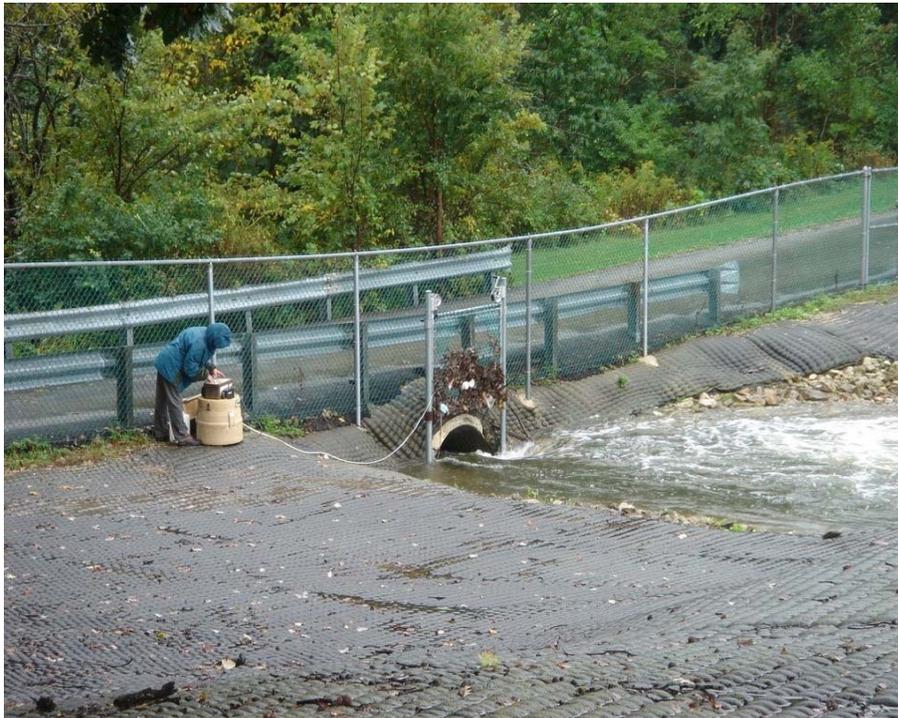
**Isco Model 2700 sampler located at dam spillway and downstream culvert.
Note high flow conditions.**

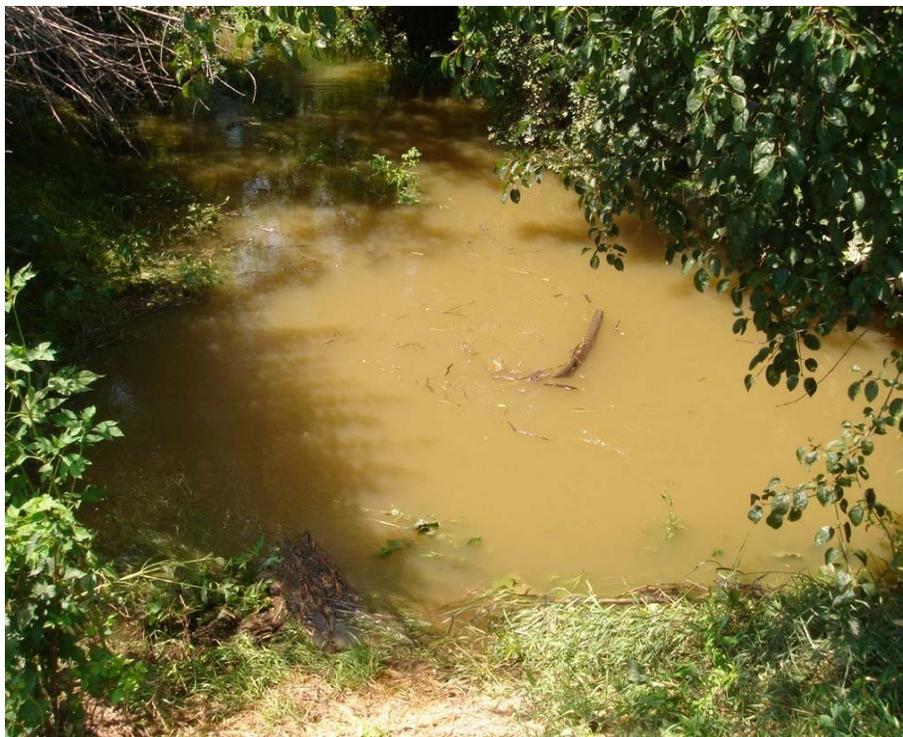
Example condition of heavy turbidity following storm event located at Gilmer Rd culvert

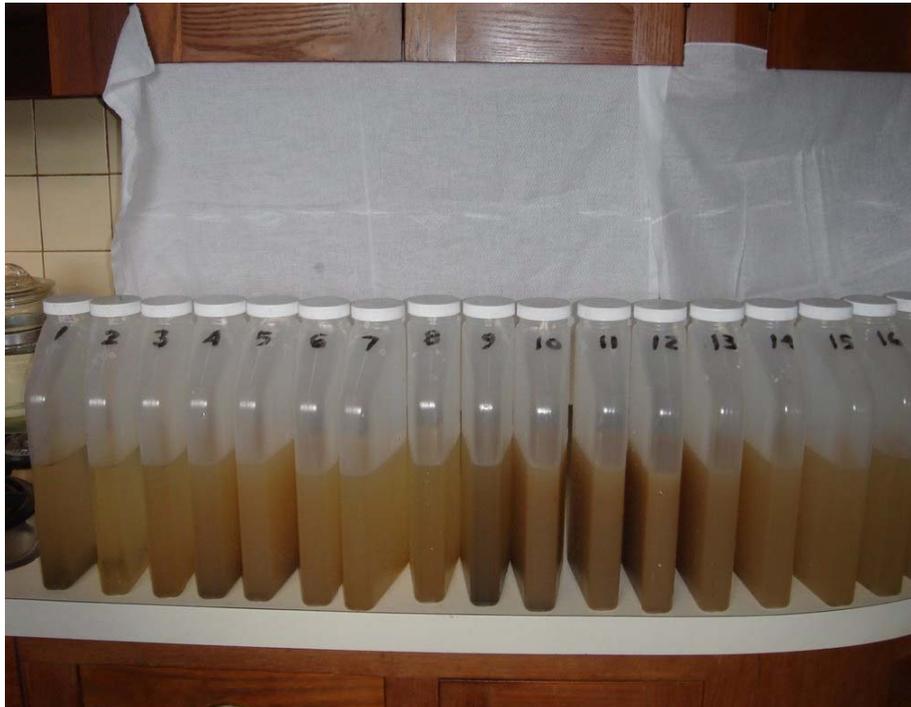
Sequential sampler containers prepared for turbidity testing and sample composite

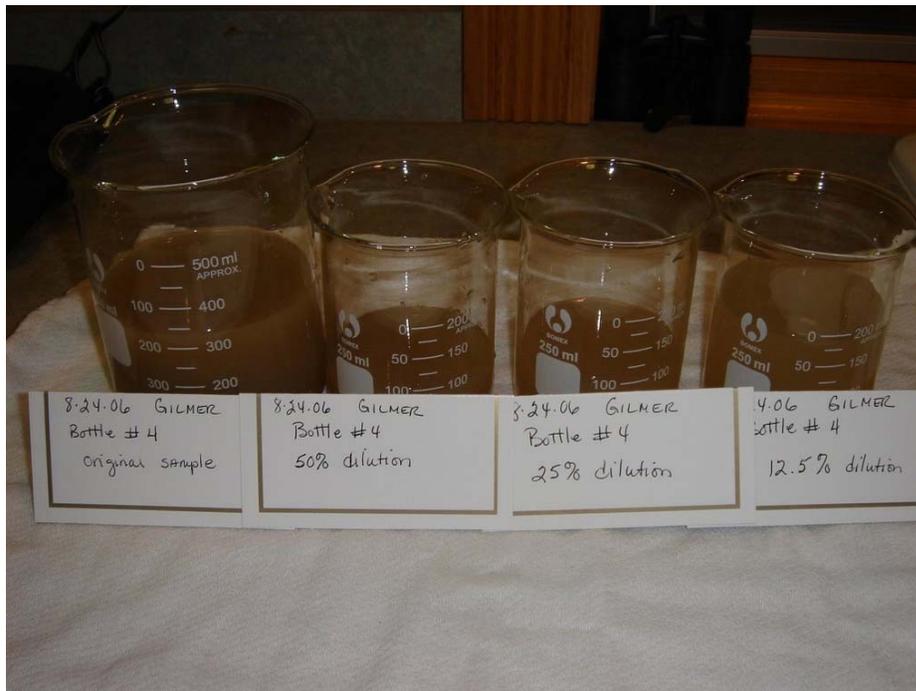
Dilution process for turbidity testing to obtain sample concentrations in turbidity meter range

A LaMott Model 200C turbidity meter was purchased. The turbidity meter is used to assess and screen sediment concentrations in each of the sequential samples so that appropriate compositing of samples is accomplished to reflect representative water quality from the storm event. Initially, all sequential samples from each event were subjected to TSS testing to determine a correlation between TSS and turbidity. With the correlation available, only the composite sample from each event is now tested for TSS. The correlation also allows a crude estimate of sediment mass transport for each rain event. The turbidity meter was not purchased with 319 funding. New weather station software was also purchased and is now part of a major weather network of stations. The new software has a Doppler radar feature that allows a better prediction of storm rainfall intensity and magnitude. The weather station software was not purchased with 319 funding.

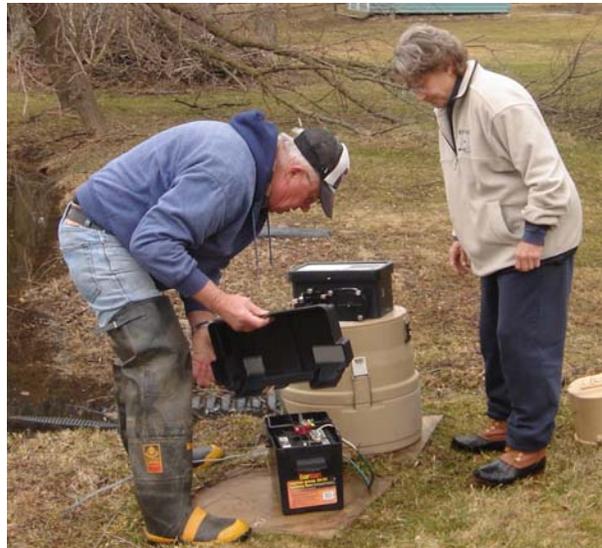
- Samples are then picked up by a professional lab for analysis.
- Results of the testing are reviewed and documented. Below is an example of a chart.
