Illinois EPA Clean Lakes Program
Clean Lakes Study Review and Implementation Report
for Lake Hillsboro, Montgomery County, Illinois

July 2007

Clean Lakes Study Review and Implementation Report for Lake Hillsboro, Montgomery County, Illinois

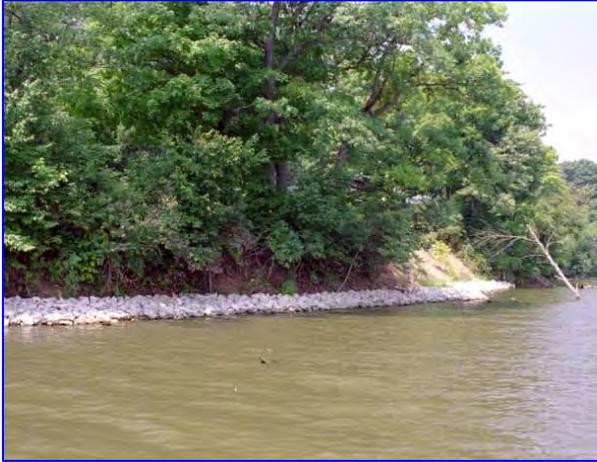
Shoreline Revetment

As previously mentioned, there have been segments of shoreline at Lake Hillsboro that have been stabilized with riprap revetments and off-shore riprap, breakwater structures. Despite these minor shoreline stabilization efforts, a significant amount of eroded shoreline within the lake is in need of protection and stabilization. Technology has resulted in the development of many products to control erosion and older methods have been improved. The following were considered when deciding the best approach for stabilizing Lake Hillsboro shoreline: riprap (both crushed stone and rounded glacial stone) with filter rock or filter fabric, erosion mats, plastic and natural geoweb, gabions, and native plantings.

Figure 2. Examples of Riprap Shoreline Protection

For the impacted areas with moderately and severely eroded shorelines, riprap is the recommended alternative to address the erosion problems at Lake Hillsboro. The advantages of riprap include its reliable longevity, ease of installation and relatively inexpensive cost over large areas. All riprap should be installed using either filter stone or filter fabric to prevent washout from behind the installed riprap. Shoreline stabilization work on this scale will require a Joint Application Permit from the Army Corps of Engineers, the Illinois Environmental Protection Agency, and the Illinois Department of Natural Resources, particularly for riprap placed as fill material beneath the normal water level.

Riprap should be placed along the undercut bank of the shoreline two feet below and two feet above normal pool (spillway elevation) at a 2:1 slope. Once the toe of the slope is protected from further undercutting by structural stabilization methods, the eroded slope will gradually slough until a state of equilibrium is reached. If a shallow, gently sloping littoral zone is present, an offshore breakwater may be feasible and would allow natural establishment of native plant species to provide additional soil stabilization and nearshore habitat. Representative photographs of shoreline stabilization options are provided in Figure 2. The estimated cost of riprap stabilization using A-grade, gradation RR4 broken stone riprap with filter fabric is approximately \$60 per linear foot installed. Estimates of probable costs for shoreline stabilization at Lake Hillsboro are listed in Table 1.
