Rayse Creek Watershed Management Plan

**Department of Forestry
Southern Illinois University Carbondale
Research Publication No. NS-019
October 2006**

RAYSE CREEK WATERSHED MANAGEMENT PLAN

Prepared for
Illinois Environmental Protection Agency

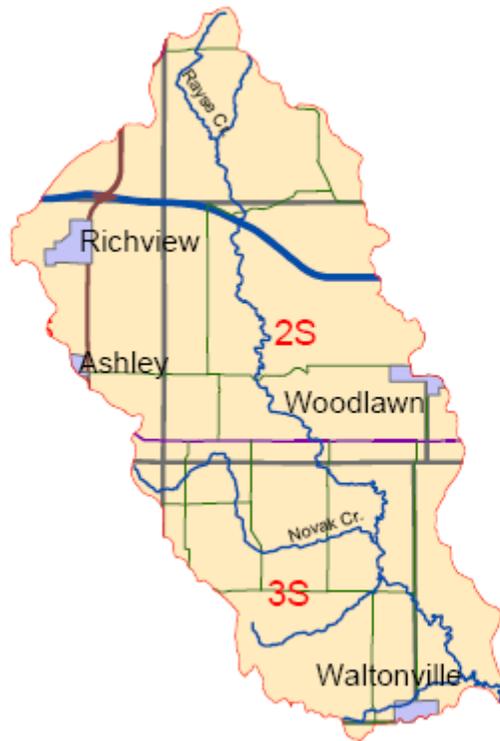
Figure 1. Rayse Creek watershed boundary

A *watershed* is defined as a topographically delineated area that is drained by a network of streams and/or rivers. Thus, the high elevation points around a stream and its' tributaries form the watershed boundary.
