Kickapoo Creek Project – Phase I IEPA 319 Grant

Final Report Grant #3190713

Farnsworth Group Inc.
2709 McGraw Drive
Bloomington, IL 61704
(309) 663-8435

The City of Bloomington Department of Parks and Recreation
101 W. Washington Street
Bloomington, IL 61704
(309) 434-9999

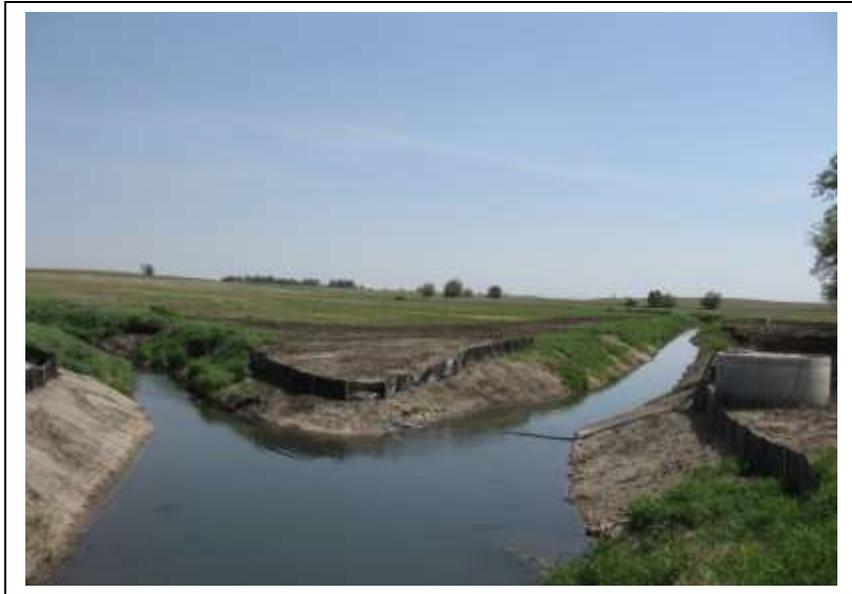
The channel excavation began in August 2008 at the downstream end of the project. Photos 1, 2 and 3 in Appendix A show the previous channel and its agricultural floodplain prior to construction. The deep, straight, trapezoidal channel and lack of vegetative diversity can be identified in the photos. Photo 4 shows a post-project view of the western tributary for comparison to Photo 3. The meandering flowline, laid-back banks, and rock bank stabilization are apparent.

1. Confluence of tributaries prior to project. Note straight, deep trapezoidal channel.

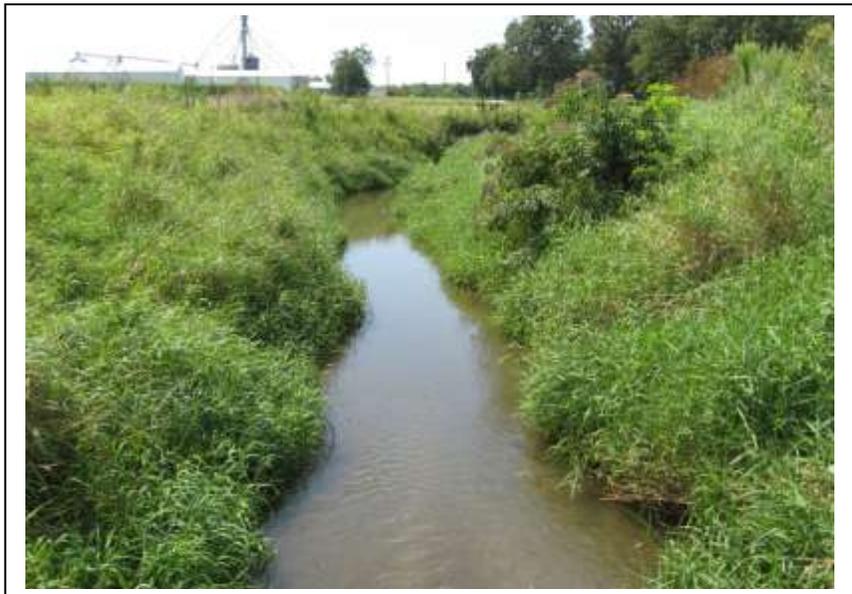
2. Looking downstream in channel prior to start of construction. Note tall, steep banks and reed canary grass vegetation.

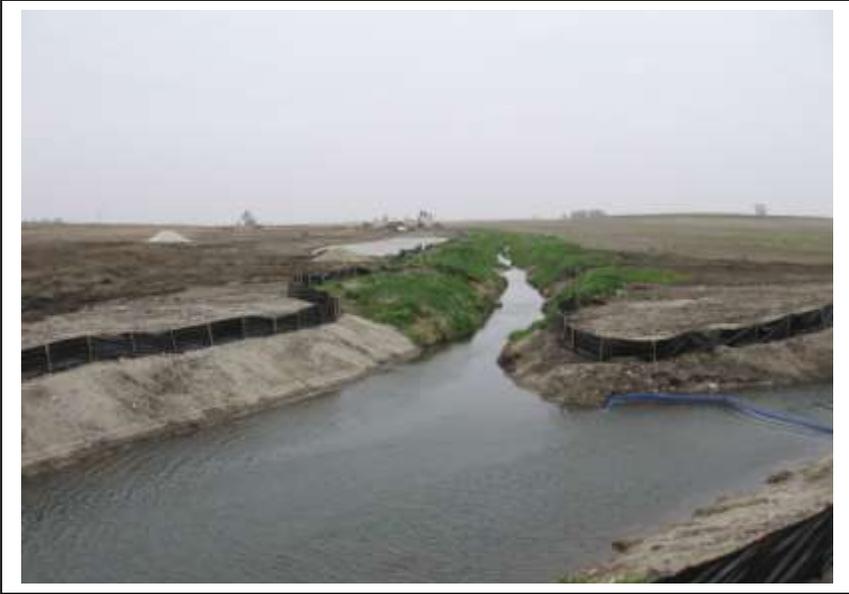
3. View up northern tributary. Note adjacent subdivision construction to left (west) of channel.

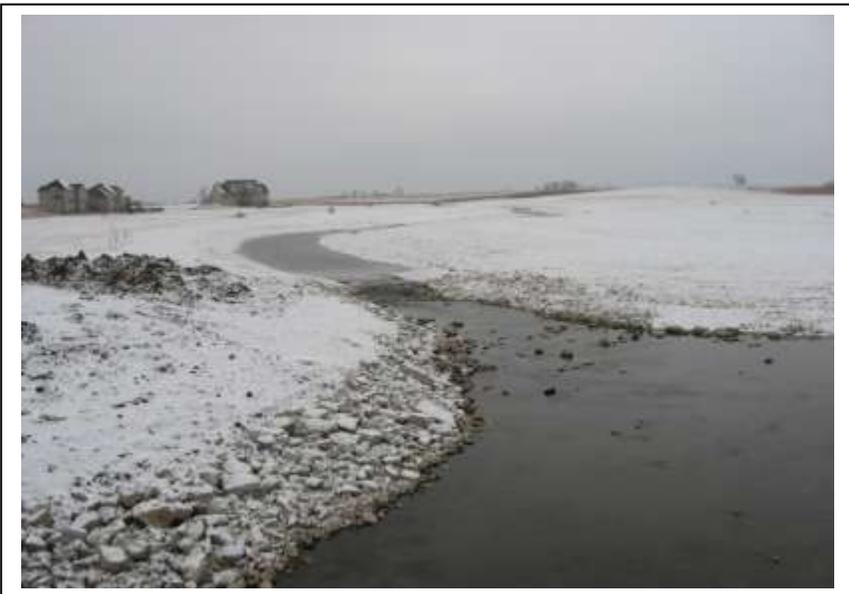
4. View up northern tributary after stream excavation.

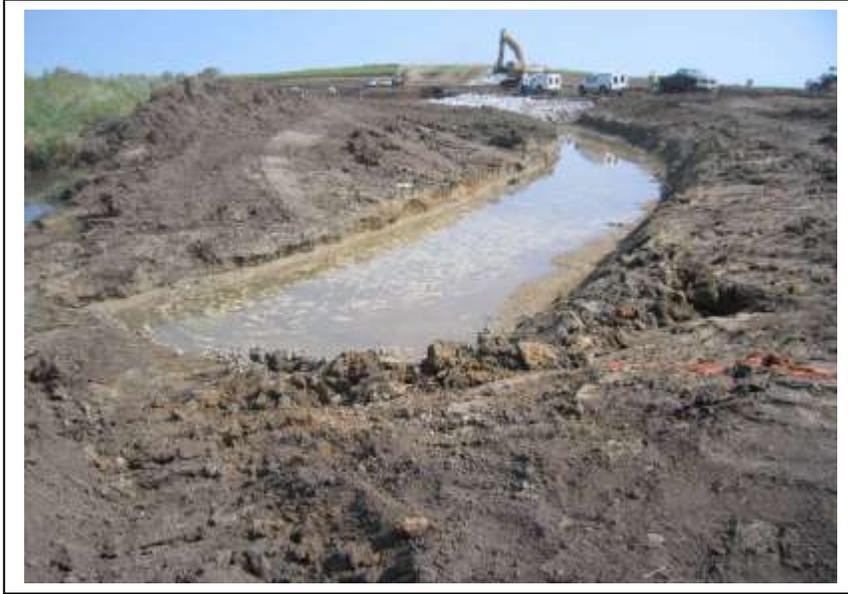
Photos 5, 6 and 7 in Appendix A show construction details of the channel construction. A total of 68,000 cubic yards of earth were removed from the floodplain and used in the adjacent upland subdivision. This provides significant additional floodplain storage, particularly in conjunction with the high-flow restriction of the pedestrian bridge backing water up during extreme events. Approximately 8,200 tons of large stone rip rap (IDOT gradation RR5) was used in the bank protection for these 2,775 lineal feet of channel restoration. An additional 2,400 tons of rock was used to create the 8 Newbury weirs shown in Figure 8.

5. Channel excavation.

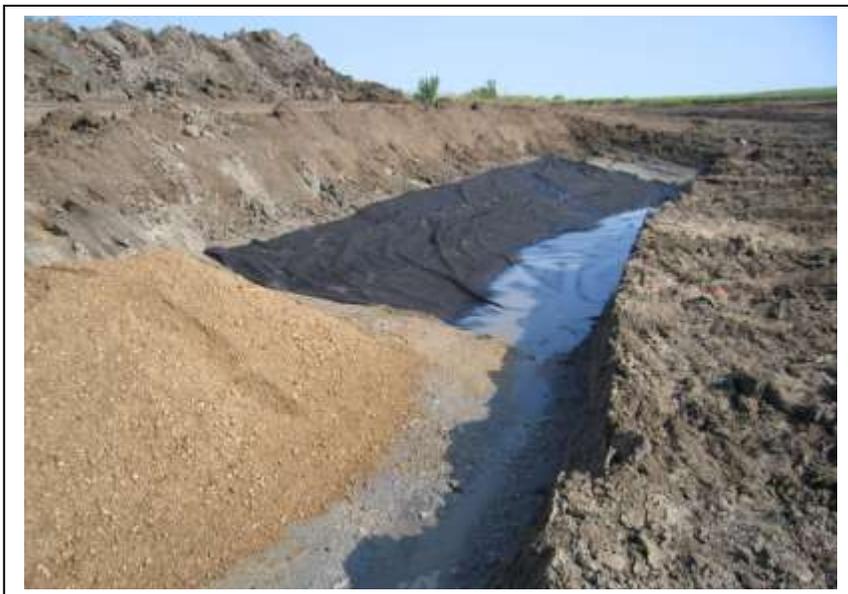
6. Fabric, and bedding under rip rap channel bank protection.

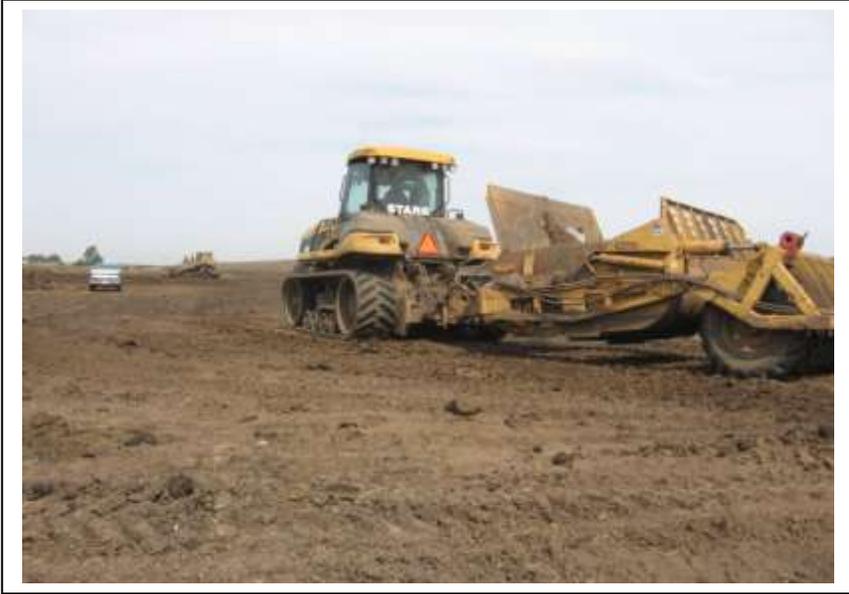
7. Floodplain excavation.

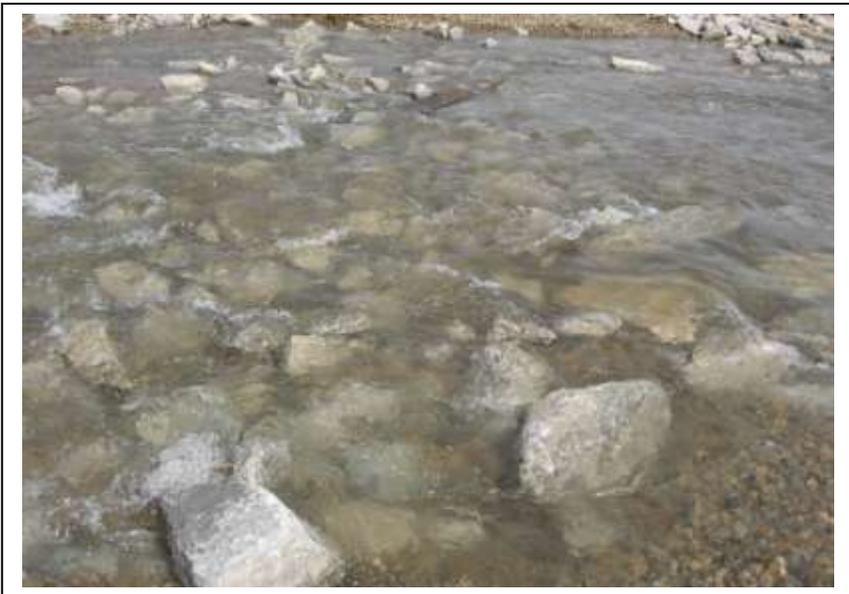
8. Completed rock riffle.

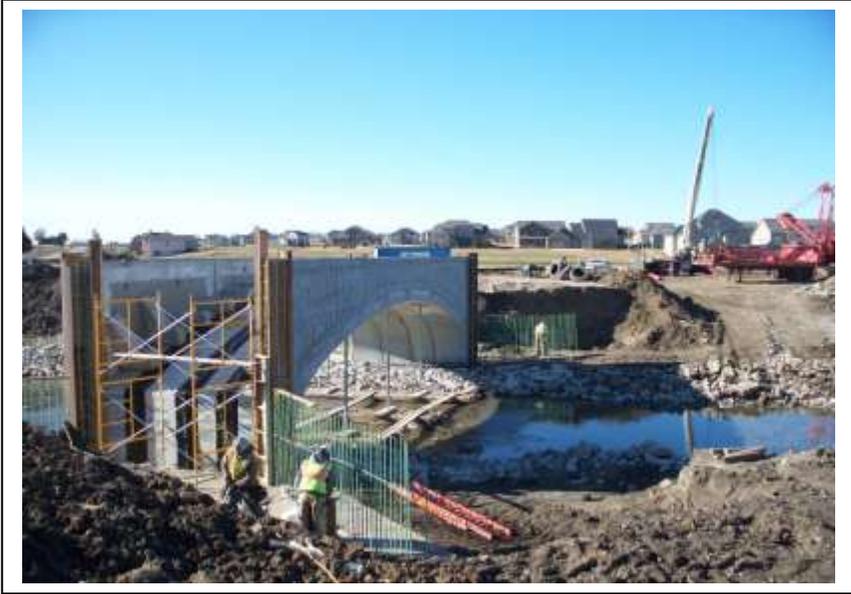
The pedestrian bridge restriction consisted of a 54-foot span pre-constructed, three-sided bridge installed downstream of the confluence of the two restored reaches. Photos are included Appendix A (photos 9 and 10). Additional photographs of the completed channel remeandering are shown in photos 11 and 12.

9. Pedestrian bridge construction

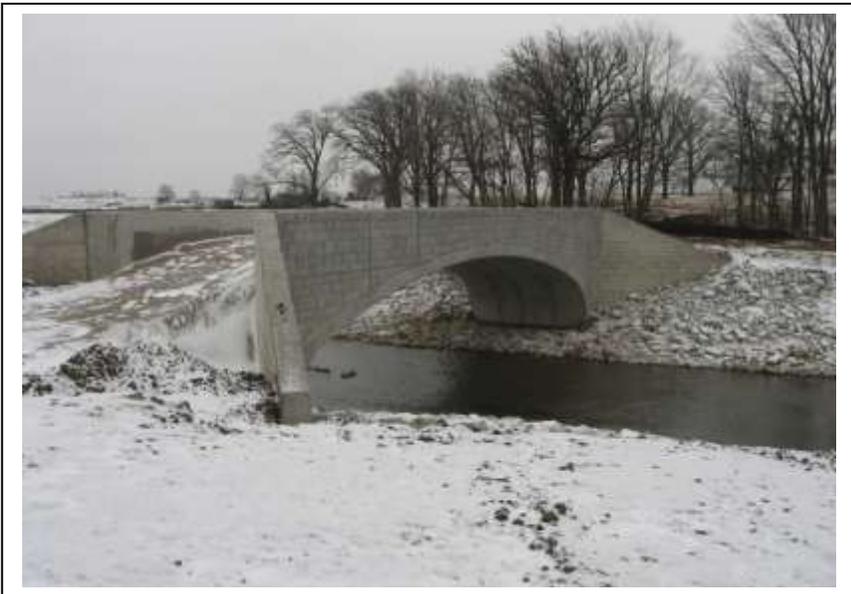
10. Completed bridge.

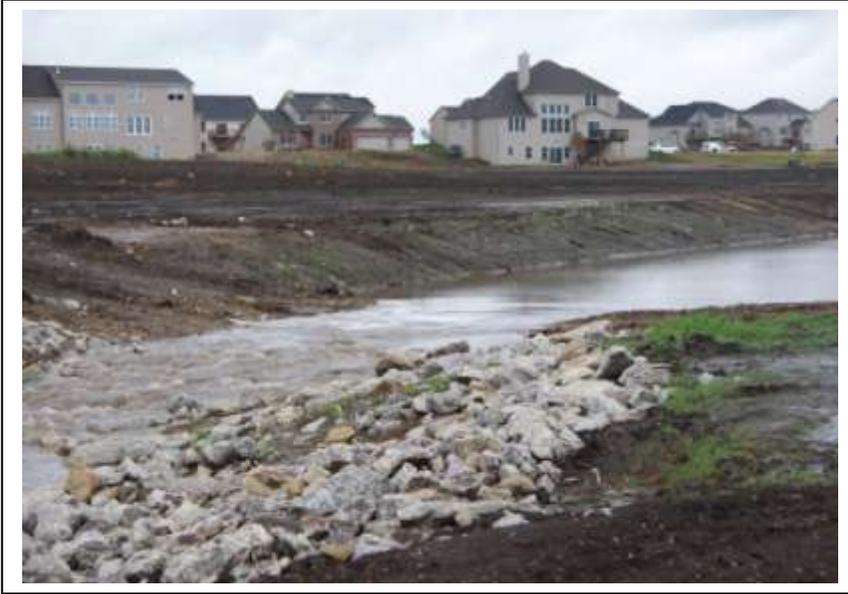
11. Completed rock riffle.

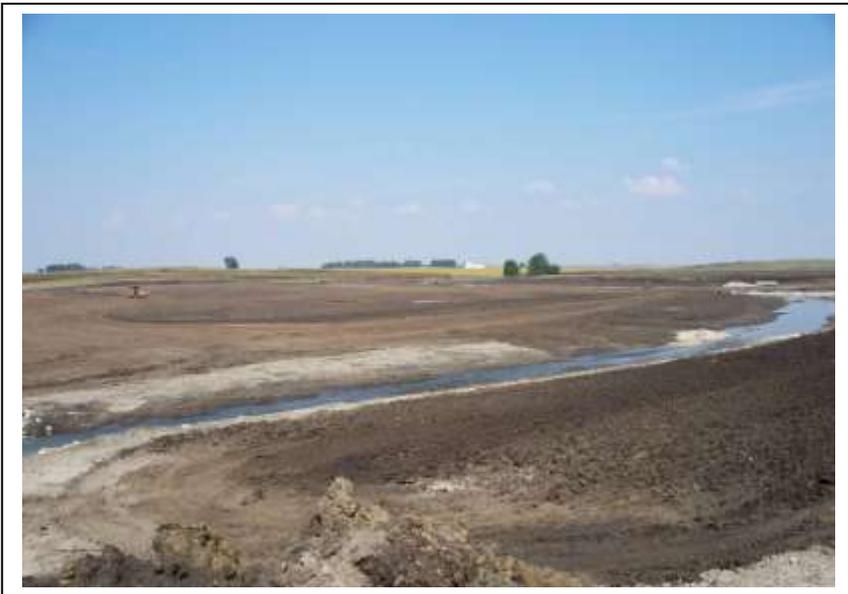
12. Completed east branch.

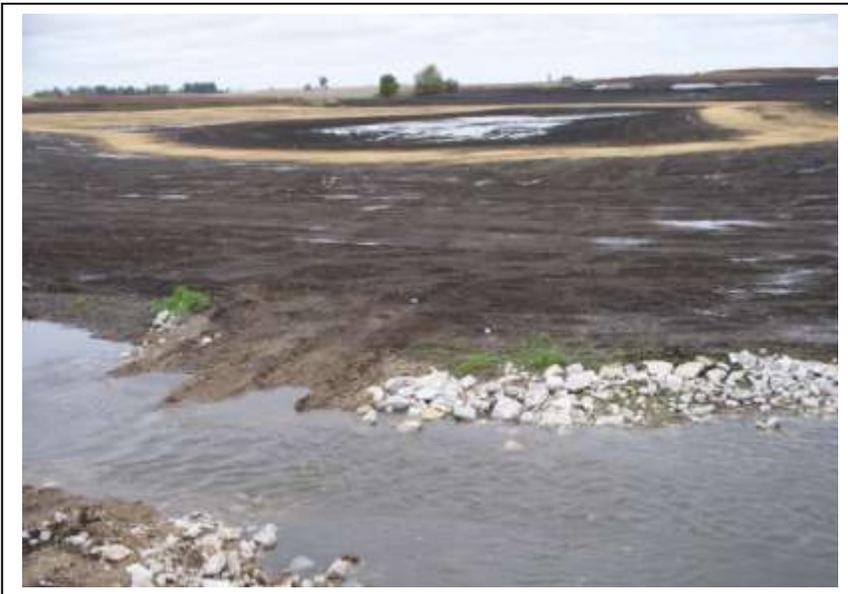
The restoration of the floodplain was achieved, although challenges encountered during construction and over the winter created many unexpected hardships. The site contractor completed Division A by the contracted deadline of October 1st, 2008 – the installation of the pedestrian bridge notwithstanding, which had a separate deadline of November 15th, 2008. At that time, the project was turned over to a second, separate landscaping contractor for Division B. Labor issues and the landscaping contractor's inability to mobilize created delays of over a month, resulting in little to no germination of the cover crop or installation of the erosion controls necessary to prevent erosion and protect the native seeds during the winter months. A photo of the initial fall/winter seeding is provided in Appendix B, photo 1. The lack of cover vegetation and subsequent loss of erosion controls is evident in photos 2 and 3 taken during the spring and winter.

2. Spring 2009. Note loss of mulch and lack of cover crop.

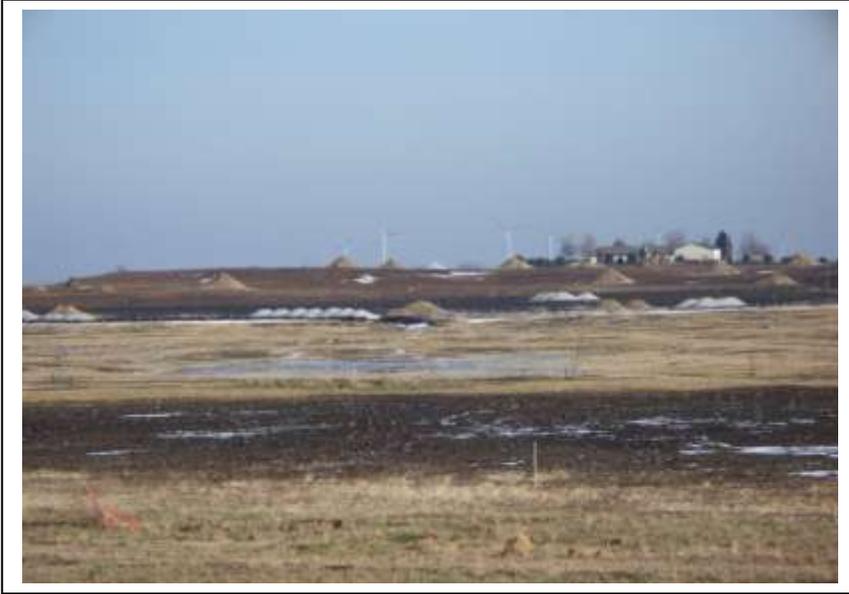
3. Winter 2009

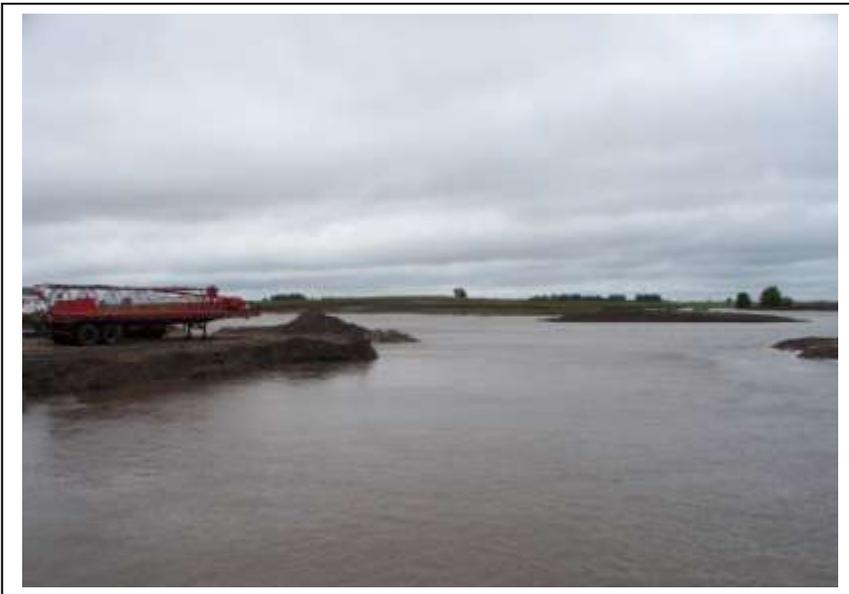
Compounding the lack of established erosion protection in the restored floodplain, the site was inundated with five (5) major, high-flow events from initial excavation until eventual establishment of the designed vegetative and structural erosion controls. An example is provided in photo 4 with some of the impacts to the site shown in photos 5 and 6. The lack of established protection of the soils was illuminated by these flood events, resulting in erosion, sedimentation, loss of cover and loss of native seed throughout the restoration.

4. Site was hit with 5 major floods between initial excavation and permanent seeding/erosion control.

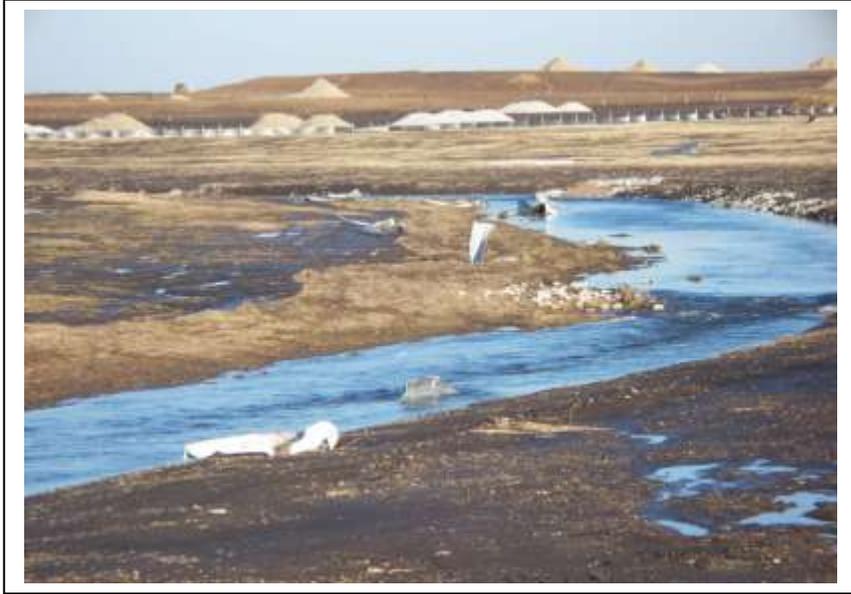
5. Debris in floodplain after destructive winds and major rainfall. Note impact to un-vegetated floodplain.

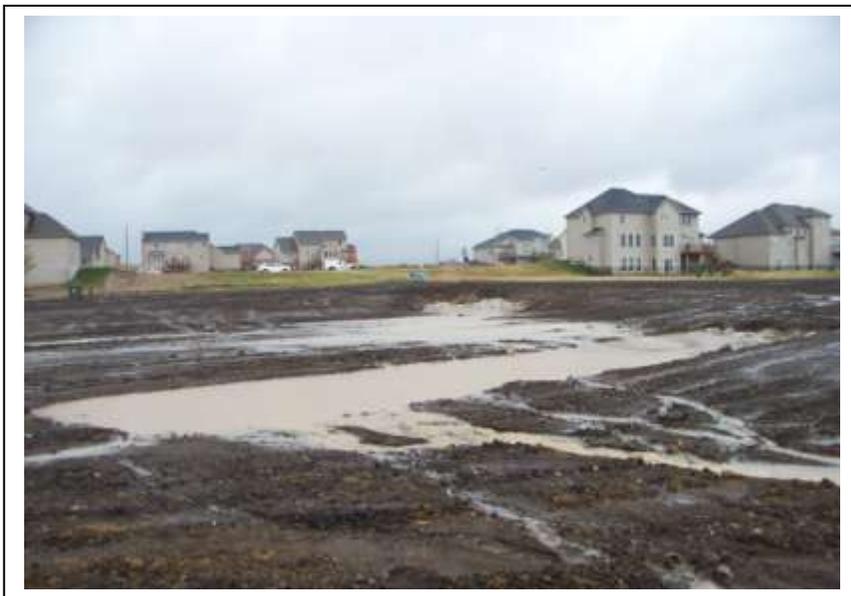
6. Western wetland during high flow event. Note lack of vegetation.

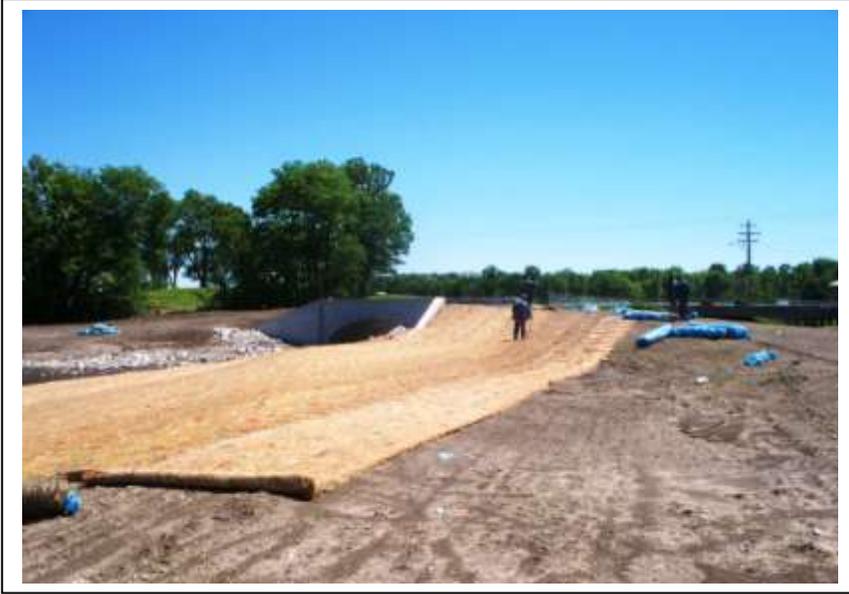
7. Erosion control installation, spring 2009.

In the spring of 2009, after lengthy discussion and negotiation with the landscaping contractor, the floodplain was re-seeded with native vegetation and erosion control blankets were installed in critical

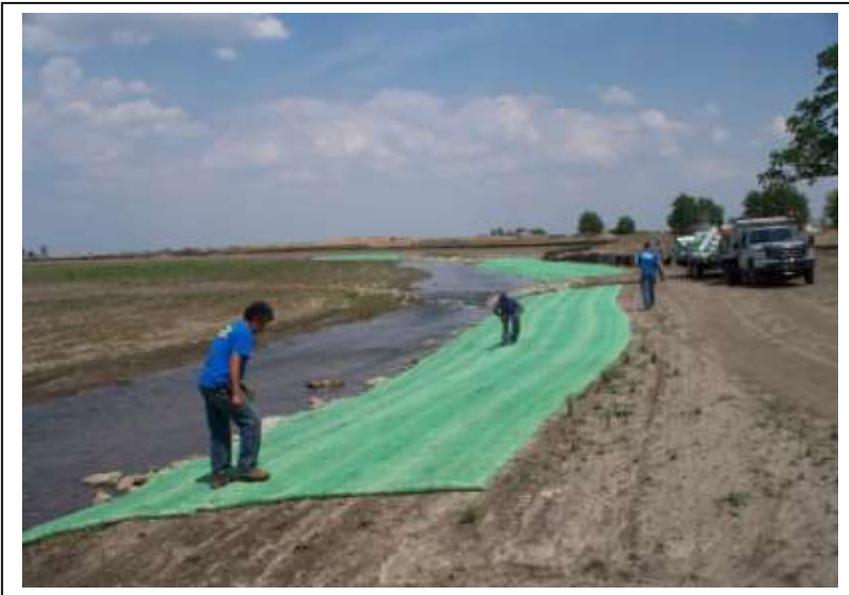
8. Erosion control blanket installation, spring 2009.

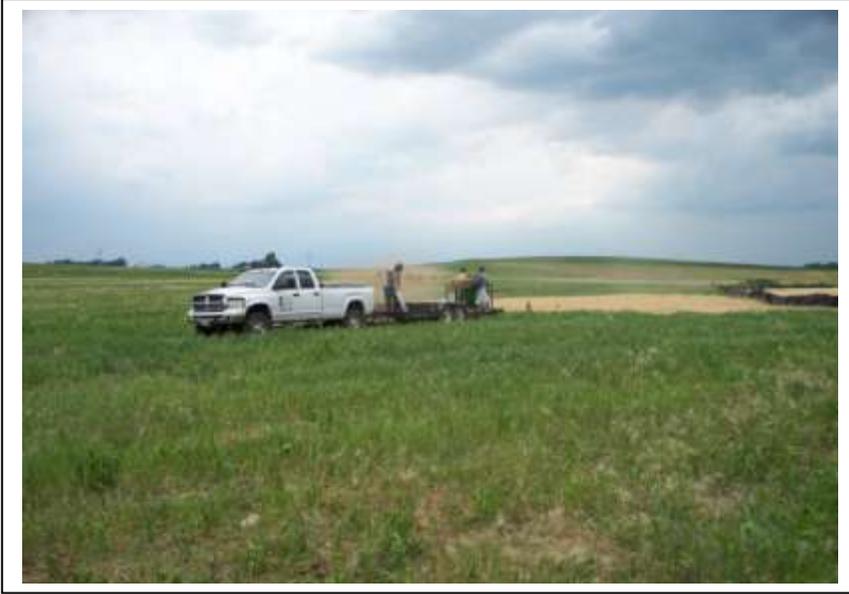
9. Re-vegetation, spring 2009.

areas along the creek (photos 7-9). Unfortunately, the live plantings in the wetlands were eliminated to accomplish the necessary re-seeding of the floodplain. However, additional grant monies were utilized to conduct limited live plantings in some of the wetland areas (photos 10 and 11). Throughout the spring, cover crops and some native vegetation has begun to emerge (photo 12) and re-vegetation of the floodplain is well underway (photos 13 and 14).

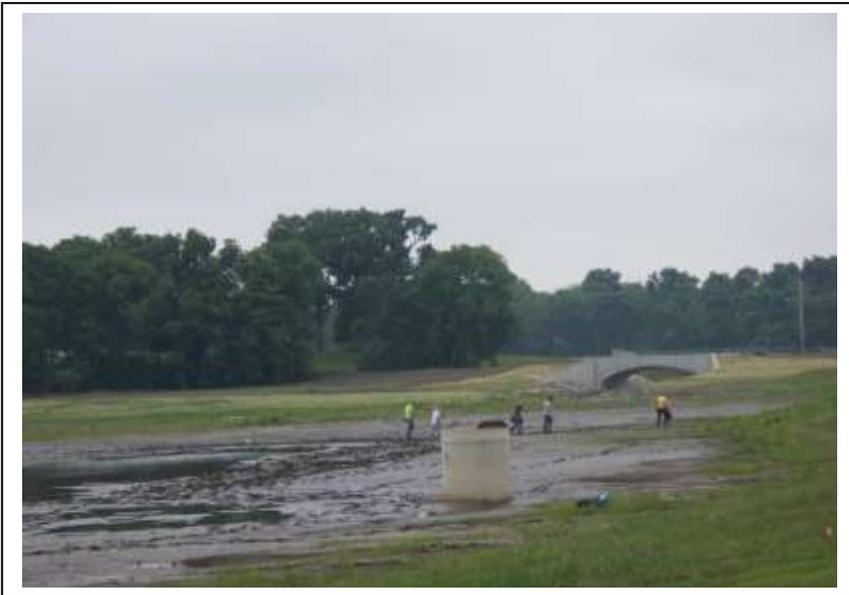
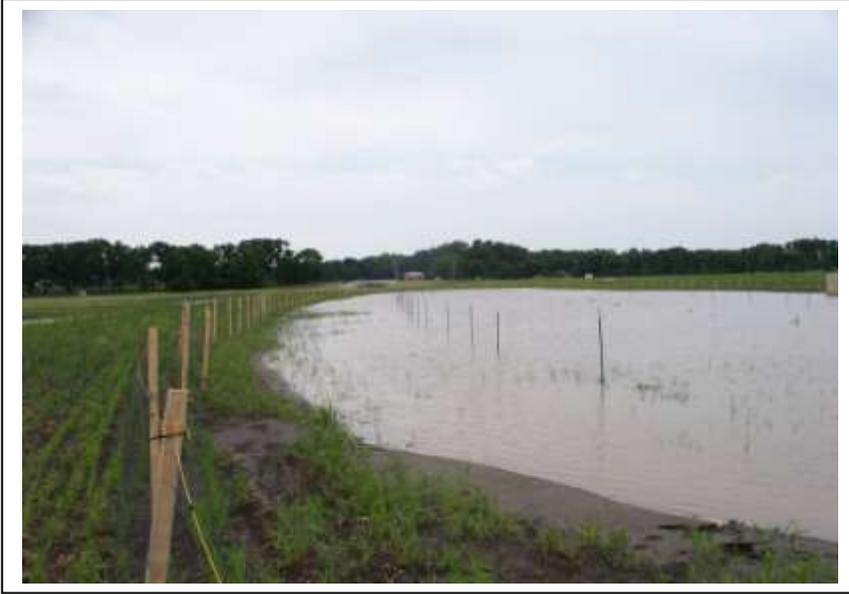
10. Live plantings in wetland, summer 2009.

11. Live plantings in wetland, summer 2009.

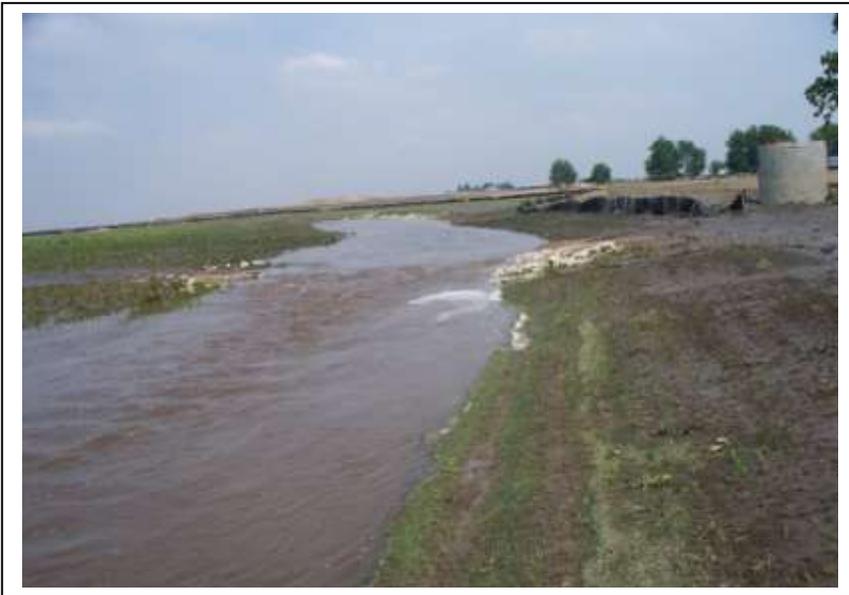
12. Emergence of vegetation, spring 2009.

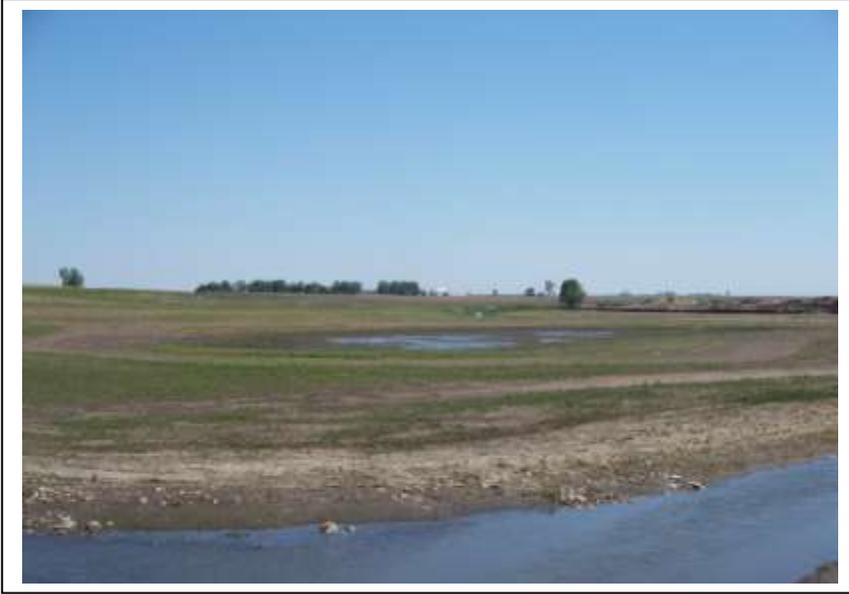
13. Central wetland at emergence of vegetation, spring 2009.

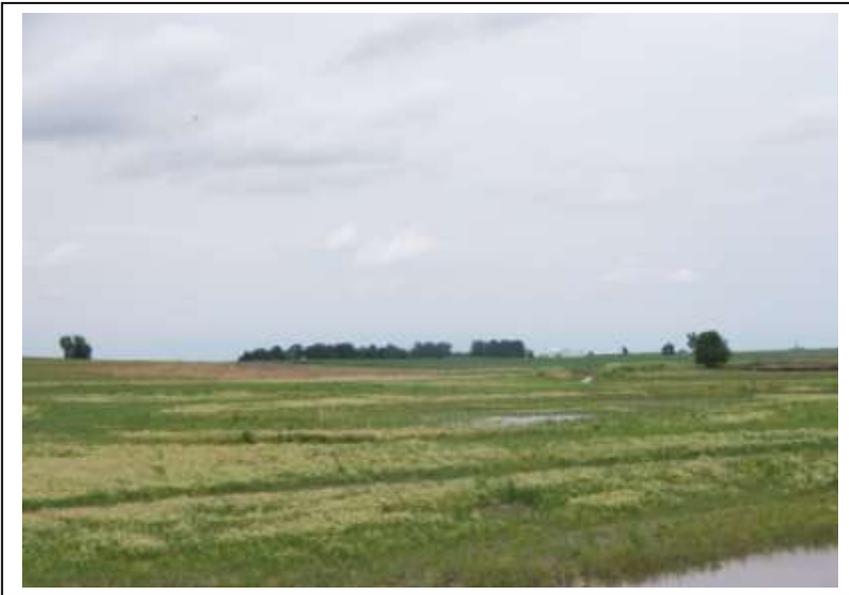
14. Central wetland, summer 2009.
