Concrete Restoration for Route 66 in Illinois

Amy Lamb Woods, P.E.
Thornton Tomasetti, Inc.

September 2012

103 Illinois Route 66: Historic Concrete Treatment Guide

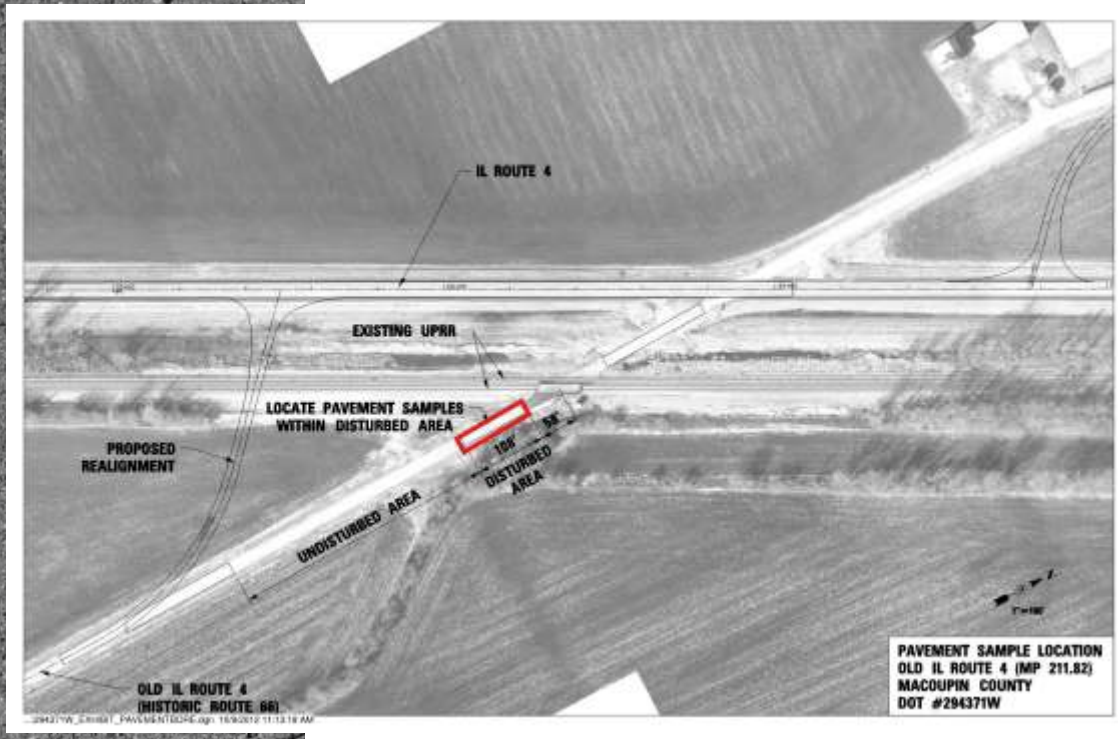
Fig. 19
Core 1 location near Nilwood/Girard, Illinois (IDOT image).

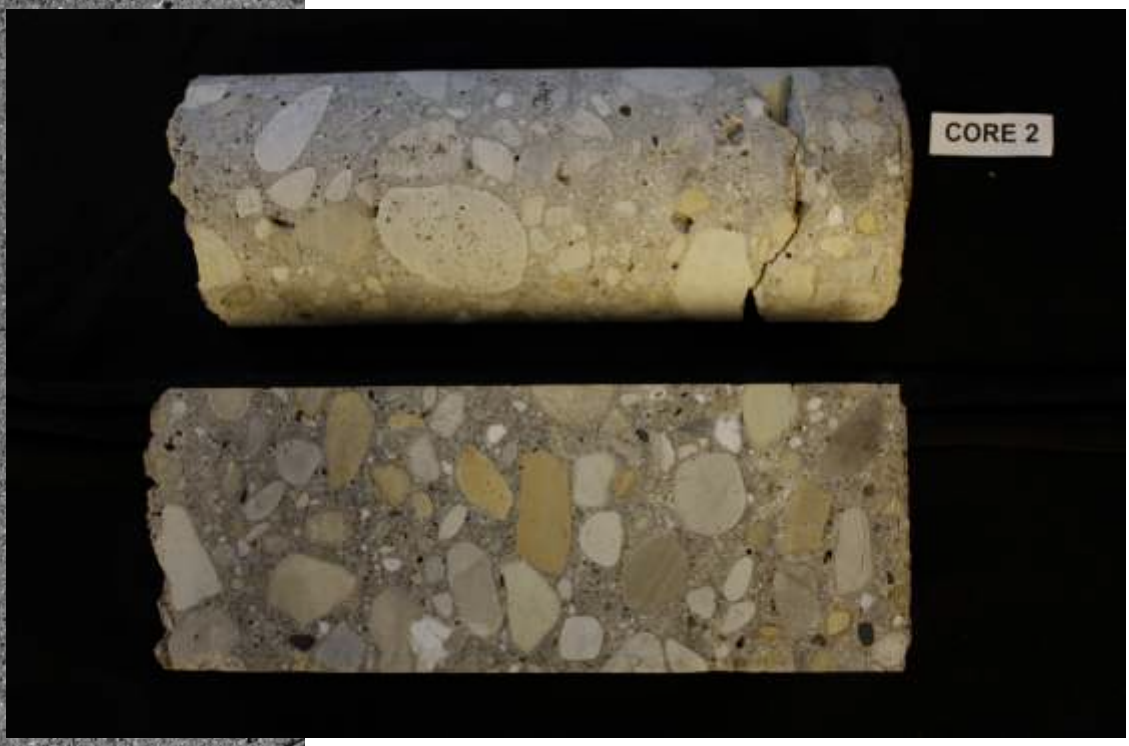
Fig. 23
Core 2 (Pontiac/Dwight); lapped surfaced shown on lower half of the core sample.

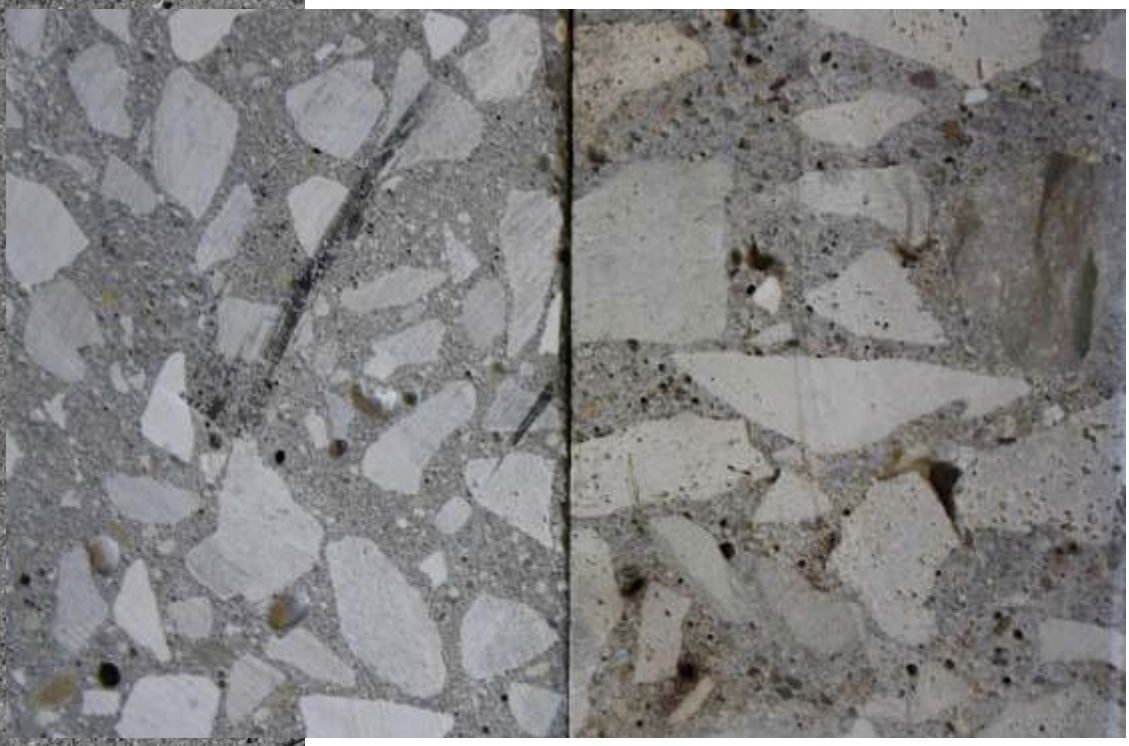
Fig. 27
Currently available crushed limestone (left) compared to aggregates in Core 1 (samples from Ozinga).

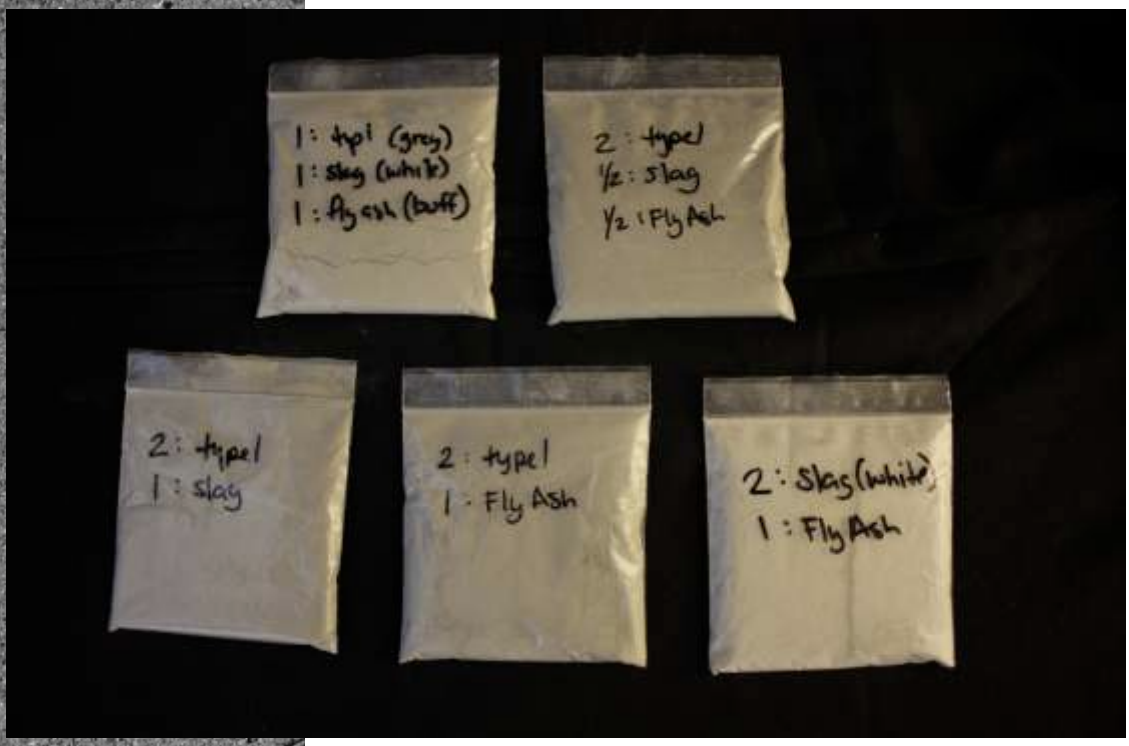
Fig. 31

Fig. 30
Cements and pozzolan samples illustrating their variety of colors (samples from LaFarge and Holcim).

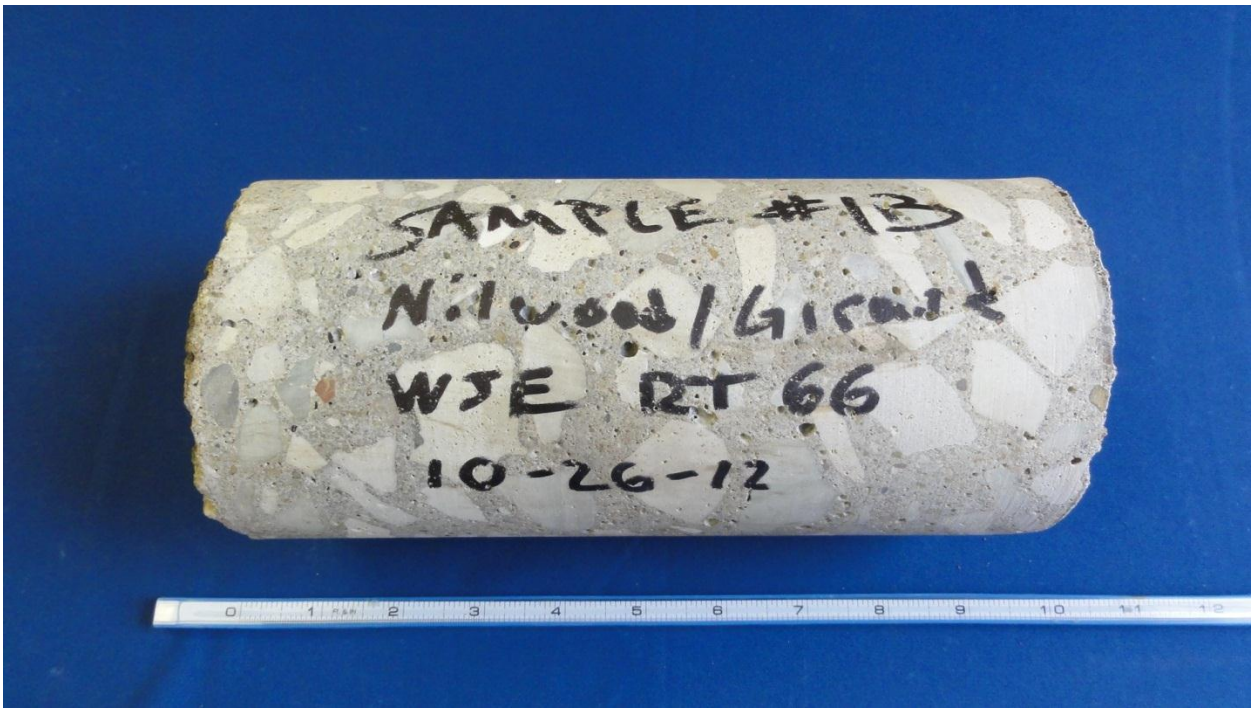
Figure 1. Core sample 1B as received. Top surface of the core is on the right of the photograph.

Figure 2. Core 1B; bottom surface of the core as received.

Figure 3. Core 1B; weathered top surface of the core as received.

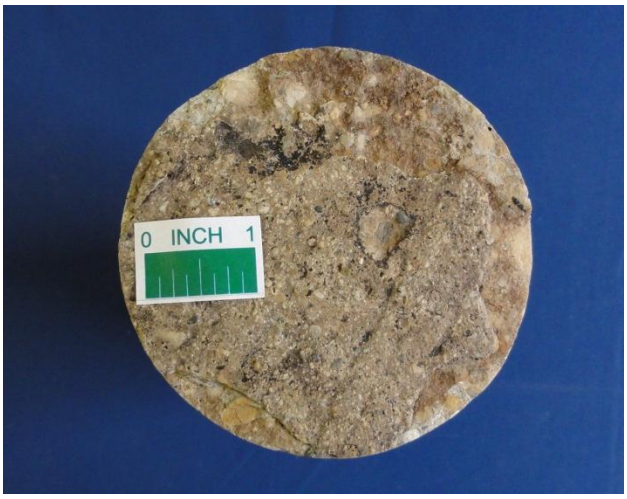
Figure 5. Core 2B; partially weathered, scaled top surface of the core as received.

Figure 6. Core 2B; bottom surface of the core as received.

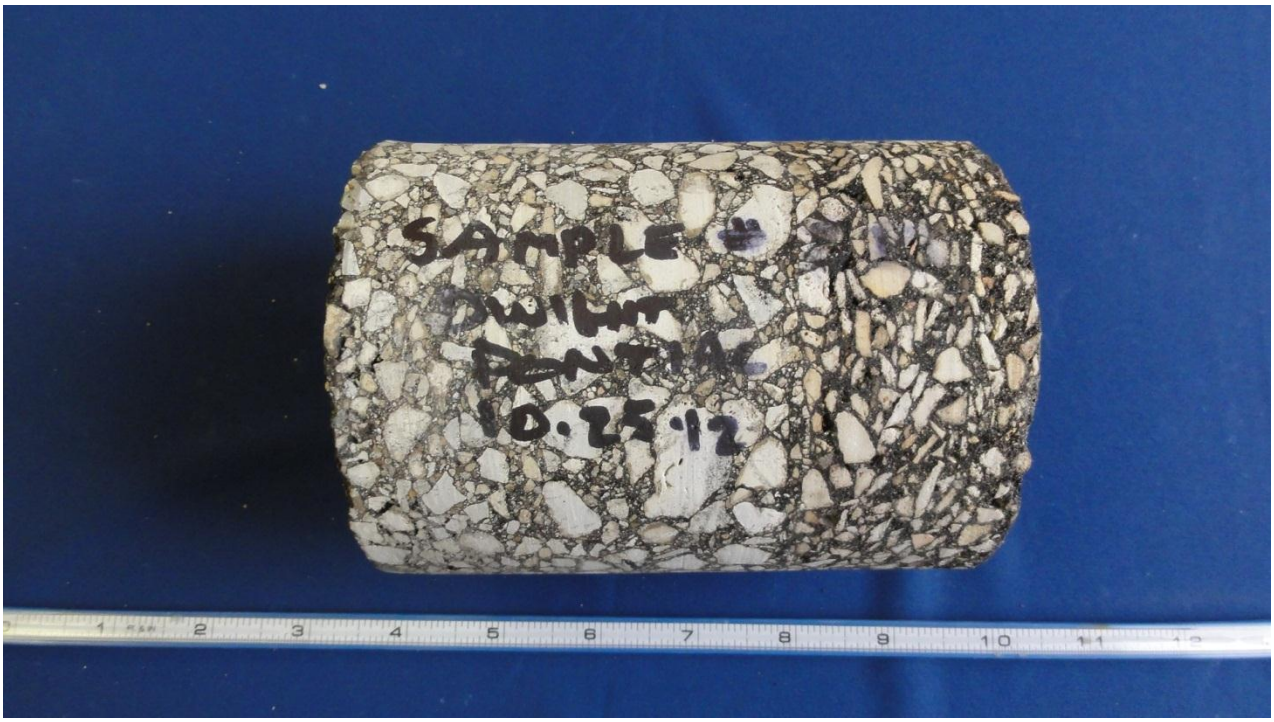
Figure 7. Asphaltic Core identified as Dwight /Pontiac (number designation illegible) as received. Top surface of the core is on the left of the photograph.

Figure 8. Top surface of the asphaltic core

Figure 9. Bottom surface of the asphaltic core.

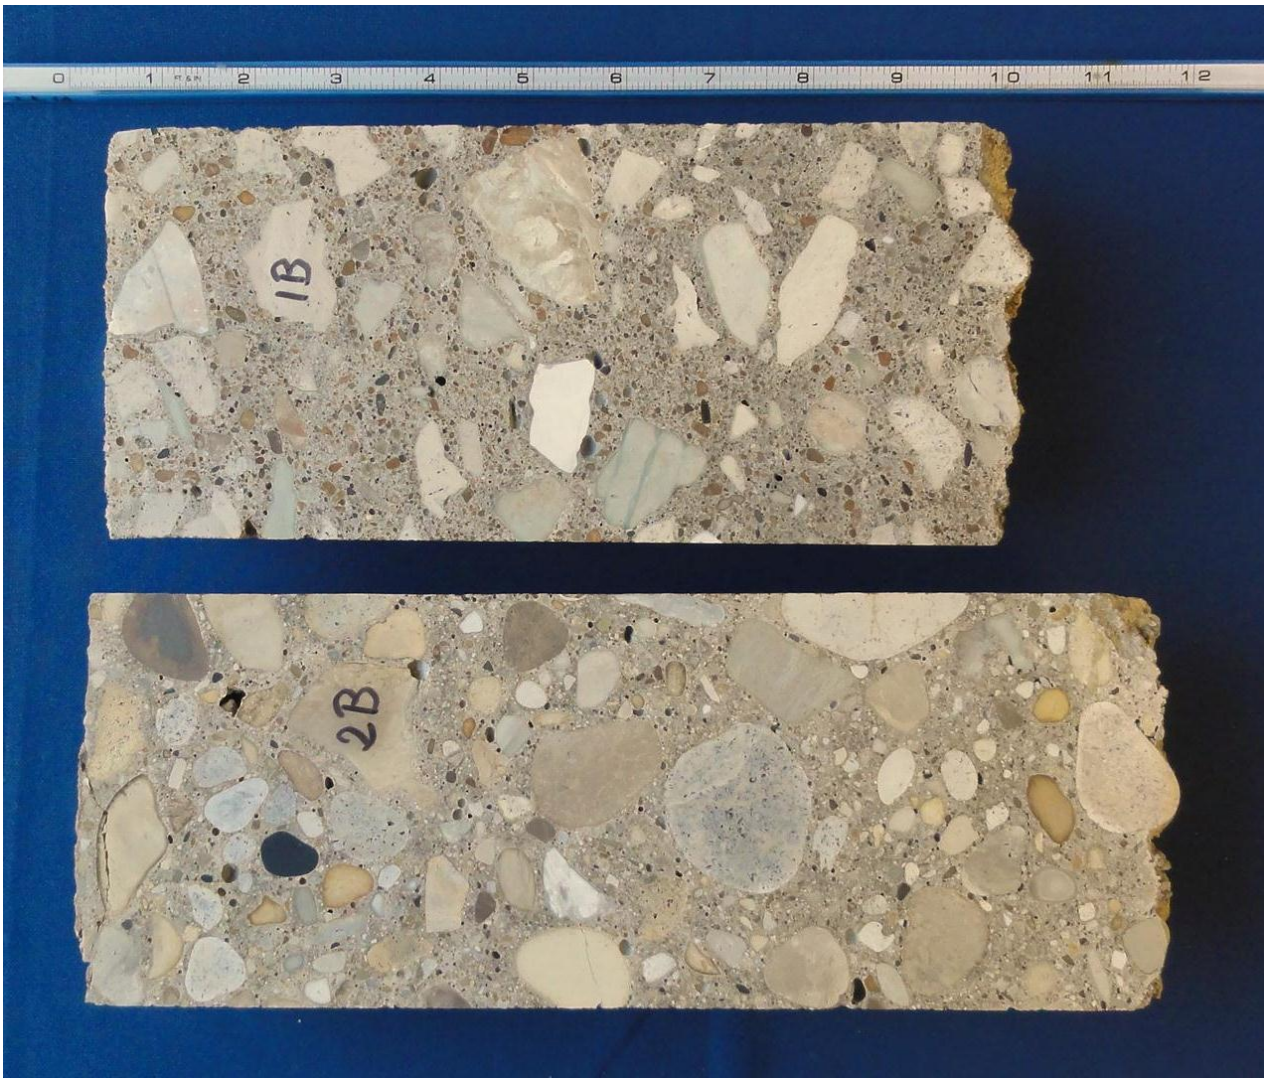
Figure 10. Lapped longitudinal cross sections of Cores 1B and 2B. Top surfaces of the cores are on the left of the photograph. Coarse aggregate in Core 1B is crushed limestone and in Core 2B it is natural calcareous and siliceous gravel. The distribution of the aggregates is uniform in both cores.

Figure 11. Lapped section of Core 1B. Crack locations are marked in red.

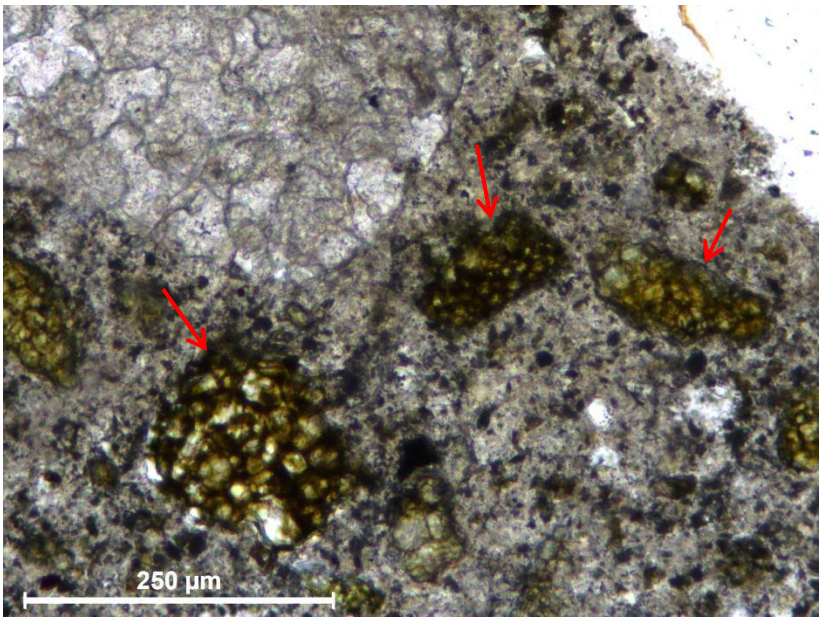
Figure 12. Core 1B - Arrows show examples of large residual portland cement particles. Thin-section photomicrograph. Plane-polarized light.

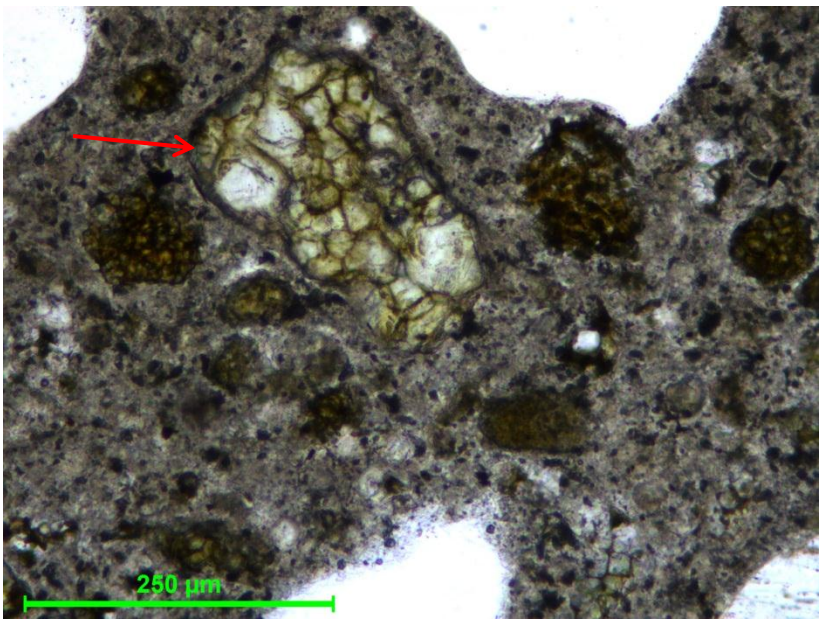
Figure 13. Core 1B - Arrow shows cement particle that is similar in size to small fine aggregate particles. Thin-section photomicrograph. Plane-polarized light.

Figure 14. Lapped section of Core 2B. Crack locations are marked in red.

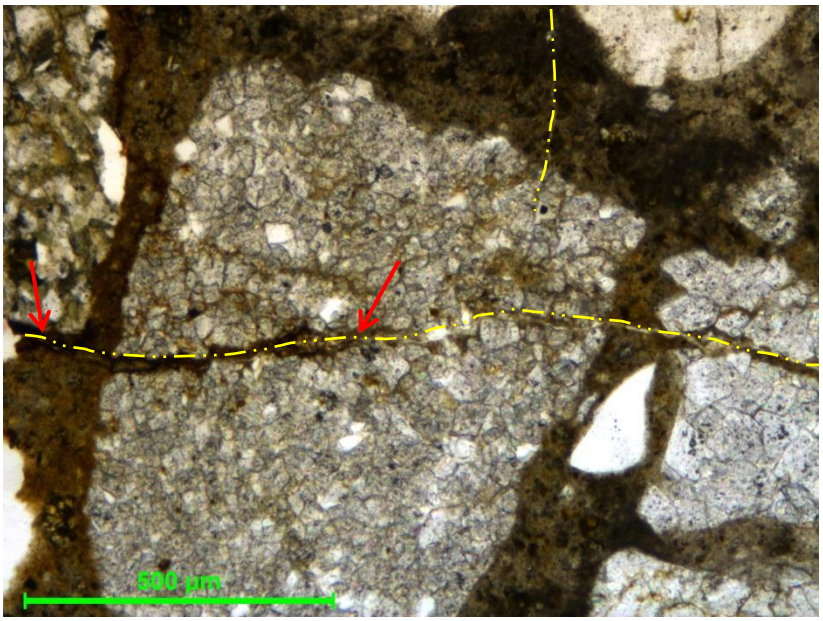
Figure 15. Core 2B - Microcracks are marked with yellow dashed lines. Red arrows show a section of a vertical microcrack that is filled with asphaltic material. Top surface is on left. Thin-section micrograph. Plane-polarized light.

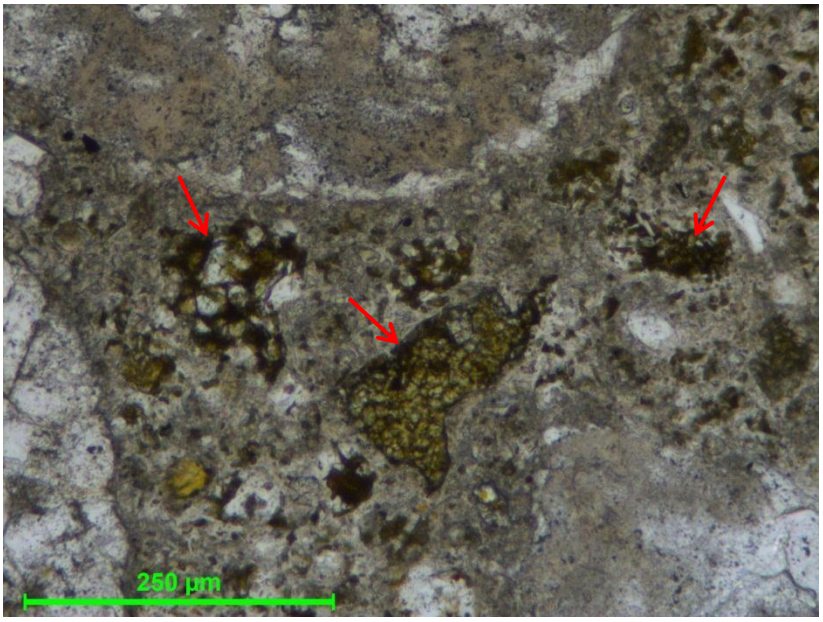
Figure 16. Core 2B - Arrows show examples of large residual portland cement particles. Thin-section photomicrograph. Plane-polarized light

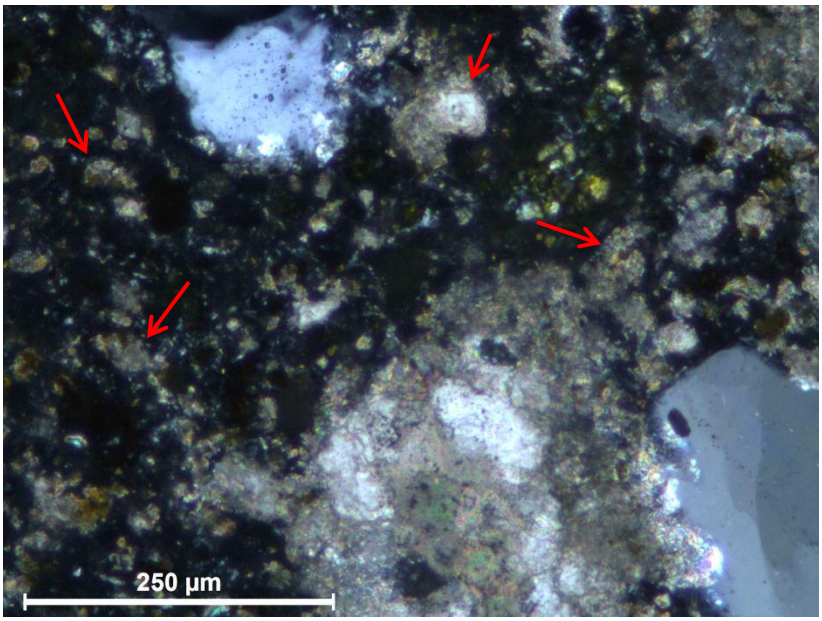
Figure 17. Core 2B - Arrows show examples of dust-size carbonate particles in the paste. Thin-section photomicrograph. Cross-polarized light.
