Re: Well Installation and Sampling Report
Abandoned Crestwood Well #1
LPC# 0310605500
Village of Crestwood, Cook County, Illinois
HWA-8317, Work Order No. 2

Figure 1
Monitoring Well Location Map
Crestwood Site
Crestwood, Cook County, Illinois

BORING AND WELL INSTALLATION LOG

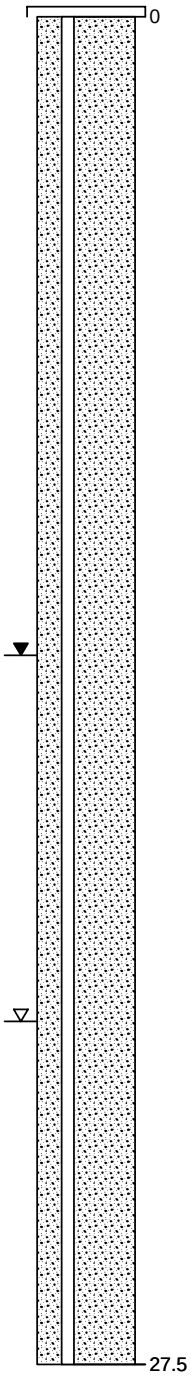
Monitoring Well
MW-01

31.5	SC		CLAYEY SAND and GRAVEL - gray, stiff, very moist to wet, some clay, medium-grained sand, coarse-grained dolostone gravel.	3/24	---	Rough drilling from 32 ft to 33 ft. Possible cobble. Drilled to 33 ft. Collected split spoon from 33 ft to 34 ft where competent bedrock was encountered.

33.5						
35.5	DO		DOLOMITE - light gray,strongly cemented, trace fossils, multiple fracture sets 0.2 to 0.3 m (0.5 to 1 ft) thick at various depths.

37.5				96/96	---	
39.5						
41.5			As Above			
43.5						
45.5			As Above - 0.1 m (3 in) fracture set.			
47.5			As Above - 0.3 m (1 ft) fracture set.	120/120	---

49.5						
51.5			As Above - 0.3 m (1 ft) fracture set.			
53.5			End of Boring at 16.2 m (53 ft) bgs.
