AERIAL ASSESSMENT OF DUTCHMAN CREEK JOHNSON COUNTY, IL December, 2004

Prepared by Wayne Kinney for Illinois Department of Agriculture

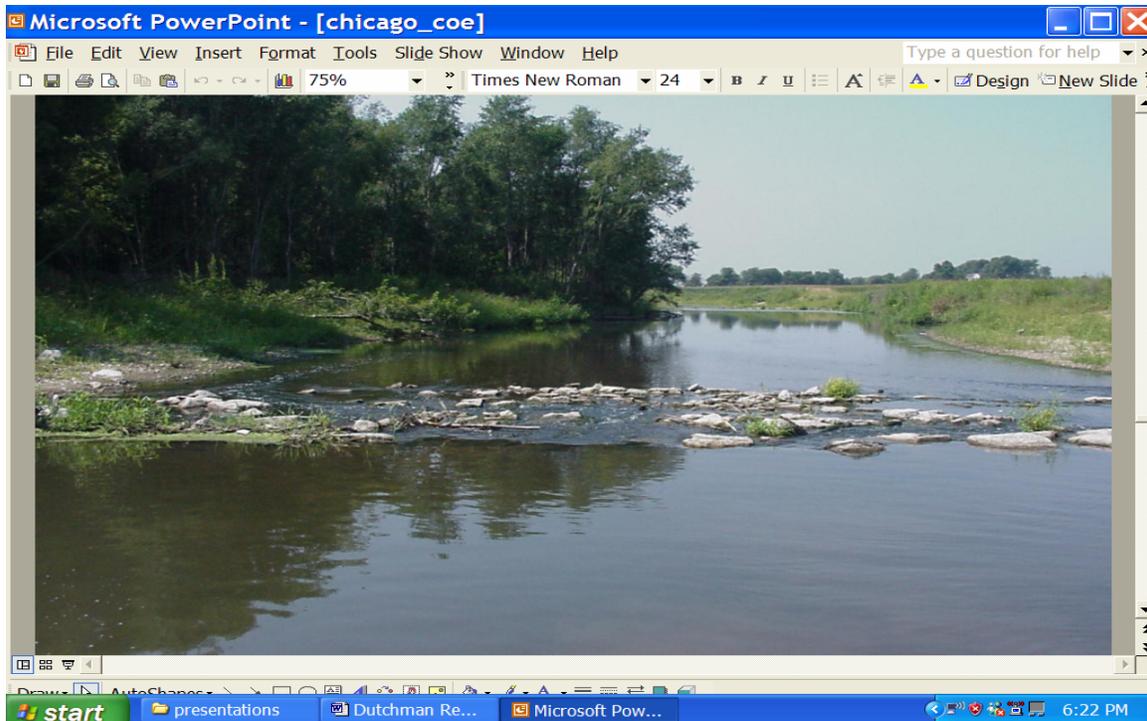
Fig. 13 Newberry Rock Riffle near Bloomington, Illinois

For estimating purposes, assume 8 Newberry type structures three feet high with a net drop of 1 foot per structure. Each structure will require approximately 650 tons of stone at a cost of \$40 per ton installed. Therefore, each structure is estimated to cost \$26,000 for a total estimated cost of \$208,000. Fig. 13 is an example of a Newberry style rock riffle near Bloomington, Illinois.

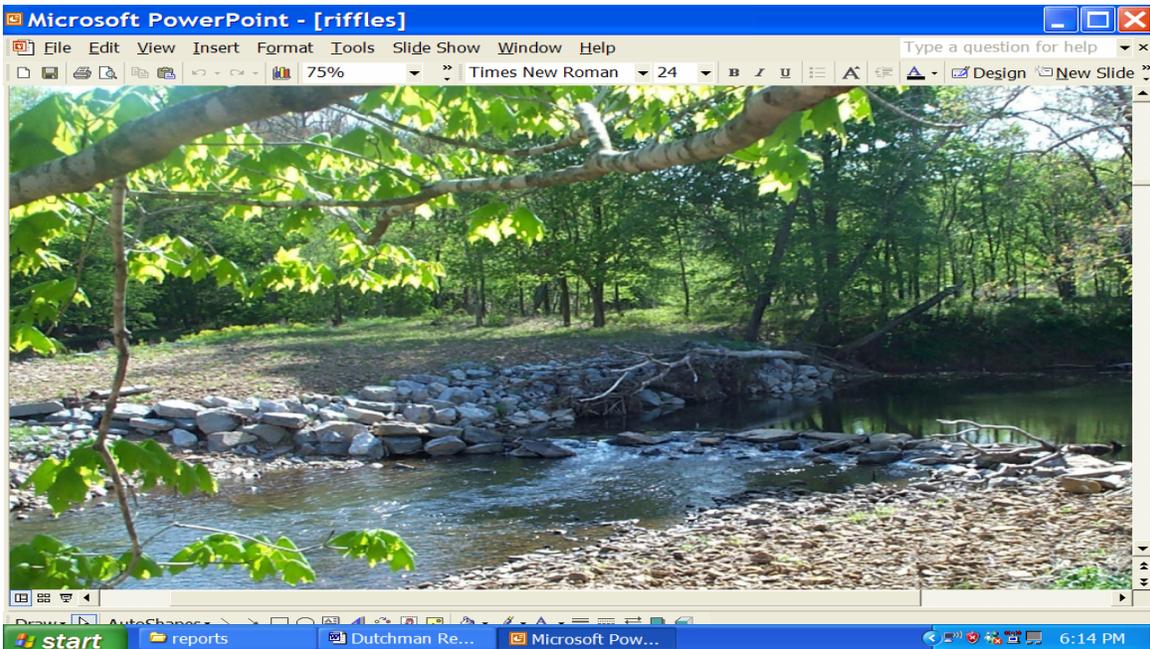
Fig. 14 Cross Vane Grade Control Structure near Eddyville, Illinois

Instead of using the Newberry type structure, the use of Rock Cross Vanes may be more effective at re-aeration. Cross Vanes would more easily adapt to concentrating the low flow toward the center of the stream and therefore increase the effective height, create more turbulence and consequently result in more aeration. Cross Vanes may be more economical as they would require considerably less stone, however the difficulty in construction and the handling of larger stones may offset most of the potential cost savings.

Fig. 14 is an example of a Cross Vane Structure constructed on Lusk Creek near Eddyville, Illinois.
