Mine Subsidence in Illinois: Facts for Homeowners

Circular 569 2013 2nd edition

ILLINOIS STATE GEOLOGICAL SURVEY
Prairie Research Institute
University of Illinois at Urbana-Champaign

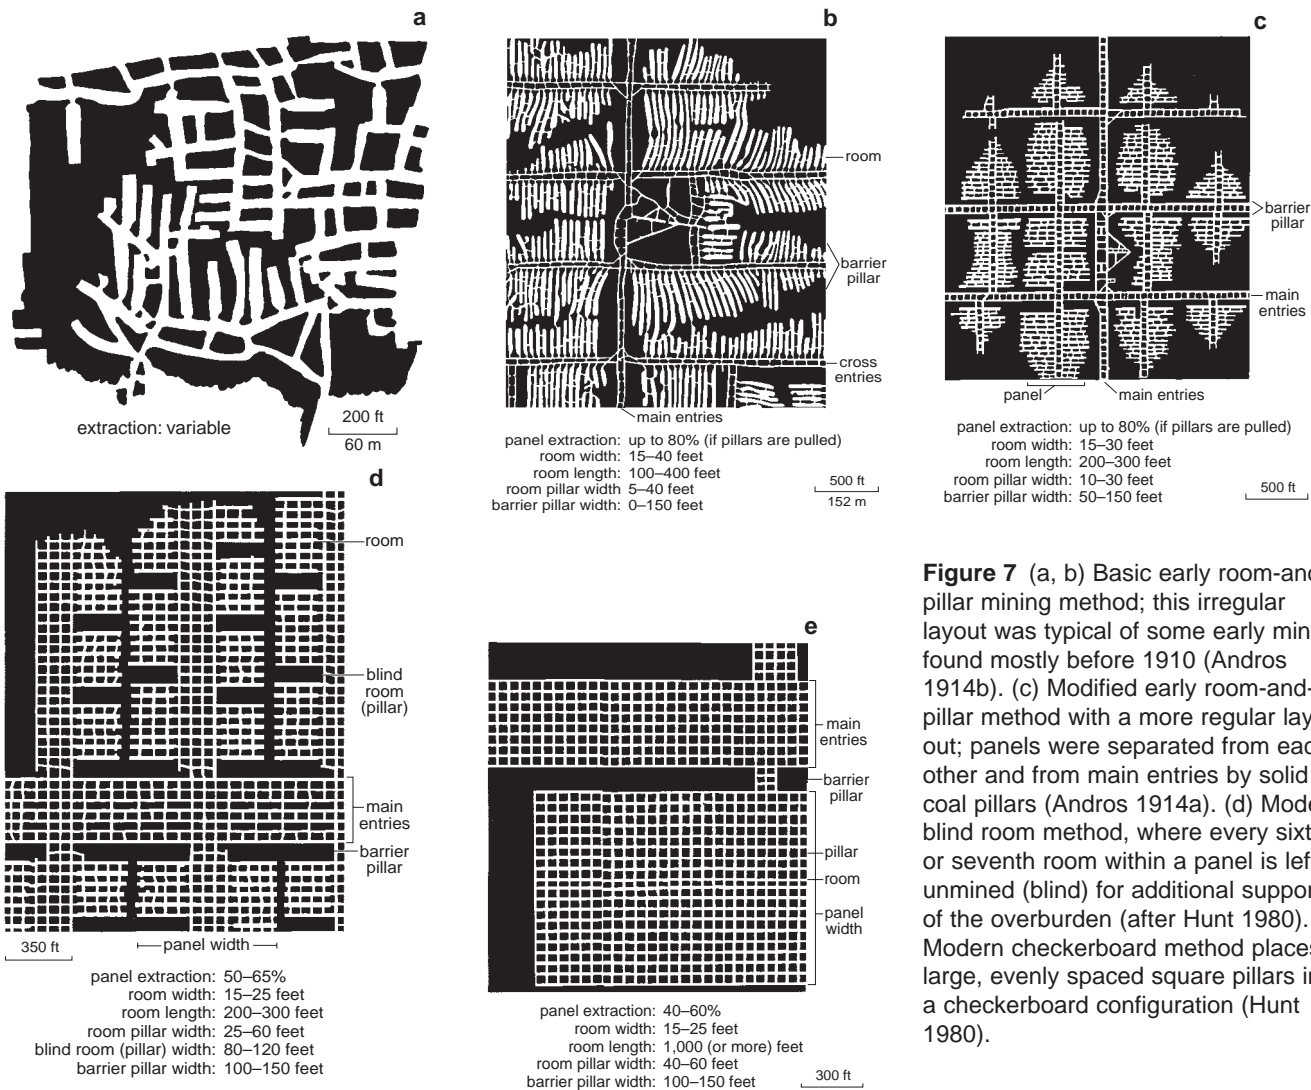
Figure 7 (a, b) Basic early room-and-pillar mining method; this irregular layout was typical of some early mines found mostly before 1910 (Andros 1914b). (c) Modified early room-and-pillar method with a more regular layout; panels were separated from each other and from main entries by solid coal pillars (Andros 1914a). (d) Modern blind room method, where every sixth or seventh room within a panel is left unmined (blind) for additional support of the overburden (after Hunt 1980). (e) Modern checkerboard method places large, evenly spaced square pillars in a checkerboard configuration (Hunt 1980).

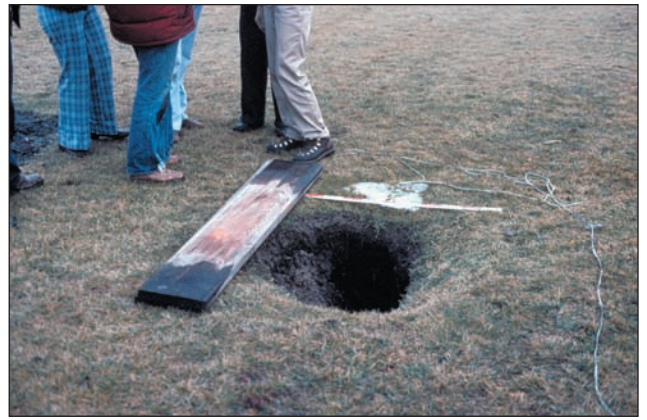
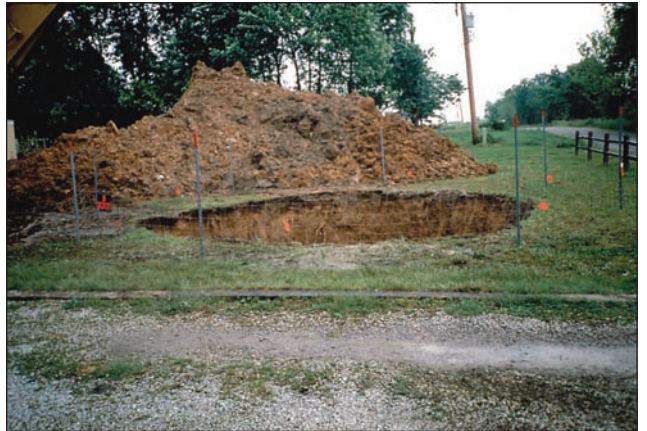
Figure 8 Diagram (Wildanger et al. 1980) and photographs of typical pit subsidence events.

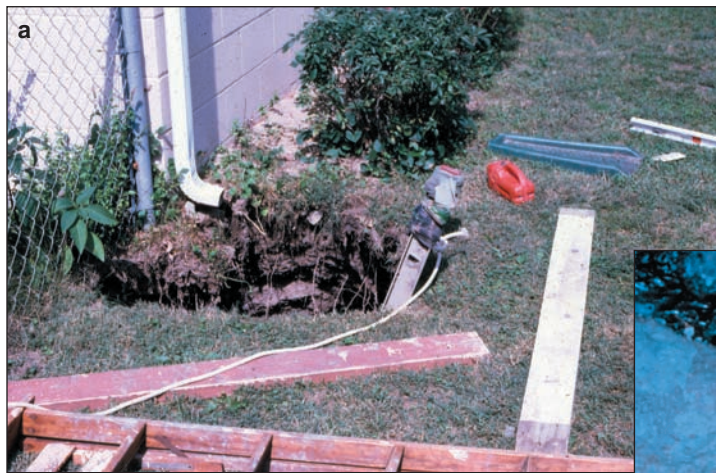
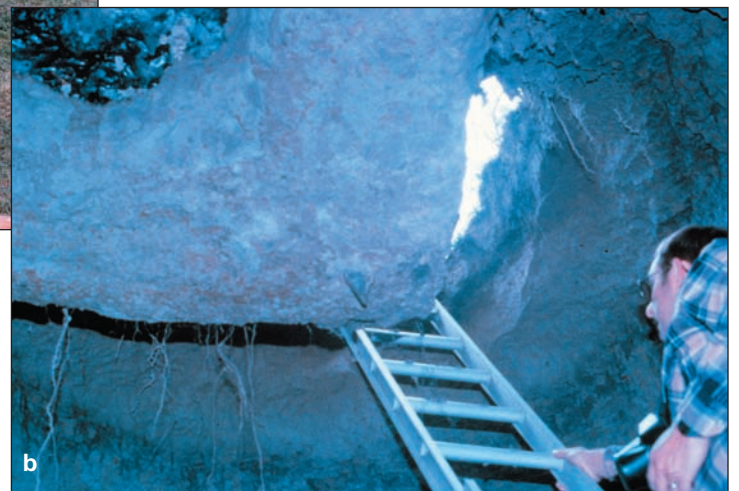
Figure 9 Pit subsidence under the corner of a house from (a) above and (b) below ground.

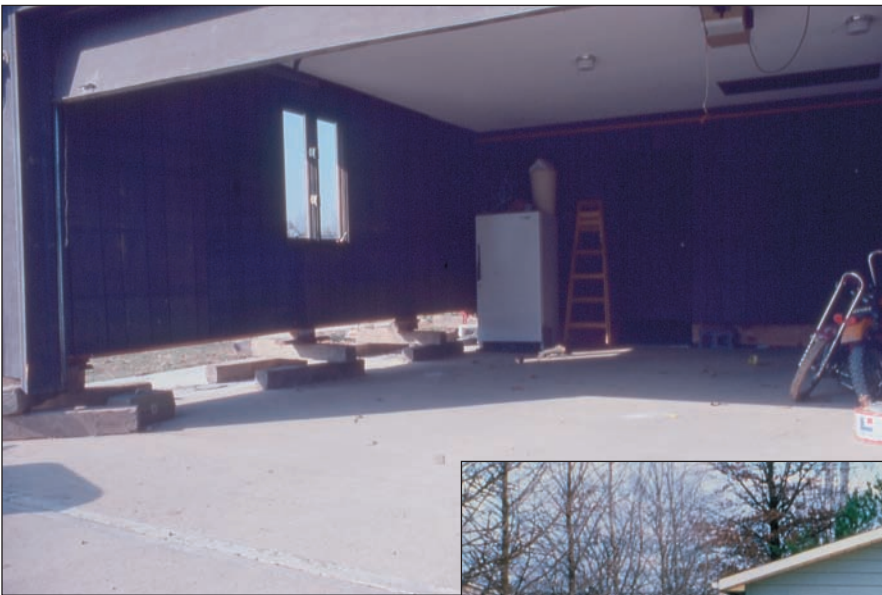
Figure 16 Load-bearing walls of a garage on a slab. The entire superstructure (frame) has been raised to a level position, exposing the interior of the garage. This re-leveling eliminates damaging stresses from differential movements of the foundation and maintains the superstructure level throughout the life of the event.

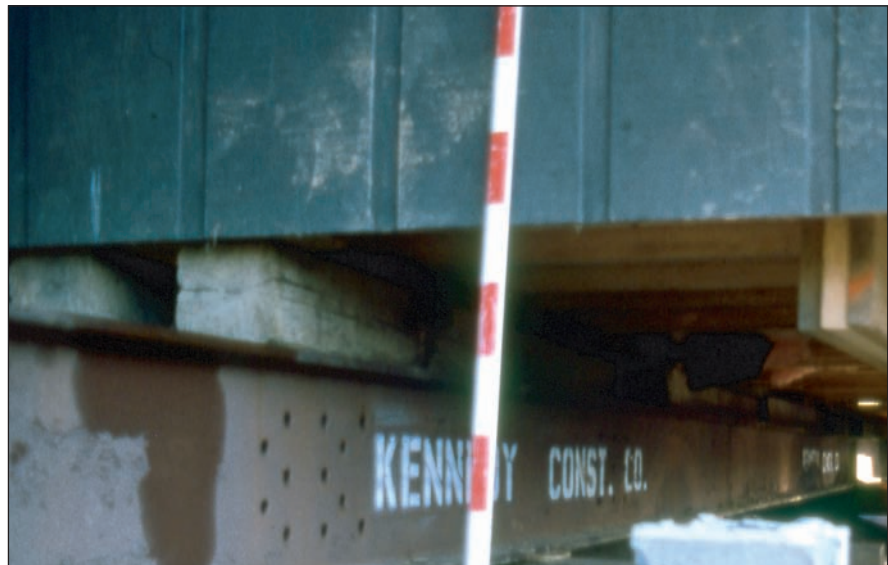
Figure 17 Concrete blocks of a crawl space have been removed to make room to jack the house to a level position. I-beams support the re-leveled house.

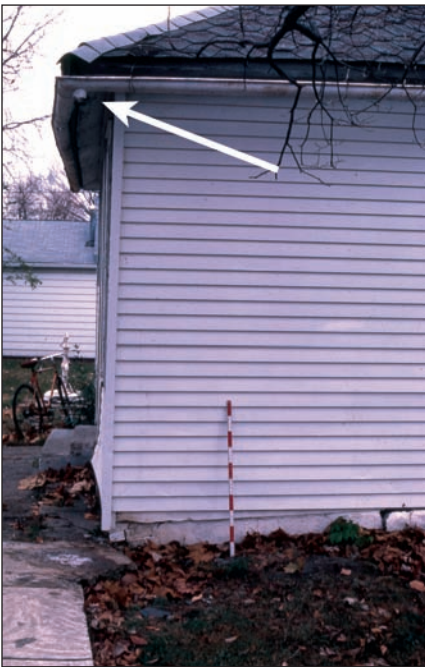
Figure 20 Foundation sinking at the corner of a building due to reduced support caused by excessive, repeated moisture changes. Note gutter drainage (arrow) and lack of downspout to channel drainage away from the foundation.

Reduced load-bearing support of the soil can cause foundations to tilt or sink at the corners (fig. 20). To avoid problems, homeowners should take measures to keep excessive amounts of water away from foundation walls. Downspouts should discharge water several feet from the house. The soil should be built up around the house and graded to slope away from the foundations so that water will then drain away from the house. The cracks produced in foundations by this rotating downward movement of the corner are wide at the top of the foundation and decrease to a nearly hairline crack near the base (footing) of the foundation. This pattern is in contrast to that

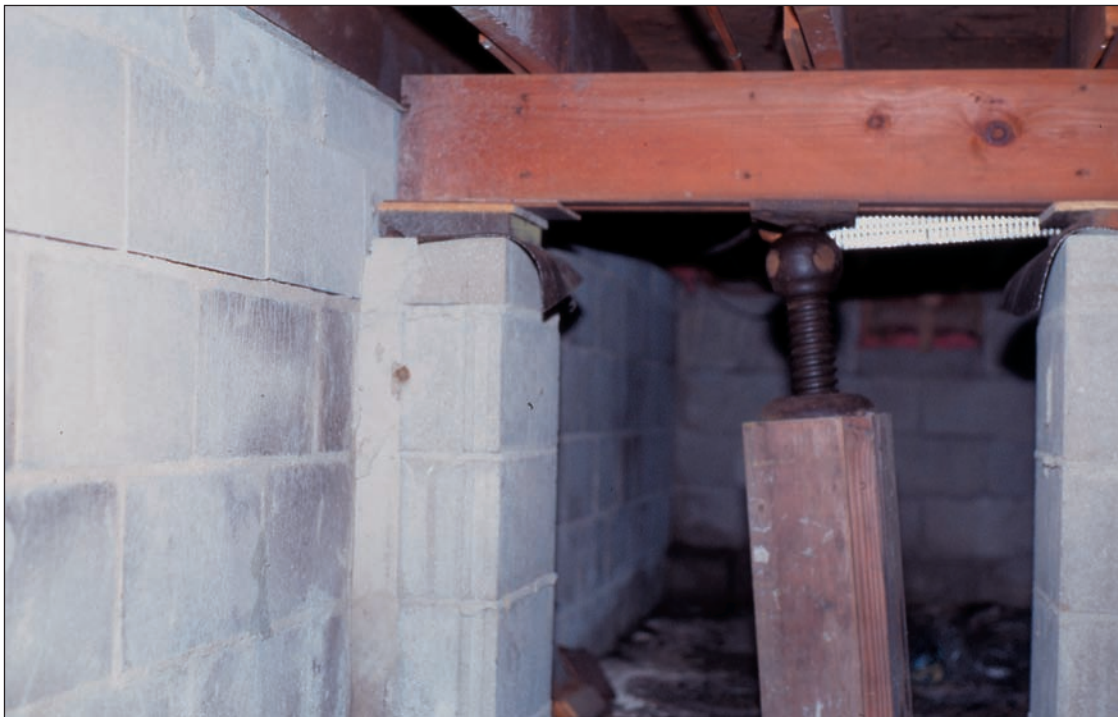
Figure 25 This main beam is not attached directly to the foundation wall. Because the beam is settling a different amount than the foundation and because some of the thick layers of shims are compressing, cracks have developed in the house above the beam.

Vertical intermediate supports for the main beam of a house may sink if they do not rest on properly sized concrete footings. Many times concrete blocks are used in crawl spaces to support the main beam running down the center of the house. Sometimes these blocks are resting directly on the soil, and, because they do not provide enough bearing area, they will sink into the soil. If there is inadequate contact area between a beam and a vertical support, enough weight can be concentrated onto the beam to crush it, thus lowering the floor. Also, if a thick stack of shims has been used between the beam and the vertical support, the shims may compress, lowering the beam (fig. 25). The ends of the main beam should

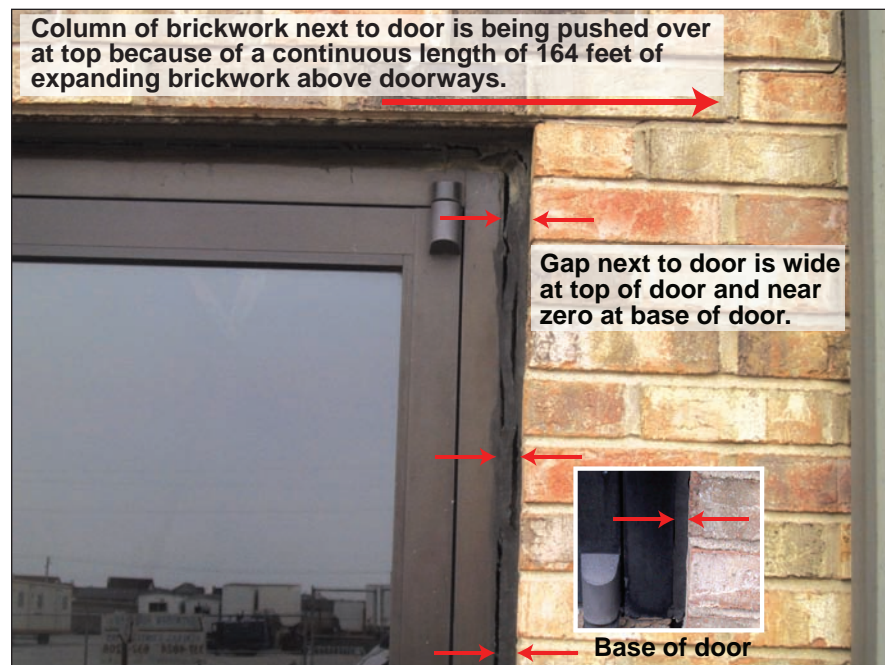
Figure 27 The long, continuous length of brickwork above the door is expanding, pushing the top of the door frame to the right while the base of the door remains stationary. This movement creates the gap and causes the door to stick while opening and closing.

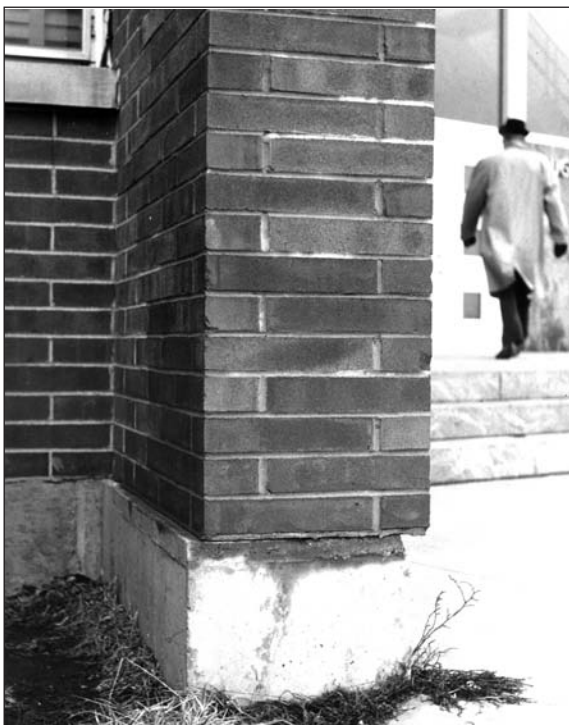
Figure 28 The largest movements are at the edges of the long, continuous wall. At this point, the short brick wall is being pushed off the foundation by the long, continuous brick wall to the left.

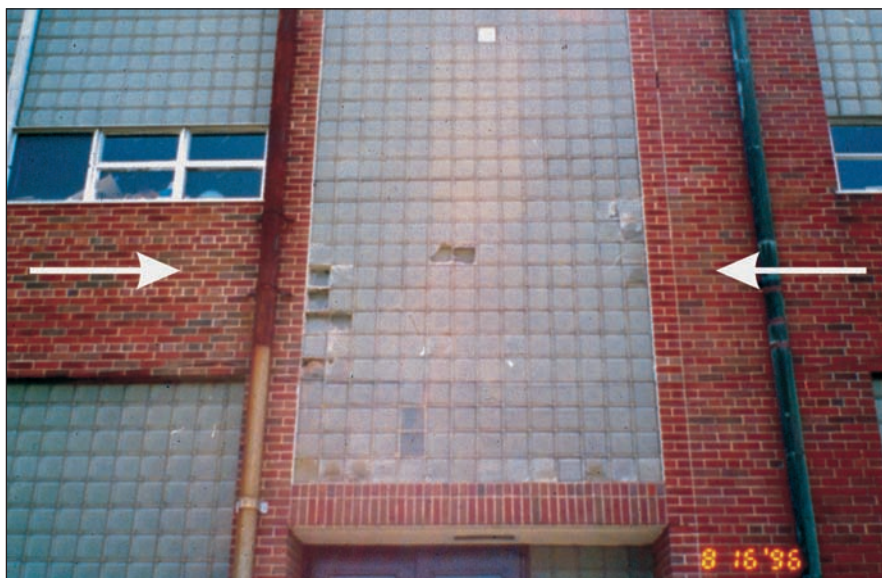
Figure 29 The long, continuous brickwork intersects the vertical glass block wall. Pressures have broken the glass blocks in line with the long, continuous expanse of brickwork.

blocks, may be crushed (fig. 29), and the sliding wall may become separated from the interior floor slab. To minimize this type of problem, functioning expansion joints should be incorporated into the construction. Expansion joints should be clear of any hard materials that may have fallen in during construction, and pliable caulking should be used to seal the gap.
