0390055036—DeWitt County
Clinton/Clinton Landfill 3
Groundwater File
Inspection Date: 1–2 April 2014
Inspector: Jeff Turner

Landfill Groundwater Inspection

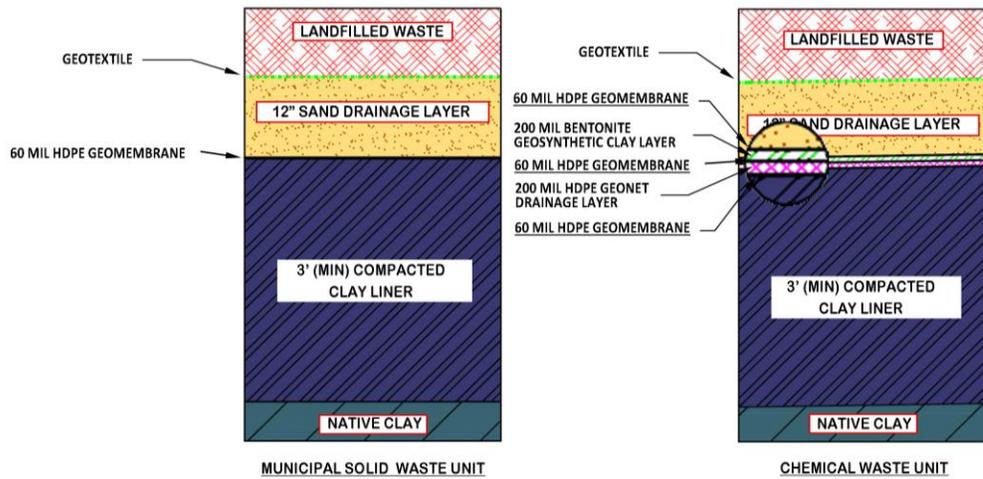
CLINTON LANDFILL NO. 3 - TYPICAL FLOOR LINER SECTIONS

The design of the liner and leachate drainage systems for the MSWU is one that is frequently used at non-hazardous waste landfills in Illinois. Starting from the bottom and going up, the liner consists of a layer of compacted clay three feet thick overlain by a 60-mil high density polyethylene (HDPE) geomembrane. The purpose of the liner is to stop leachate from migrating out of the waste and into the surrounding environment. On top of the liner is the leachate drainage layer, which consists of a one foot layer of sand overlain by a geotextile to exclude fine particles. The purpose of the sand layer, in conjunction with a network of pipes within it (known as the leachate collection system), is to prevent the height (or head) of leachate standing on the liner from exceeding one foot. The pipes conduct the leachate to a sump where it is pumped out of the landfill and into storage tanks. It may be solidified and placed back into the landfill or transported off-site for treatment. The current permit (Modification 44) authorized the installation of leachate recirculation wells in the MSWU only.

The design for the CWU exceeds Illinois' requirements for liner and leachate drainage systems in non-hazardous waste landfills. Under CWU design, again starting at the bottom, there is a three foot layer of compacted clay and a 60-mil HDPE geomembrane. These two layers constitute the secondary liner. On top of the secondary liner, there is a 200-mil HDPE geonet that serves as the secondary leachate drainage layer. On top of the geonet is a 200-mil bentonite geosynthetic clay liner (GCL) sandwiched between two layers of 60-mil HDPE geomembrane. This geomembrane/GCL/geomembrane sandwich serves as the primary liner system. Finally, on top of the primary liner system is the primary leachate drainage system composed of a foot of sand overlain by a geotextile.

The CWU design provides redundancy in the form of the secondary liner. If the primary liner system were to leak, the secondary liner is there to prevent leachate from escaping into the environment. Also, if leachate constituents were found in the secondary leachate drainage system, it would provide an early warning that the primary liner system has failed. For this reason, the secondary leachate drainage system is sometimes called the witness zone.

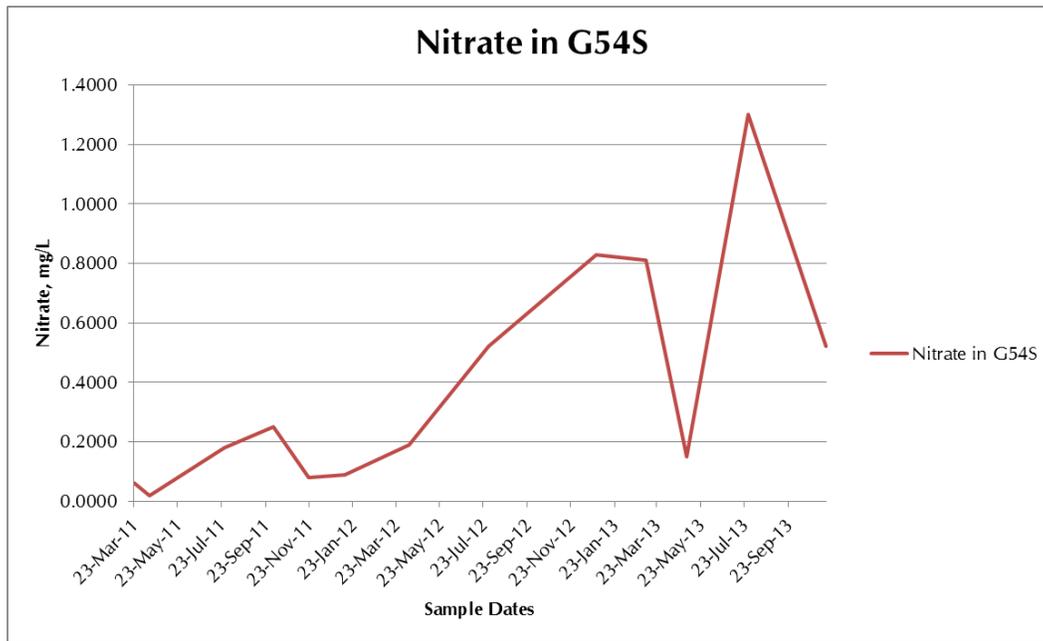
At the time 2012-019 was approved (30 April 2012), there was no apparent trend in nitrate concentrations in this well. However, nitrate concentrations in G54S show an apparent visual increasing trend in more recent times.

I emailed Joyce Day about the G54S nitrate increases and trend. She provided the following information.

The notice of observed increase for third quarter 2012 was in error in stating that a nitrate increase had previously been confirmed in G54S; however, nitrate was in fact addressed in the third/fourth quarter 2012 alternate source demonstration, Log 2013-030. It was not discussed in the 24 January 2013 initial submittal (hence my failure to find it there) as first quarter 2013 results (which were to be used for confirmation) were not yet available. Consequently, it was addressed in a 26 June 2013 addendum, per discussion with the Permit Section. Thus, while the chain of events led to the submittal being late, the observed nitrate increase in G54S has been included in an alternate source demonstration.

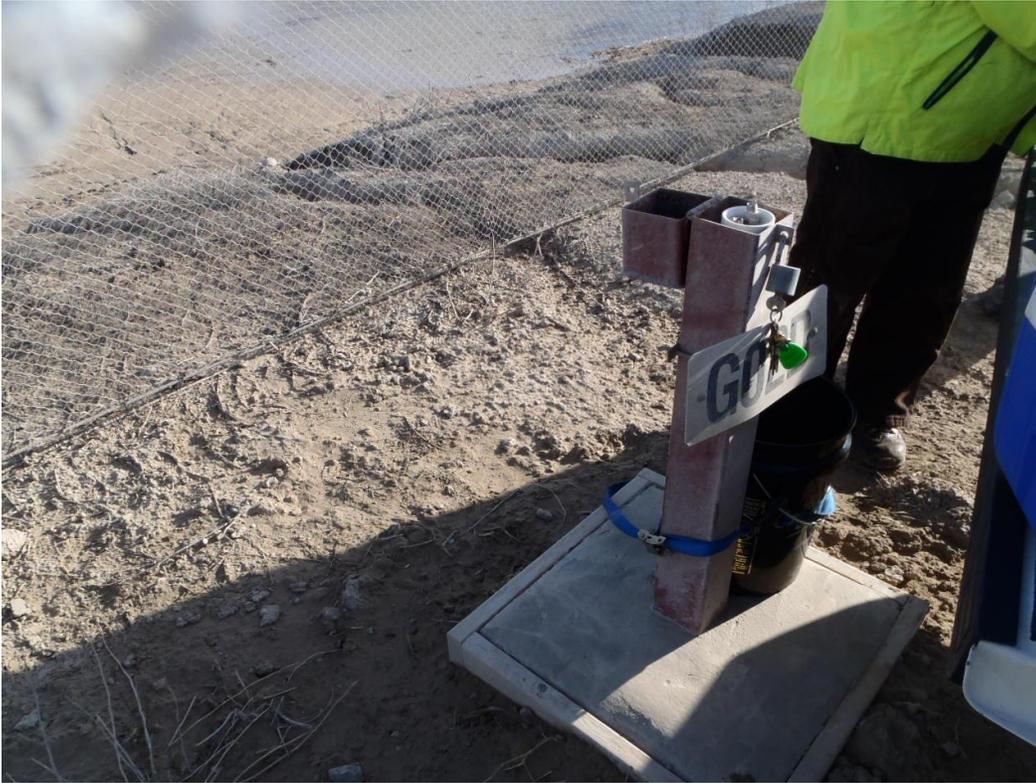
Date: 4/1/2014
Time: 8:34 A.M.
Direction: Northeast
Photo by: Jeff Turner
Exposure #: 001
Comments: G02D

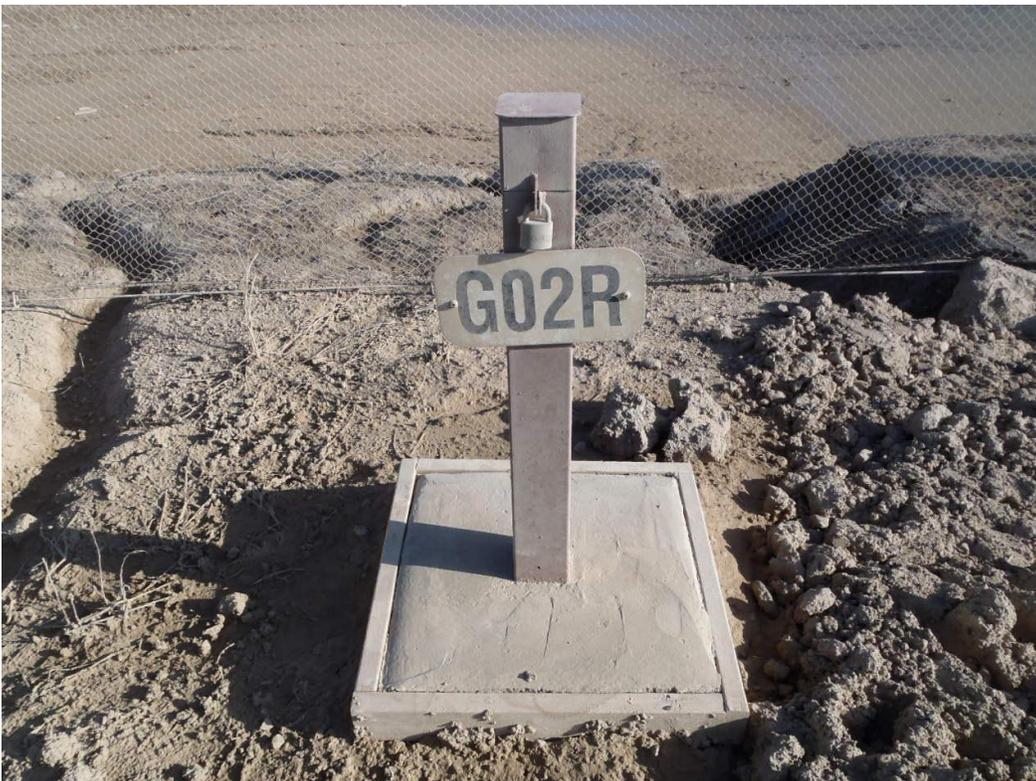
Date: 4/1/2014
Time: 8:35 A.M.
Direction: North
Photo by: Jeff Turner
Exposure #: 002
Comments: G02R

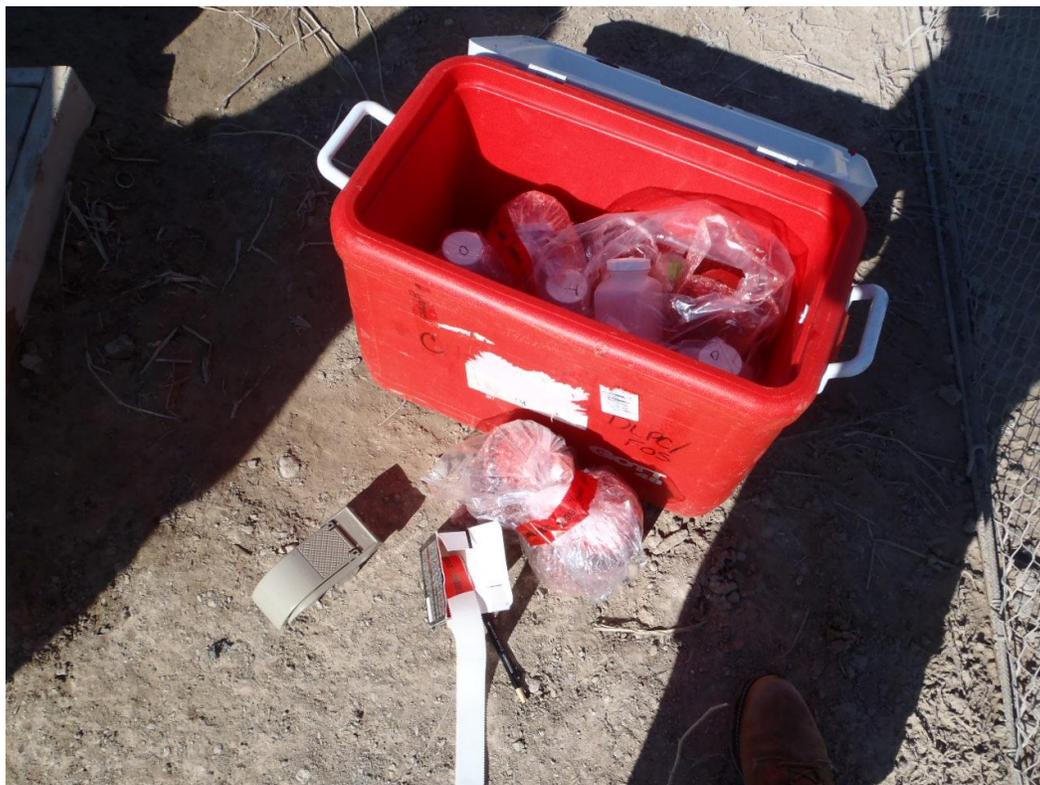
Date: 4/1/2014
Time: 9:46 A.M.
Direction: West
Photo by: Jeff Turner
Exposure #: 003
Comments: G02D
sample

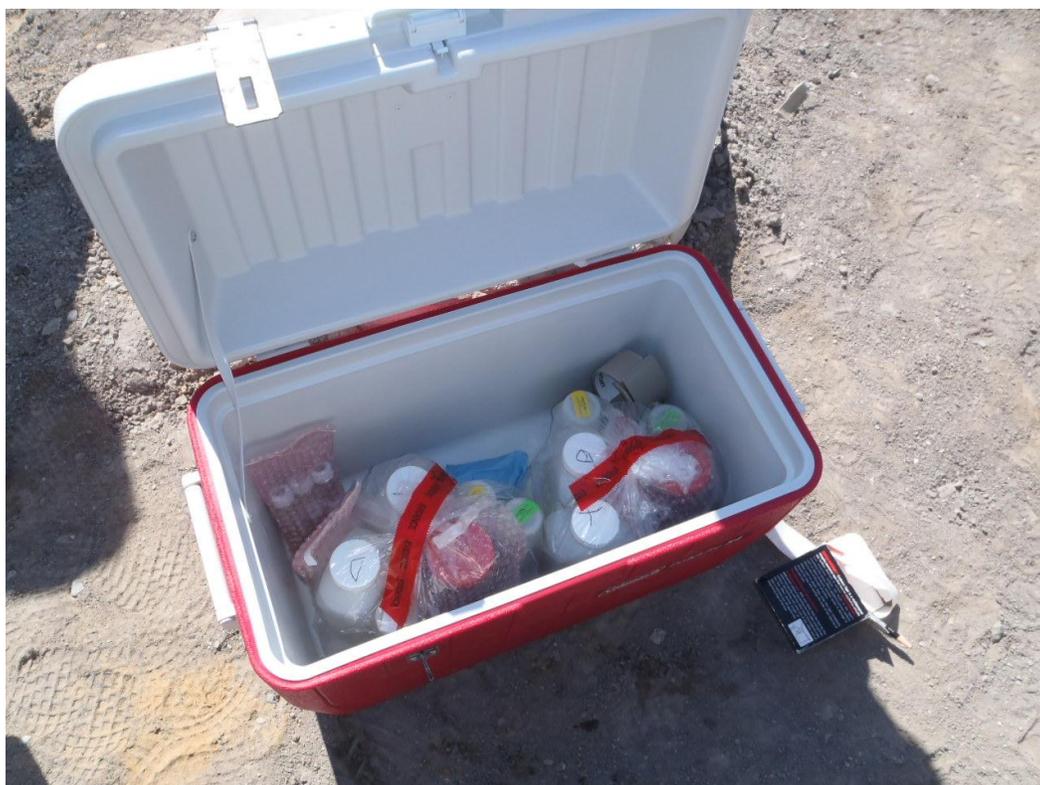
Date: 4/1/2014
Time: 11:09 A.M.
Direction: South
Photo by: Jeff Turner
Exposure #: 004
Comments: G25D
sample, including
field duplicate
"G90D"

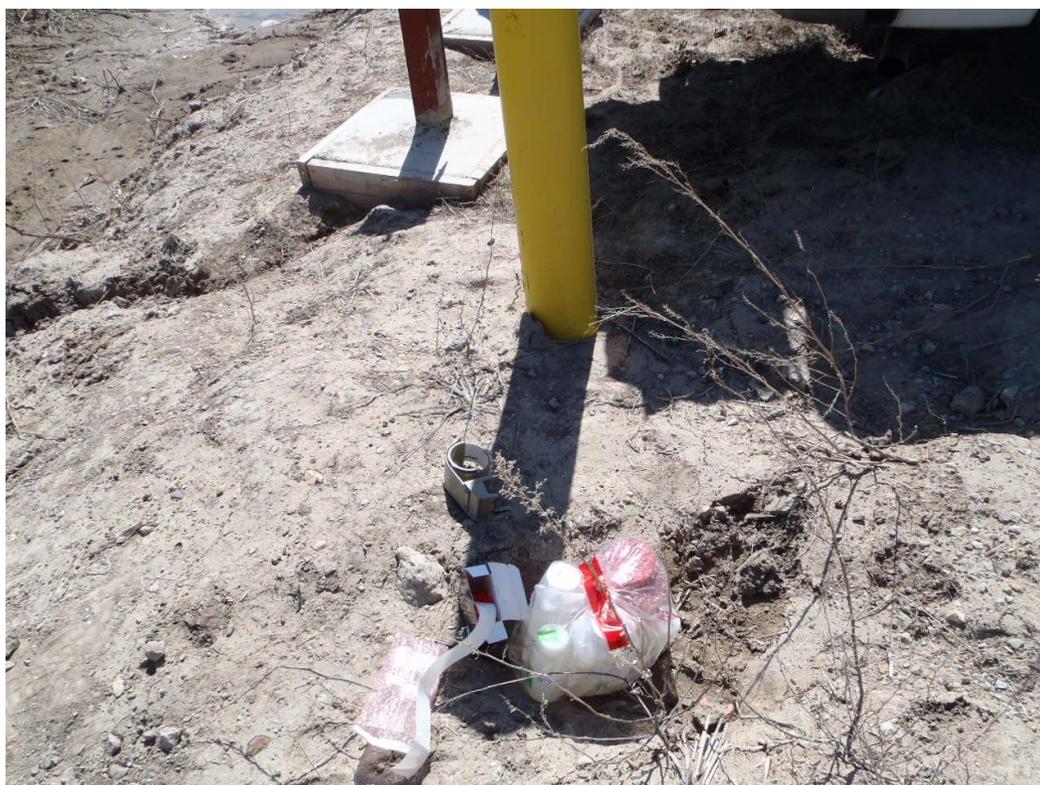
Date: 4/1/2014
Time: 12:18 P.M.
Direction: South
Photo by: Jeff Turner
Exposure #: 008
Comments: G16D &
sample

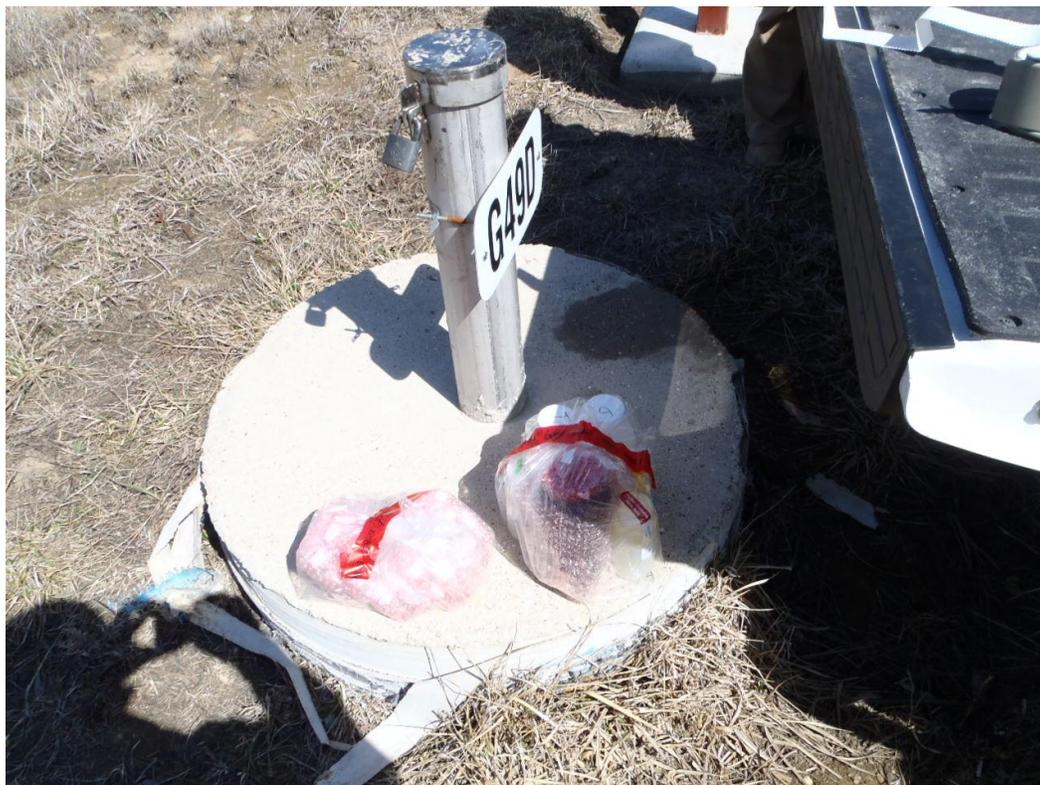
Date: 4/1/2014
Time: 2:21 P.M.
Direction: East
Photo by: Jeff Turner
Exposure #: 011
Comments: G49D &
sample

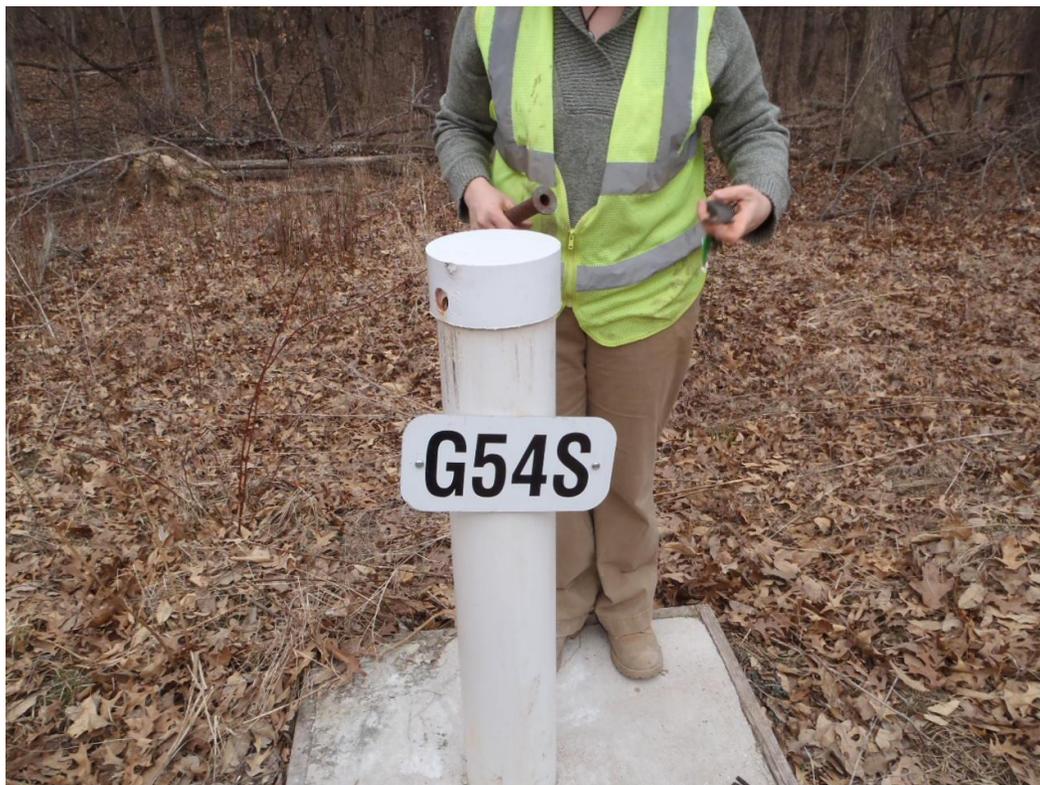
¹⁷ G54S is in a wooded area southeast of the CWU. Access is across an open field and then on a trail through the woods. Having now seen the well, I can well believe that access is difficult during wet weather and that it would be too far to walk carrying heavy equipment. Thus, inclement weather sometimes results in sampling delays.

Date: 4/1/2014
Time: 4:23 P.M.
Direction: East
Photo by: Jeff Turner
Exposure #: 023
Comments: G54S

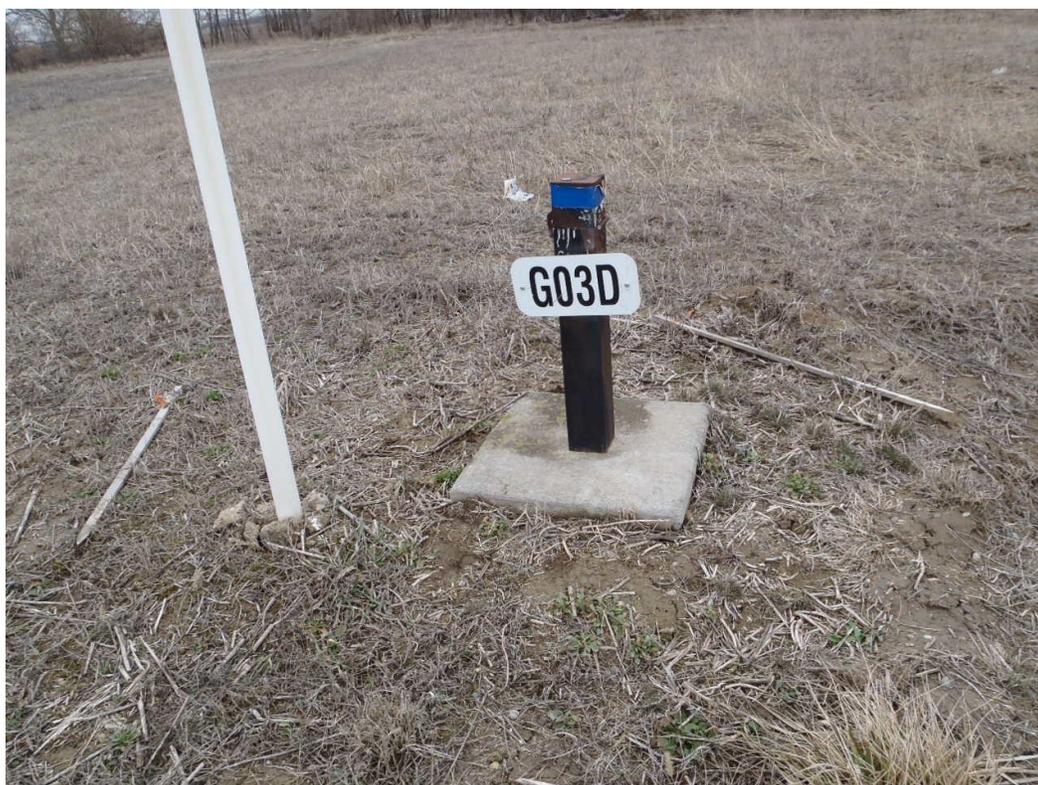
Date: 4/2/2014
Time: 10:48 A.M.
Direction: East
Photo by: Jeff Turner
Exposure #: 040
Comments: G03D;
white pipe is
visibility marker

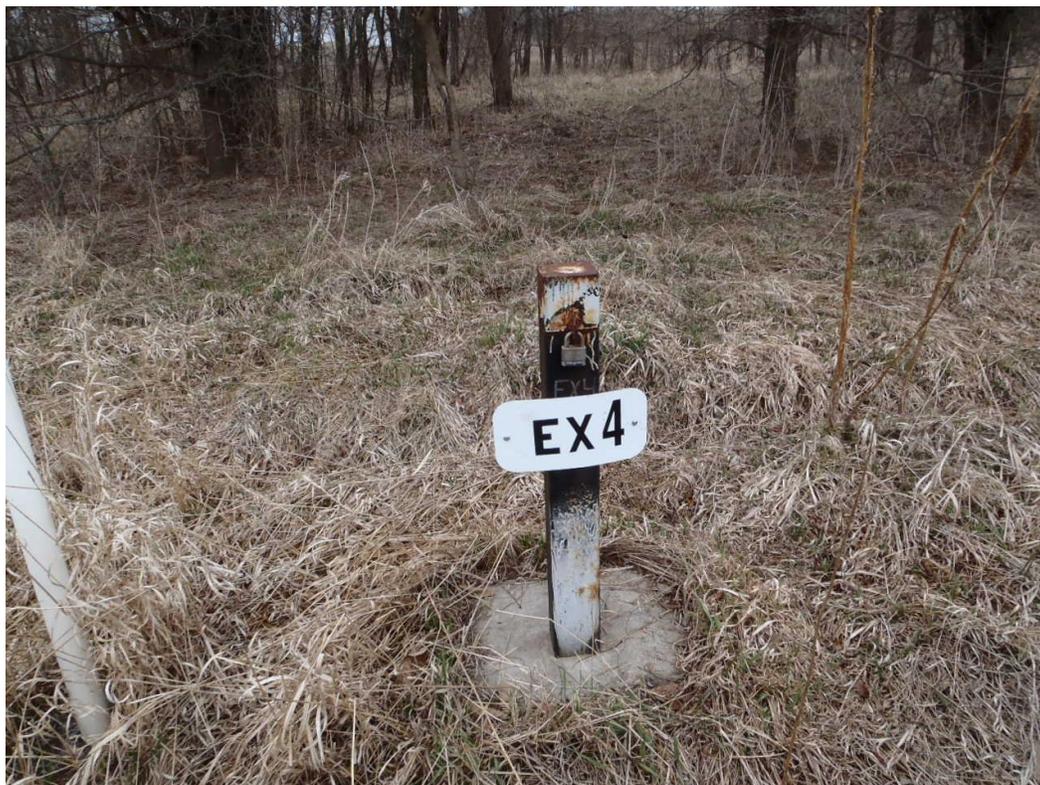
Date: 4/2/2014
Time: 11:05 A.M.
Direction: West
Photo by: Jeff Turner
Exposure #: 041
Comments: EX-4; white pipe is visibility marker

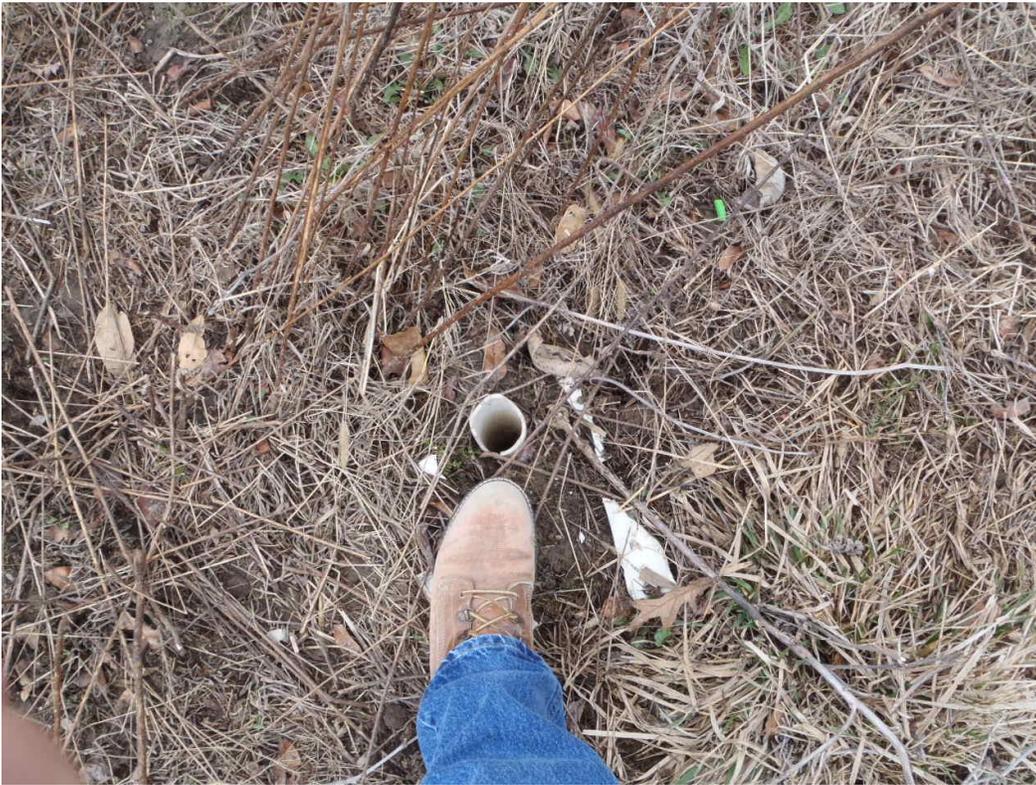
Date: 4/2/2014
Time: 11:11 A.M.
Direction: South
Photo by: Jeff Turner
Exposure #: 043
Comments: Broken
visibility marker just
east of G04M

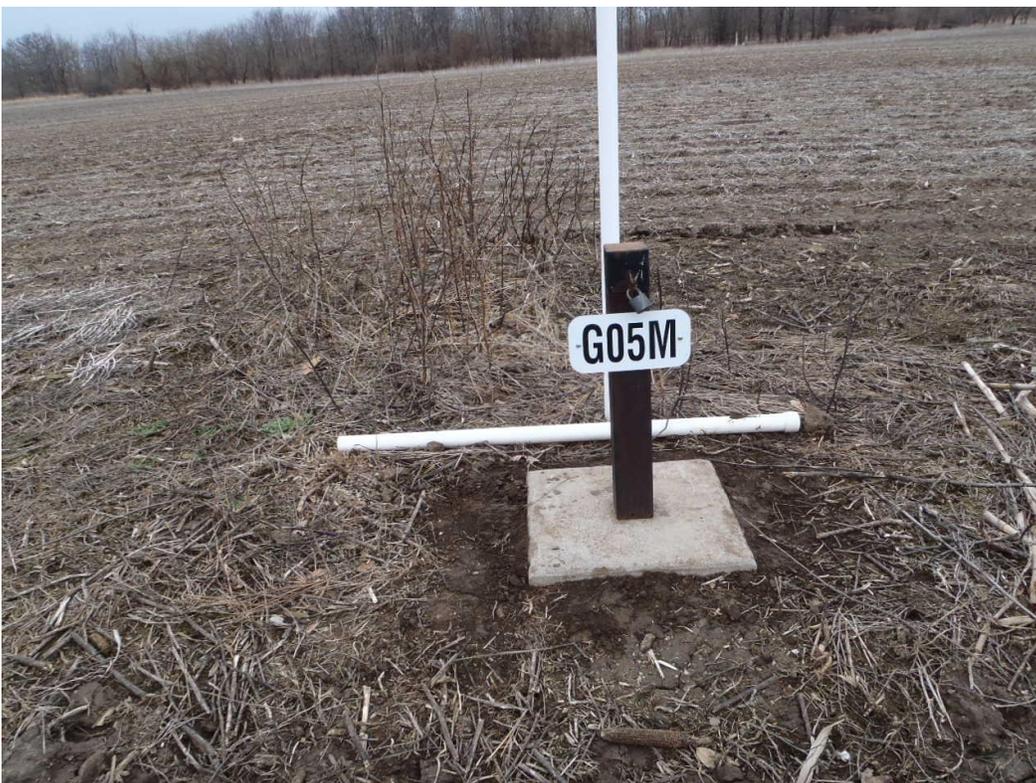
Date: 4/2/2014
Time: 11:15 A.M.
Direction: West
Photo by: Jeff Turner
Exposure #: 044
Comments: G05M;
upright white pipe is
visibility marker

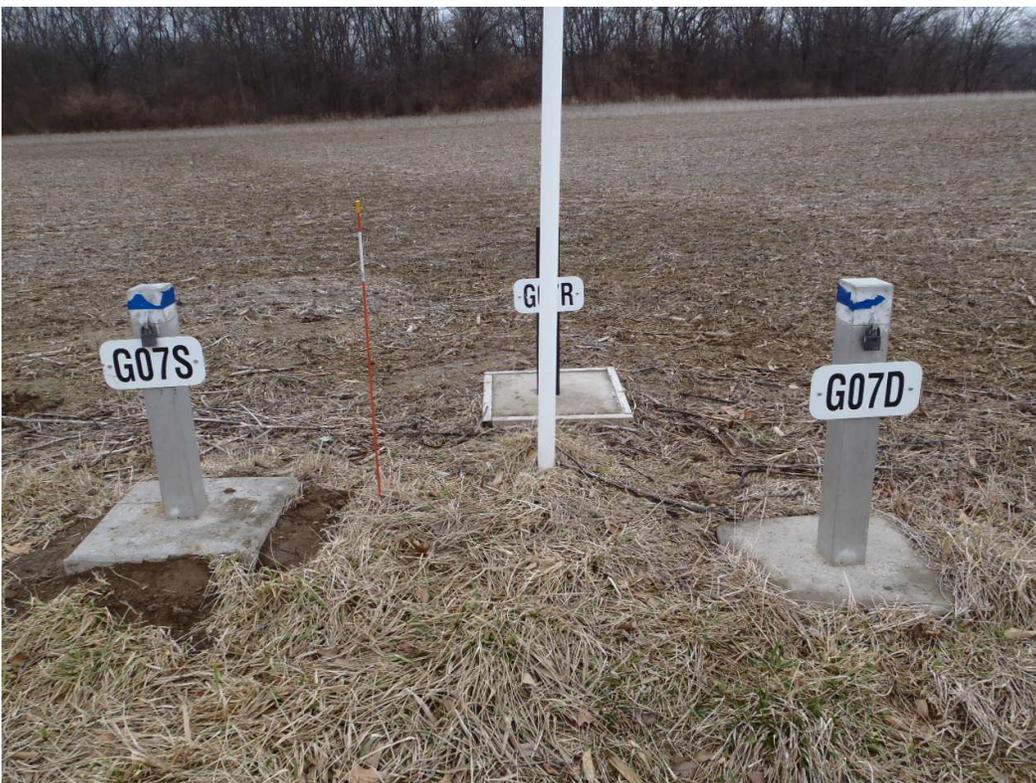
Date: 4/2/2014
Time: 11:23 A.M.
Direction: West
Photo by: Jeff Turner
Exposure #: 046
Comments: G07
cluster; white pipe is
visibility marker.
Well behind white
pipe is G07R.

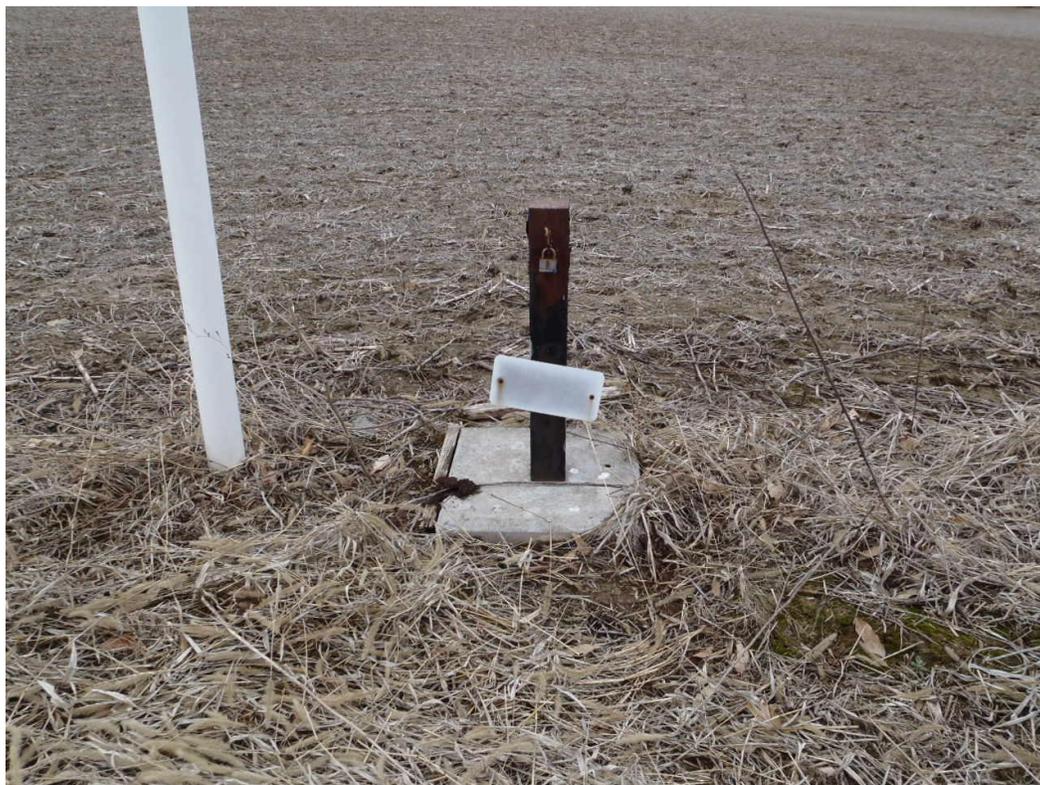
Date: 4/2/2014
Time: 11:29 A.M.
Direction: East
Photo by: Jeff Turner
Exposure #: 047
Comments: EX-5; white
pipe is visibility
marker
