ILLINOIS ENVIRONMENTAL PROTECTION AGENCY

Re: LPC#0390055036—DeWitt County
Clinton/Clinton Landfill #3
Compliance File

LPC#0390055036—DeWitt County
Clinton/Clinton Landfill #3
FOS File
February 18, 2014 Inspection
Inspector: Dustin Burger
GIS Information from BOL Inventory: N40.11507 W-88.9589

Narrative Inspection Report

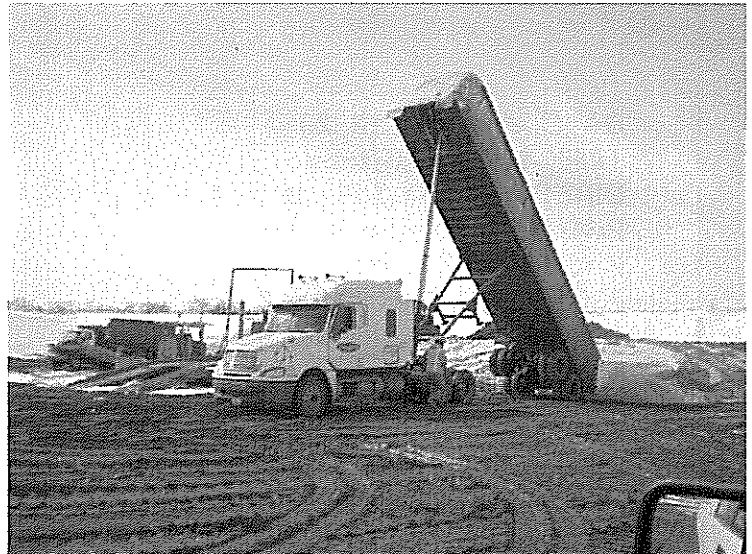
The active area was located on the floor of cell 5A1. We watched several trucks unload. One carried bottom ash from ADM (photo 1). Another was a transfer semi-truck that used the truck tipper to dump a load of municipal waste. The landfill trains the truck drivers to operate the tipper, so the landfill is not required to have an employee stop their work to operate the equipment. The tipper is not used often, and this was actually one of the few times I have seen it operate at this landfill. As a contrast, the landfill at Pontiac where Mr. Bryant worked previously operates 3-6 tippers at a time. At one time that facility had over 10 operating at once. The difference between the two facilities is the Pontiac site's main customers were transfer stations in the Chicago area, whereas most of the waste received at Clinton comes in on rear loading packer trucks (what most people would call a typical garbage truck) and roll-off boxes, which are large removable dumpsters that can be carried by a truck.

DATE: February 18, 2014
TIME: 11:10A.M.-Noon.
DIRECTION: West
PHOTO by: Dustin Burger
PHOTO FILE NAME:
0390055036~02182014-001.jpg
COMMENTS: Load of bottom ash
being dumped

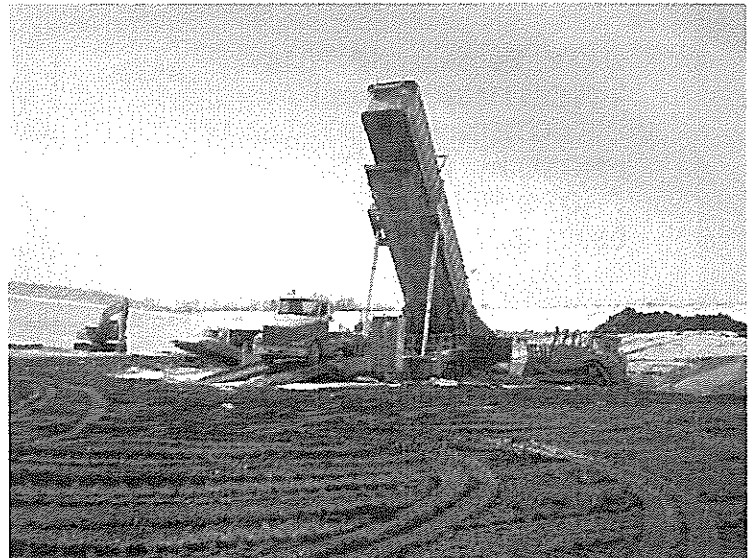
DATE: February 18, 2014
TIME: 11:10A.M.-Noon.
DIRECTION: West
PHOTO by: Dustin Burger
PHOTO FILE NAME:
0390055036~02182014-002.jpg
COMMENTS: Load of municipal
waste on truck tipper

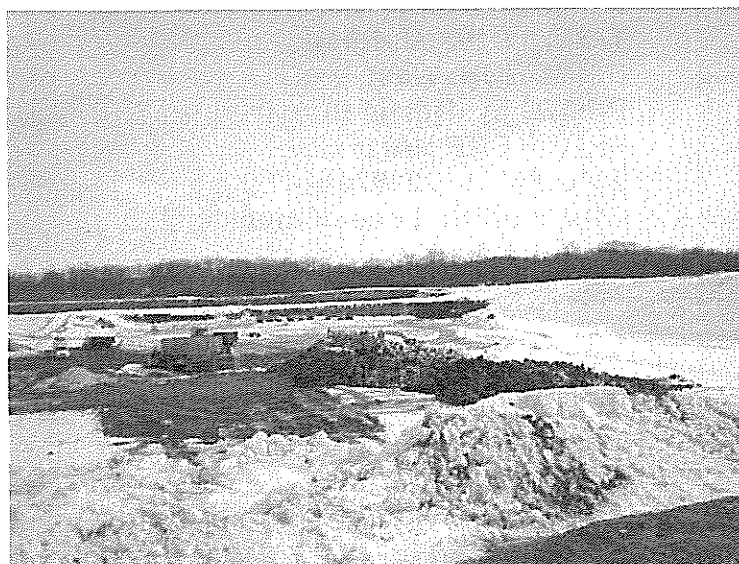
DATE: February 18, 2014
TIME: 11:10A.M.-Noon.
DIRECTION: East
PHOTO by: Dustin Burger
PHOTO FILE NAME:
0390055036~02182014-004.jpg
COMMENTS:

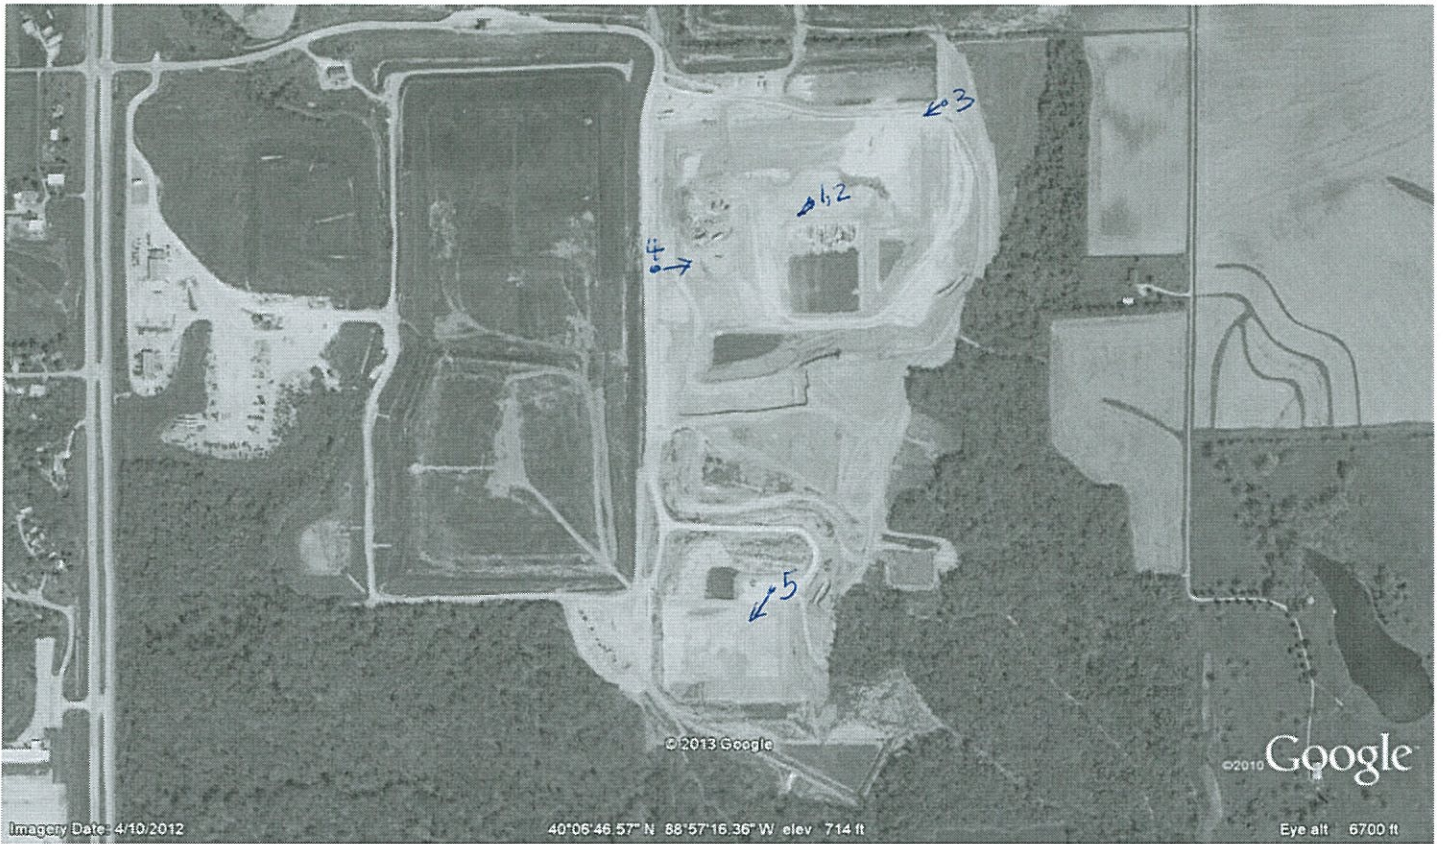
Site Map.

* denotes photo location/direction.
